# ENVIRONMENTAL MONITORING REPORT

# HARTENBOS LANDGOED PHASE 2 DEVELOPMENT ON A PORTION OF THE REMAINDER OF THE FARM VAALEVALLEY 219, MOSSEL BAY

**DATE:** 12<sup>th</sup> December 2019

**REPORT NR:** EMR/HBLG/MSB/04/19

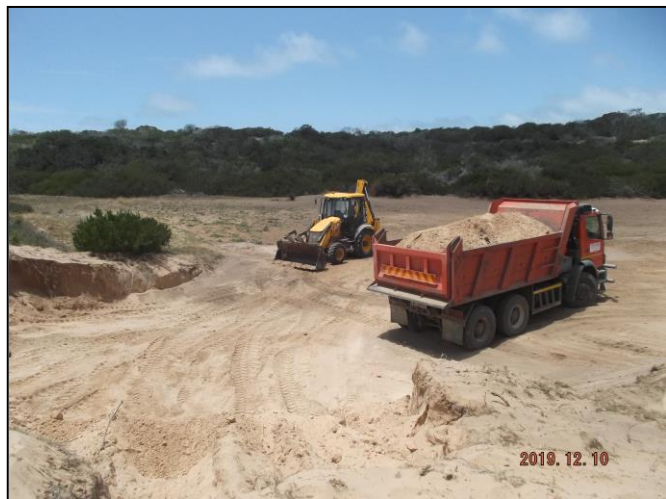
**Image 1: As understood by the operator the sand was excavated and transported to a different location**

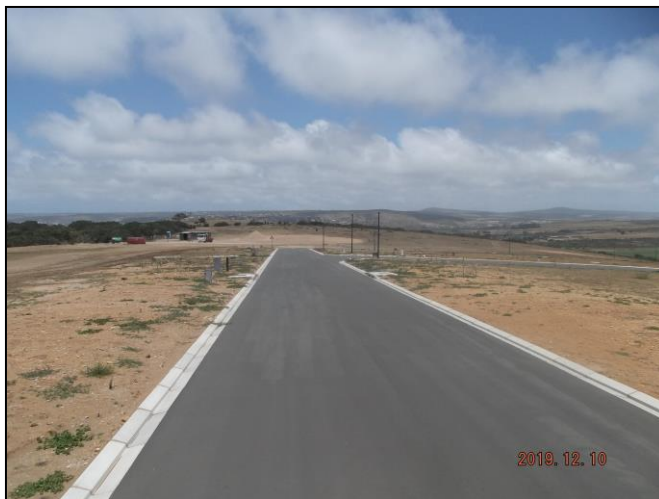
**Image 2: New road network within the development site**

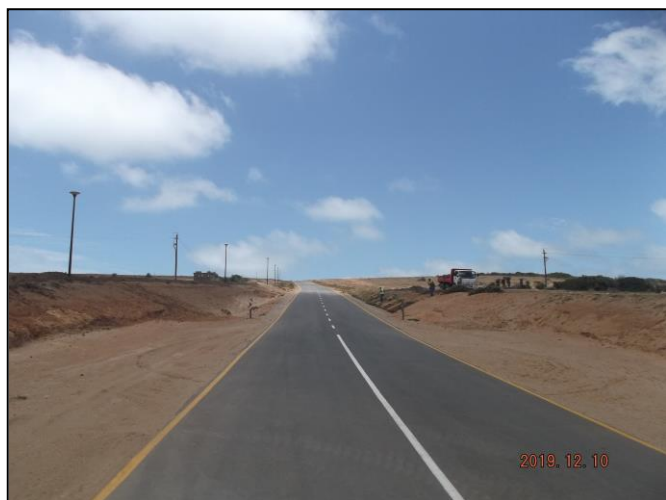
**Image 3: New road network within the development site**

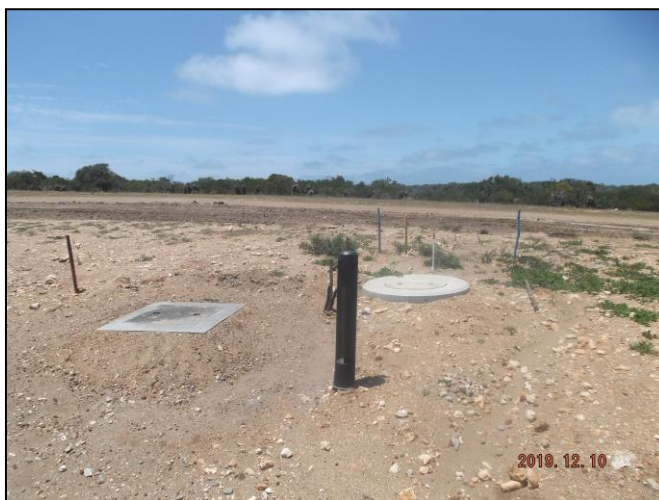
**Image 4: New installed sewerage cesspit and valve chamber**

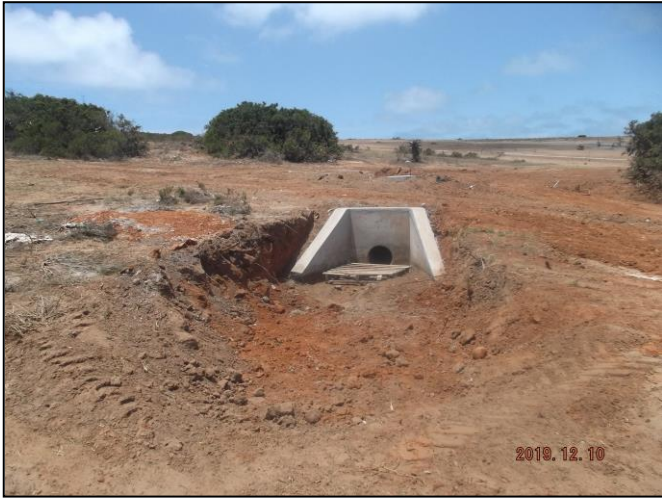
**Image 5: New installed storm water culvert**

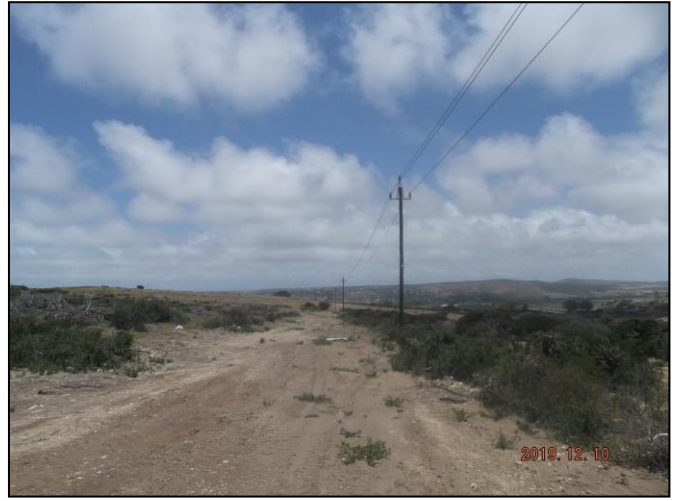
**Image 6: New installed powerlines within the development site**

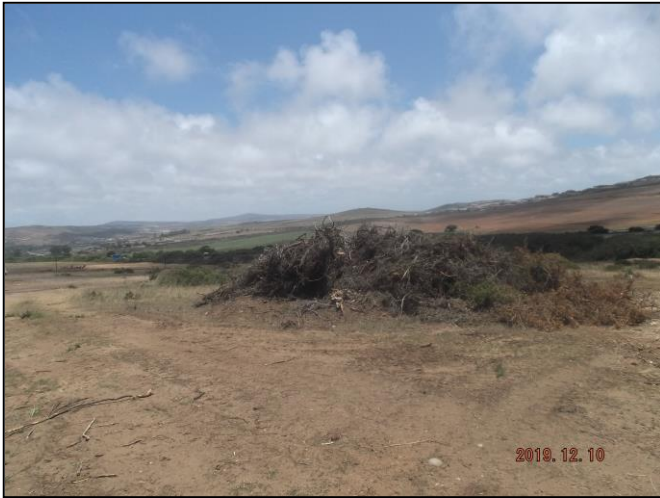
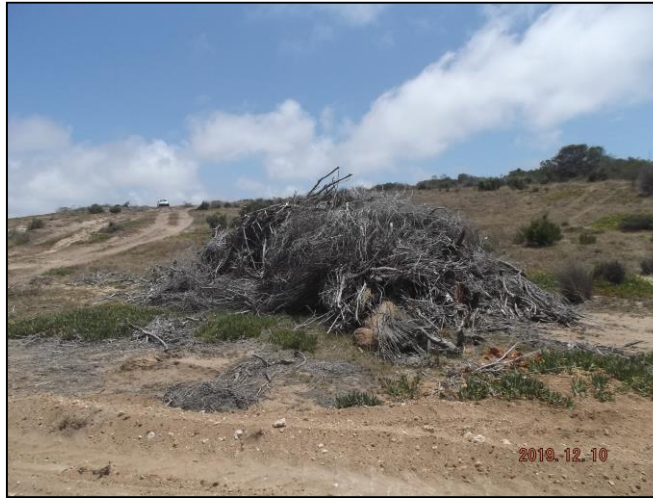
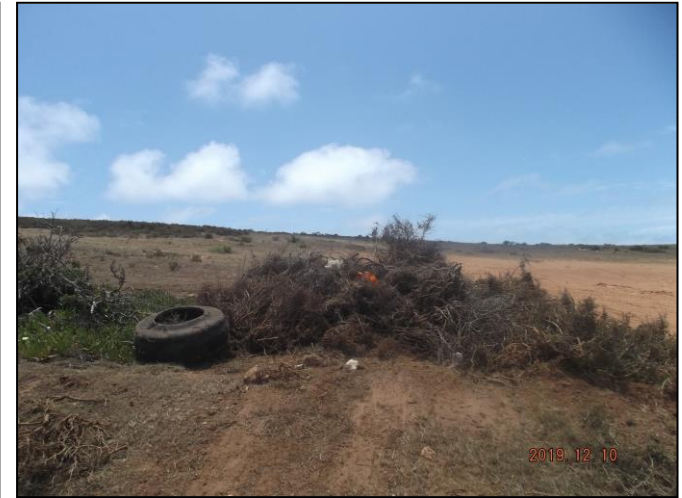
| Section<br><b>5</b> | | <b>COMPLIANCE WITH EA and EMPr</b> | |
|---|---|---|---|
| Housekeeping | Partial | The general housekeeping of the site was in a good condition. Building rubble and mostly removed branches were stored on site (Images 7 to 12). | The building rubble must be removed from site and disposed of at an appropriate registered facility. |

**Images 7 to 11: The branches must be removed from the ground and disposed of at an appropriate registered facility**

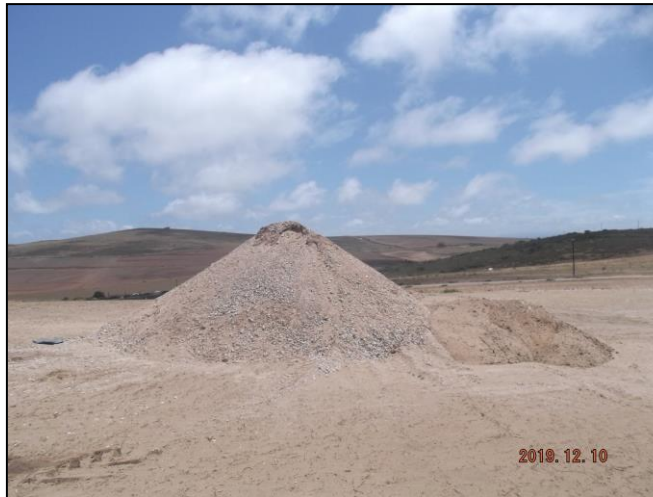
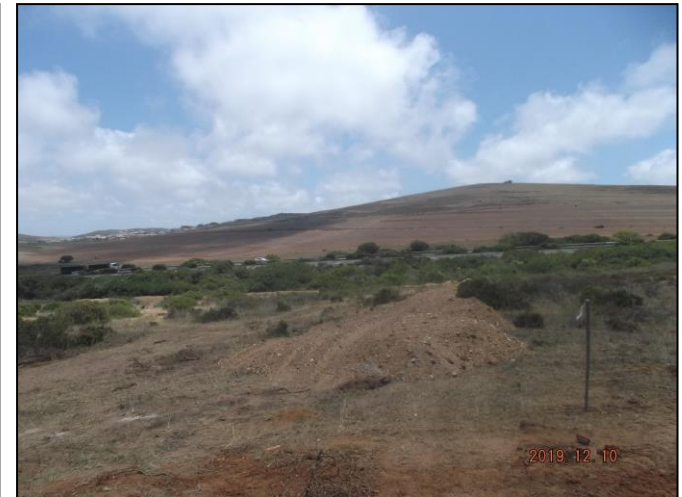
| Section<br><b>5</b> | | <b>COMPLIANCE WITH EA and EMPr</b> | |
|---|---|---|---|
| Topsoil and subsoil management<br>Stockpiles and lay-down areas | No | No stockpiles were demarcated on site (Images 13 and 14). | Topsoil and subsoil which has been removed must be stored separately and left in that position for the duration until rehabilitation ventures. Please refer to page 22 of the approved EMPr. In addition, no stockpiles must be mixed with foreign material. |

**Images 13 & 14: The stockpiles must be demarcated for the duration of the project**

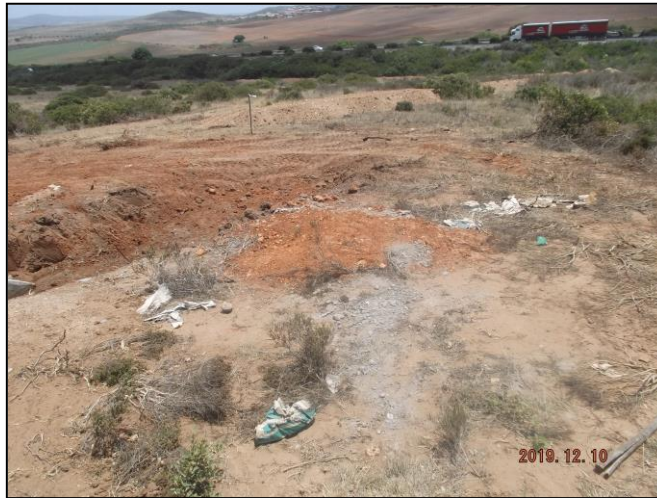
| Section<br>5 | COMPLIANCE WITH EA and EMPr | | |
|---|---|---|---|
| Concrete Management | Partial | Concrete building rubble was noted to a small extent within the development site (Image 15). | The concrete rubble must be removed from the ground and disposed of at an appropriate registered facility. |

**Image 15: The concrete rubble must be removed from the ground and disposed of at an appropriate registered facility**

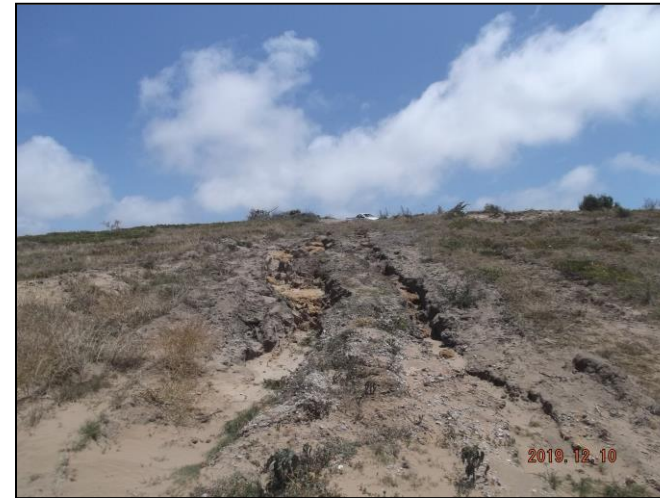
| Section<br>5 | COMPLIANCE WITH EA and EMPr | | |
|---|---|---|---|
| Erosion Control and Stormwater Management | No | Erosion was noted on site to a small extent (Image 16). | The erosion gullies must be rehabilitated and further erosion must be mitigated. Silt fences/traps must be installed to trap sediment. |

**Image 16: The erosion gullies must be rehabilitated on site and further erosion must be mitigated**

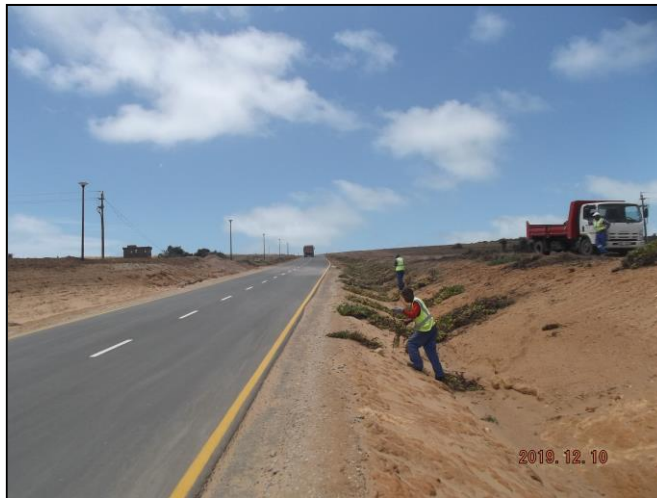
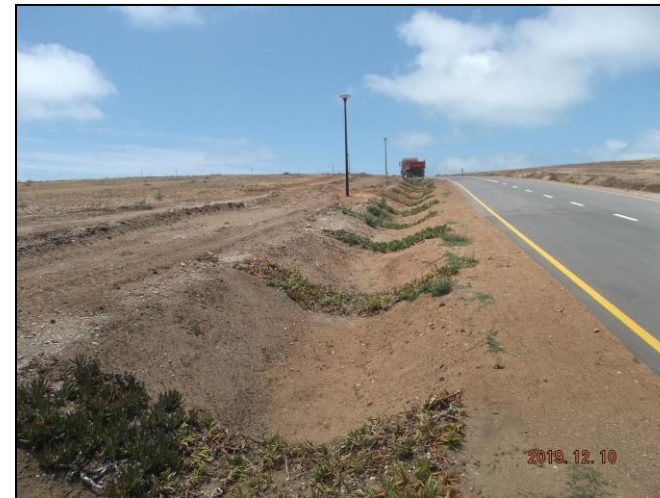
| Section<br>5 | COMPLIANCE WITH EA and EMPr | | |
|---|---|---|---|
| Rehabilitation | Yes | As noted during the site inspection, the contractor was rehabilitating the disturbed areas with indigenous vegetation harvested from within the development footprint (Images 17 and 18). | Final rehabilitation and landscaping must be undertaken once construction activities have concluded on site. Completed areas must be rehabilitated as soon as practically possible by implementing the rehabilitation mitigation measures as specified within the approved EMPr. |

**Images 17 & 18: The disturbed areas within the development site was rehabilitated with indigenous vegetation**
