# THE MAINTENANCE OF TRUNK ROAD 33/4 (MEIRINGSPOORT) BETWEEN KM1.5 AND KM 19.5, WESTERN CAPE

## FORMAL ECO AUDIT REPORT

12 February 2025

## FINDINGS IN TERMS OF THE APPROVED EMPR DURING THE SITE VISIT ON 31<sup>ST</sup> OF JANUARY 2025

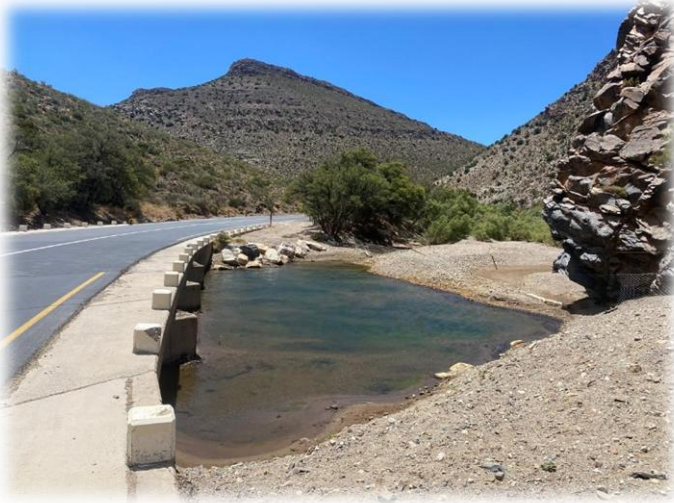
| <b>Removal, Moving/Excavation of Ground Material</b> | <p>Only the minimum amount of excavations must be undertaken.</p> <p>Where practical and feasible, excavations should be done by means of manual labour.</p> | Partial-Complaint |

| | <p>Use can be made of a TLB where excavation of large amounts of material needs to be excavated, removed, moved and deposited.</p> <p>Sediment removal is done only what is required to allow functionality of the structure. Manual labour was previously done at km19.5 as a TLB could not be used to access below the structure.</p> <p>The contractor should please confirm where the excavated material is disposed, it was noted that removed sediment was used to infill where material was washed away. It was mentioned to the RE that additional spoil areas are proposed other than Municipal landfill sites, there areas should be approved prior to any spoiling taking place.</p> | |

| | Finding | Close Out Recommendation |
|---|---|---|
| 2. | <p><b>Removal, Moving/Excavation of Ground Material</b></p> <p>The contractor should please confirm where the excavated material is disposed, it was noted that removed sediment was used to infill where material was washed away, but if material is not reused and proposed to be disposed.</p> | <p>The contractor should please confirm where the excavated material is disposed if not reused, it was mentioned to the RE that additional spoil areas are proposed other than Municipal landfill sites, there areas should be approved prior to any spoiling taking place</p> |

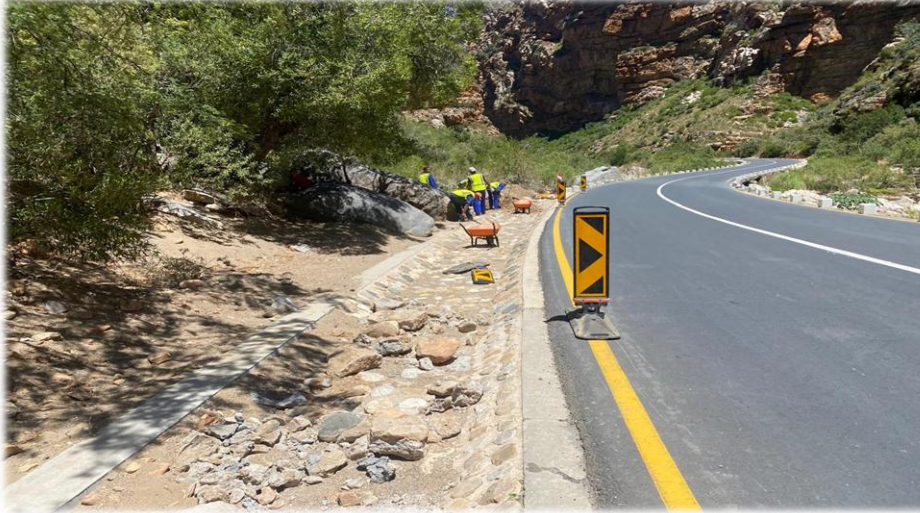
The contractors were in progress of installing the stone pitching of the side drains during the audit located within the Heritage area.
