# THE MAINTENANCE OF TRUNK ROAD 33/4 (MEIRINGSPOORT) BETWEEN KM1.5 AND KM 19.5, WESTERN CAPE

DFFE Ref: 14/12/16/3/3/1/2226

DEA&DP Ref: 16/6/D7/4/0365/24

## FORMAL ECO AUDIT REPORT

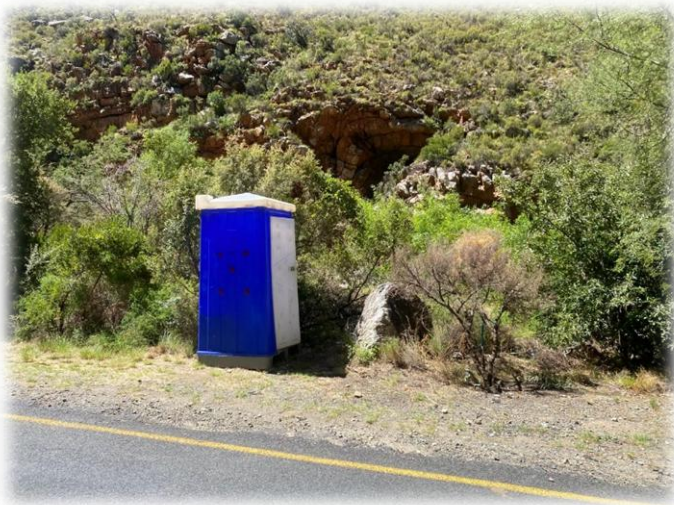
| Requirement | ECO comments and/or recommendation | Compliance |
|---|---|---|
| Toilet facilities | Chemical toilet facilities or other approved toilet facilities (1 for every 30 workers) must be used and located on the site in such a way that the toilets do not cause any form of pollution of the site.<br><br>Chemical toilets were provided. | Complaint |

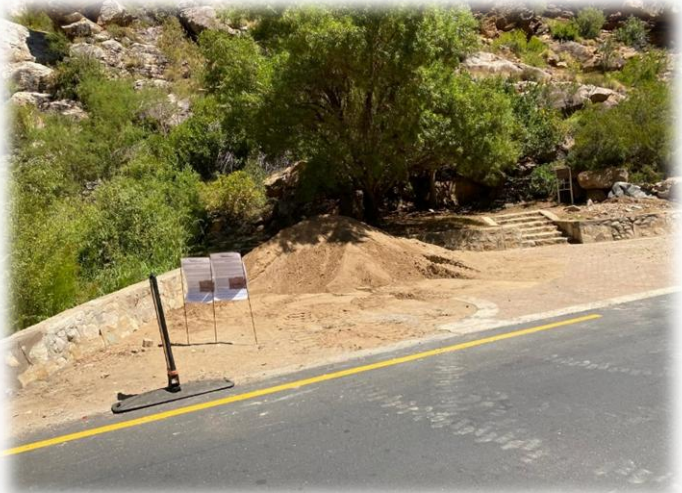
| <b>Removal, Moving/Excavation of Ground Material</b> | <p>Only the minimum amount of excavations must be undertaken.</p> <p>Where practical and feasible, excavations should be done by means of manual labour.</p> <p>Use can be made of a TLB where excavation of large amounts of material needs to be excavated, removed, moved and deposited.</p> <p>Sediment removal is done only what is required to allow functionality of the structure.</p> <p>Manual labour was previously done at km19.5 as a TLB could not be used to access below the structure.</p> <p>The contractor confirmed the sediment is used at other locations within the poort.</p> | Compliant |
