### ENVIRONMENTAL MONITORING REPORT NO.2 FOR Pinnacle Point WWTW Upgrade, Mossel Bay Municipality

**22 February to 14 March 2024**

**PINNACLE POINT WWTW UPGRADE  
ENVIRONMENTAL MONITORING REPORT NO 2**

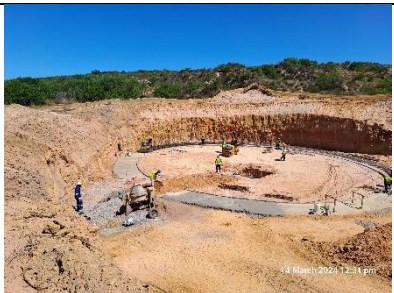
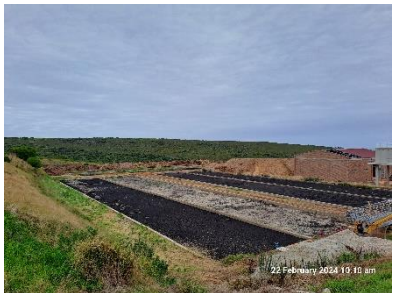
| Item | Management / Mitigation Measure | Compliance/ Notes | Photographic record (where applicable) |
|---|---|---|---|
| Site establishment | <ol style="list-style-type: none"> <li>1. The specific location for the construction site camp, storage of materials, ablation facilities, shall be identified in consultation with the ECO and must be clearly demarcated.</li> <li>2. Stockpiling of both natural and manufactured materials shall be restricted to the permanent and temporary stockpile areas identified by the Project Manager / Consulting Engineer and the ECO.</li> <li>3. Vegetation removal shall be kept to the minimum.</li> <li>4. Topsoil to be rescued and stockpiled for use during rehabilitation.</li> <li>5. No fauna or flora must be disturbed/damaged or removed outside the development footprint.</li> </ol> | <ol style="list-style-type: none"> <li>1. Site camp (including ablation facility) and construction material stockpile area are within the existing wastewater treatment works facility.</li> <li>2. Stockpile method statement was submitted to DEA&amp;DP on 15<sup>th</sup> February 2024 for approval – Verbal feedback from DEADP on 22<sup>nd</sup> February 2024 is that the method statement is <b>not approved</b> as it would require environmental authorisation. The contractor has subsequently started moving excess soil to a spoil site. The remaining soil is stockpiled on site.</li> <li>3. Vegetation clearing was limited to the development footprint - DONE.</li> <li>4. Topsoil is stockpiled within the existing WWTW facility.</li> <li>5. Disturbance is limited to the development footprint.</li> </ol> | <p>Construction and excavations are limited to demarcated development footprint (orange netting).</p> <p>Topsoil stockpile within the existing WWTW facility boundary</p> |

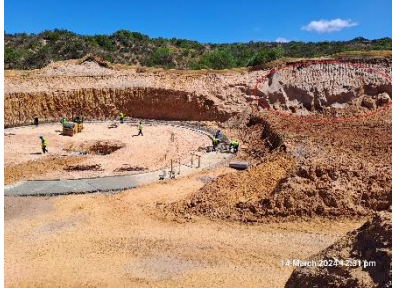
| Contaminated water control | No contaminated water from the construction site, shall be discharged into the environment. Any contaminated water shall be disposed of in an appropriate disposal facility. | Not applicable to the current activity on site – bulk excavation and foundation for the clarifier. | <p>No soil contamination noted.</p> |

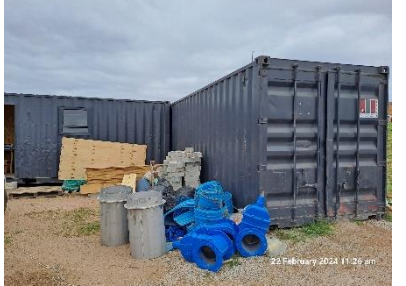
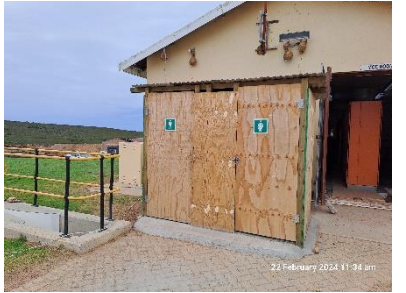
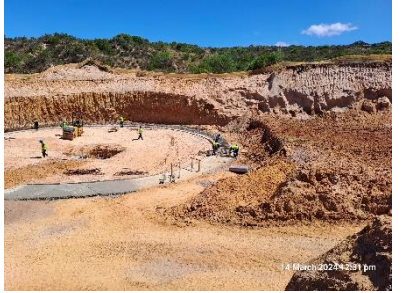
| Site and waste management | <ol style="list-style-type: none"> <li>1. Storage areas for potentially contaminating materials shall be roofed with impervious material (or double bagged in a skip until removed).</li> <li>2. Waste bins/skips must be used for all waste and litter. Waste bins must have lids to prevent content from blowing away or accumulating rainwater. Skips should be covered with netting.</li> <li>3. The burning of waste is forbidden.</li> <li>4. At least one chemical toilet must be made available on site for every 15 workers. All workers will be required to use the chemical toilet(s).</li> </ol> | <ol style="list-style-type: none"> <li>1. Storage of hazardous material as per the contractor's method statement and within the existing site camp (if any)</li> <li>2. Current activity does not generate waste, and litter bins are available at the site camp.</li> <li>3. No burning or burying of waste noted or reported to the ECO.</li> <li>4. Portable- and permanent toilets area available on site.</li> </ol> <p><b>The ECO reported the potential environmental risk related to the deep excavation of the reactor, specifically, the north-western slope that is starting to collapse even though the contractor already cut the slope back to 45 degrees. The engineers will provide suitable options to keep the slope stable which may include permanent structures. The ECO will have to evaluate the options and present them to DEADP if it is outside the scope of the current approval. It is apparent that the deep excavations were not envisioned during the BAR process as a result of the survey data that did not show the dumped berm on the north-western boundary of the development footprint.</b></p> | <p>Storage of material at the site camp.</p> <p>Toilet facilities on site</p> <p><b>Environmental risk</b> – collapsing excavation – was reported to the engineers and they are busy with a solution. Risk relating to disturbance outside of the development footprint and person safety.</p> |

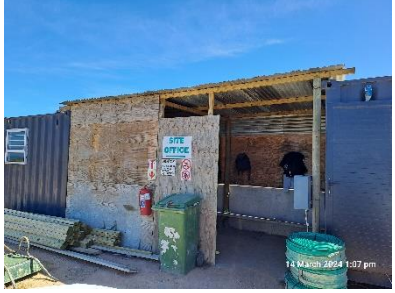
| Fire prevention and control | <ol style="list-style-type: none"> <li>Any welding or other sources of heating of materials shall be done in a controlled environment and under appropriate supervision</li> <li>Working fire extinguisher to be available on site.</li> <li>No smoking will be allowed on site, in particular in areas within or adjacent to natural vegetation, except in designated smoking points.</li> </ol> | <ol style="list-style-type: none"> <li>Not applicable to the current activity.</li> <li>As per the contractor's method statement.</li> <li>No smoking on site noted during ECO site inspection. Dedicated smoking area to be provided at the site camp.</li> </ol> | <p>Fire extinguishers on site</p> |

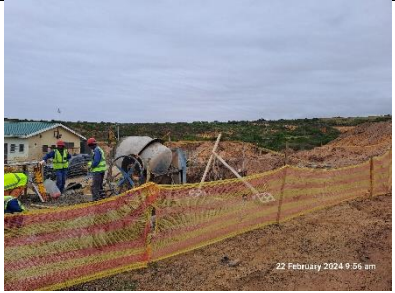
| Concrete management | <ol style="list-style-type: none"> <li>Ready-mix concrete should preferably be used.</li> <li>Cement and other potential environmental pollutants shall be stored in a dry lockable container.</li> <li>Mixing of mortar and concrete must take place on an impermeable substratum.</li> <li>Lined, concrete effluent catchpits must be created where on-site mixing takes place.</li> </ol> | No environmental issues noted in relation to the concrete foundation for the clarifier and inlet works. | <p>Stand mixer</p> |

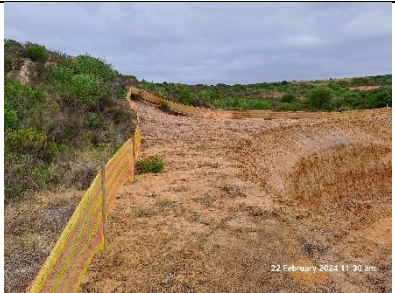
| Natural vegetation and alien clearing | <p>The surrounding area (fynbos) on the eastern side (east of the access road) and south-western side of the site and WWTW is highly sensitive and are to be regarded as No-Go areas.</p> <ol style="list-style-type: none"> <li>The development footprint must be pegged and demarcated in consultation with the ECO to avoid any disturbance of the sensitive vegetation areas.</li> <li>Topsoil rescued for use in the rehabilitation phase.</li> <li>Rehabilitate/revegetate all the disturbed surfaces after construction completed. Especially the newly created slopes directly behind the WWTW - erosion control</li> </ol> | <p>Development footprint was pegged and vegetation within the development footprint was cleared. <b>Sensitive areas as identified in the EMP are avoided.</b></p> <p>Topsoil is stockpiled for rehabilitation phase.</p> <p>Invasive aliens within the development footprint were removed.</p> | <p>No-go demarcation in place. No disturbance of the natural vegetation noted.</p> |
