### ENVIRONMENTAL MONITORING REPORT NO.8 FOR Pinnacle Point WWTW Upgrade, Mossel Bay Municipality

**MOS24.1291.10**

**22 August and 06 September 2024**

**PINNACLE POINT WWTW UPGRADE  
ENVIRONMENTAL MONITORING REPORT NO 8**

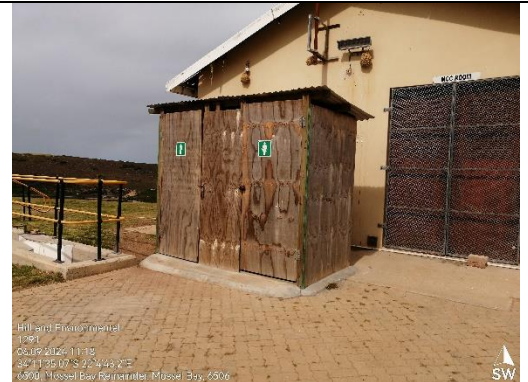
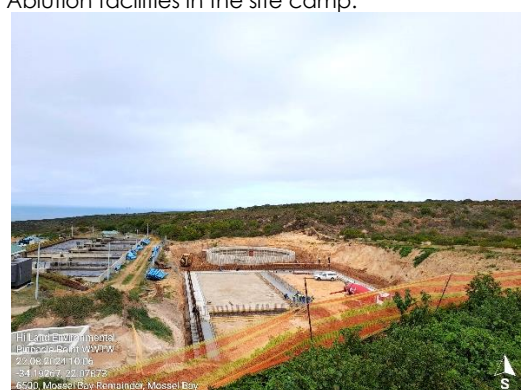
| Item | Management / Mitigation Measure | Compliance/ Notes | Photographic record (where applicable) |
|---|---|---|---|
| 2. Site establishment | <p>1. The specific location for the construction site camp, storage of materials, ablation facilities, shall be identified in consultation with the ECO and must be clearly demarcated.</p> <p>2. Stockpiling of both natural and manufactured materials shall be restricted to the permanent and temporary stockpile areas identified by the Project Manager / Consulting Engineer and the ECO.</p> <p>3. Vegetation removal shall be kept to the minimum.</p> <p>4. Topsoil to be rescued and stockpiled for use during rehabilitation.</p> <p>5. No fauna or flora must be disturbed/damaged or removed outside the development footprint.</p> | <p>1. Site camp (including ablation facility) and construction material stockpile area are within the existing wastewater treatment works facility.</p> <p>2. The contractor is spoiling subsoil material at an external site. Subsoil for backfilling is stockpiled in an already disturbed area and is demarcated (kikuyu grass and parking area) with orange netting. The remaining soil is stockpiled on site.</p> <p>3. Vegetation clearing was limited to the development footprint - <b>DONE</b>.</p> <p>4. Topsoil is stockpiled within the existing WWTW facility.</p> <p>5. Disturbance is limited to the development footprint – <b>The top layer of material next to the excavation site consists of historic dumped material (prior to the commencement of this project). The waste material layer is unpredictable due to its unknown composition and thus it poses an unknown risk (stability) and may collapse and expand beyond the development footprint.</b></p> <p><b>A request was sent to DEA&amp;DP (2 August 2024), to meet on-site to discuss/assess the environmental risk and possible solution(s), DEA&amp;DP responded (20 August 2024) reiterating that all construction activity is to</b></p> | <p>Ablution facilities in the site camp.</p> <p>Construction and excavations are limited to demarcated development footprint (orange netting).</p> |

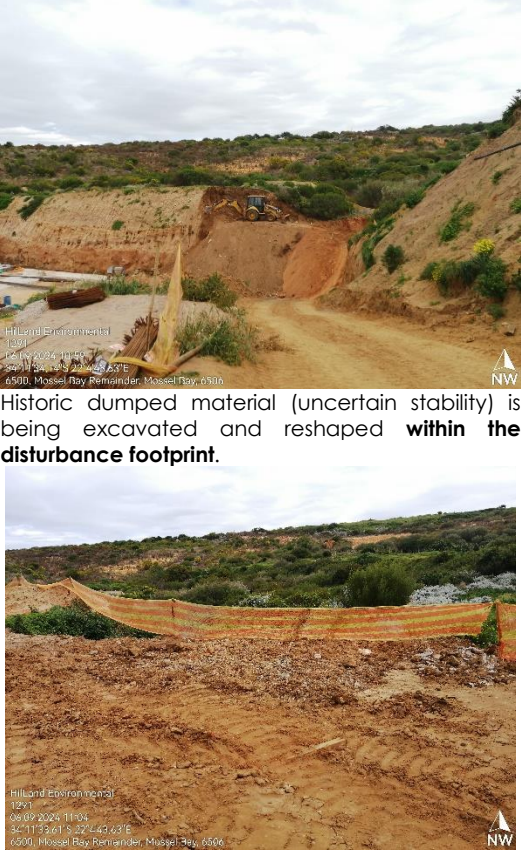
| | | <p>remain within the approved development footprint and not to be in contrary with the EA conditions. Deviation from the approved SDP/EA will require approval from DEA&amp;DP.</p> <p>The top layer of dumped material that is within the disturbance footprint is being excavated to create a bank/bench to catch the material in the case of failure. No excavation (physical disturbance of the land and vegetation outside the development footprint is permitted).</p> | <p>Historic dumped material (uncertain stability) is being excavated and reshaped <b>within the disturbance footprint</b>.</p> <p>Stockpile demarcation</p> |

The construction of the clarifier and reactors is ongoing. The slope that was battered back has a top layer of waste material which could pose a risk (collapse and expansion beyond the approved development footprint) due to its unknown nature and stability. The contractor has started to excavate the top layer of dumped material **that is within the demarcated disturbance footprint** and spoils the material at an authorised disposal facility. This is to create a bank in the excavation next to the reactor to capture any material in the event of it collapsing. Contractor and engineers must constantly monitor the slope and report any failures to the ECO immediately. Water in the clarifier/ reactor excavation from natural seepage and rainfall is being pumped out, as and when necessary, through a silt fence.

A request was sent to DEA&DP (2 August 2024), to meet on-site to discuss/assess the environmental risk and possible solution(s), DEA&DP responded (20 August 2024) reiterating that all construction activity is to remain within the approved development footprint and not to be in contrary with the EA conditions. Deviation from the approved SDP/EA will require approval from DEA&DP. An alternative option which does not require any work outside of the development footprint is implemented.

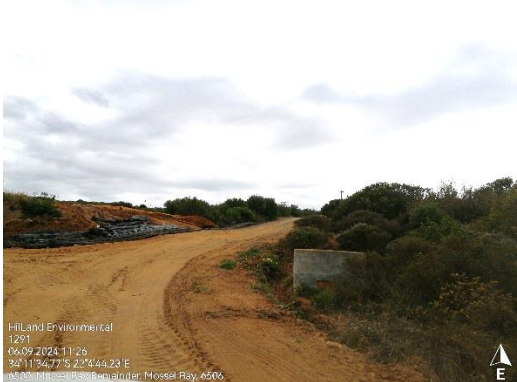
| 3. Access and traffic control | Existing access track shall be used | Existing access tracks are being used and maintained. | <p>Hilland Environmental<br/>1291<br/>06/09/2024 11:26<br/>34°11'34.77"S 22°54'44.23"E<br/>0500, Mossel Bay, Mossel Bay, 0500</p> |

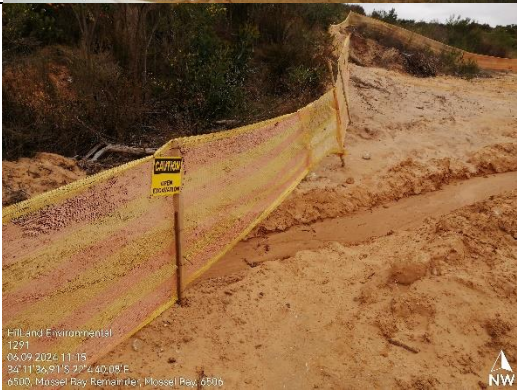
| 4. Contaminated water control | No contaminated water from the construction site, shall be discharged into the environment. Any contaminated water shall be disposed of in an appropriate disposal facility. | <p>Not applicable to the current activity on site – layer works and construction in the excavation of the clarifier and reactors.</p> <p>Dewatering is required and is done to the satisfaction of the ECO. Water is released in the stormwater trench (with a silt fence).</p> <p>A stormwater diversion trench above the northwestern edge (within the development footprint) of the clarifier excavation is in place, and maintained, to prevent stormwater from entering the excavation. Silt fences are in place at the end of the stormwater trench and must be monitored and cleared, by hand, to ensure effectiveness.</p> | <p>Hilland Environmental<br/>1291<br/>06/09/2024 11:35<br/>34°11'36.91"S 22°54'42.05"E<br/>0500, Mossel Bay, Mossel Bay, 0500</p> <p>Stormwater trench in place.</p> |

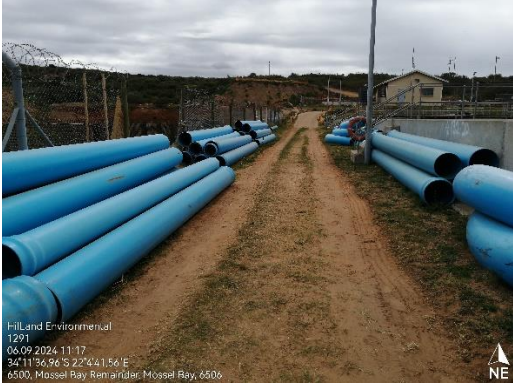
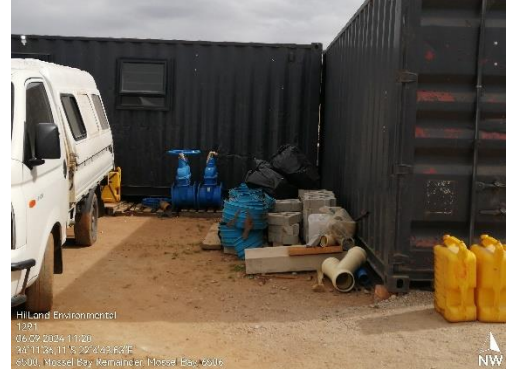
| <p>5. Site and waste management</p> | <ol style="list-style-type: none"> <li>1. Storage areas for potentially contaminating materials shall be roofed with impervious material (or double bagged in a skip until removed).</li> <li>2. Waste bins/skips must be used for all waste and litter. Waste bins must have lids to prevent content from blowing away or accumulating rainwater. Skips should be covered with netting.</li> <li>3. The burning and dumping of waste are forbidden.</li> <li>4. At least one chemical toilet must be made available on site for every 15 workers. All workers will be required to use the chemical toilet(s).</li> </ol> | <ol style="list-style-type: none"> <li>1. Storage of hazardous material (if any) as per the contractor's method statement and within the existing site camp</li> <li>2. The waste storage area is fenced off and litter bins are available at the site camp.</li> <li>3. No burning or burying of waste noted or reported to the ECO.</li> <li>4. Portable- and permanent toilets area available on site.</li> </ol> <p><b>The top layer of material next to the excavation site consists of historic dumped material (prior to the commencement of this project). The waste material layer is unpredictable due to its unknown composition and thus it poses an unknown risk (stability) and may collapse and expand beyond the development footprint.</b></p> <p><b>A request was sent to DEA&amp;DP (2 August 2024), to meet on-site to discuss/assess the environmental risk and possible solution(s), DEA&amp;DP responded (20 August 2024) reiterating that all construction activity is to remain within the approved development footprint and not to be in contrary with the EA conditions. Deviation from the approved SDP/EA will require approval from DEA&amp;DP.</b></p> <p><b>The top layer of dumped material that is within the disturbance footprint is being excavated to create a bank/bench to catch the material in the case of failure. No excavation (physical disturbance of the land and vegetation outside the development footprint is permitted).</b></p> | <p>Storage of material within the demarcated construction site.</p> <p>Litter kept in bin bags in the site camp.</p> |

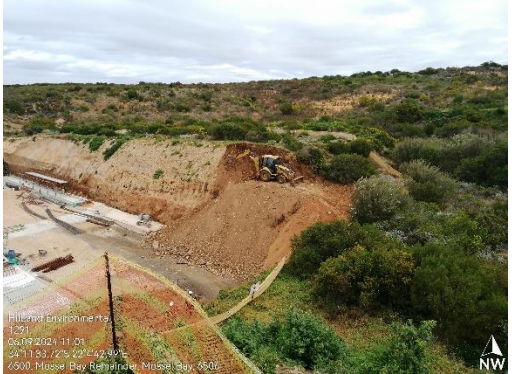
| | | | <p>Excavation of the historic dumped fill remains within the development footprint.</p> |

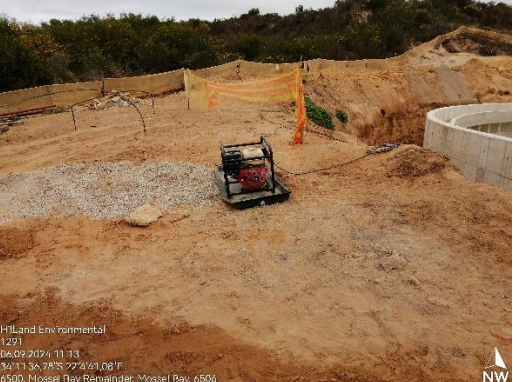
| 6. Hydrocarbon management | <p>Bunding is required when storing fuel and a drip tray must be used when refueling.</p> <p>Drip trays to be used under construction trucks (when parked overnight)</p> | <p>No fuel stored on site to the knowledge of the ECO.</p> <p><b>Drip trays are to be used as described in the contractors method statement.</b></p> | <p>Drip tray under generator.</p> |

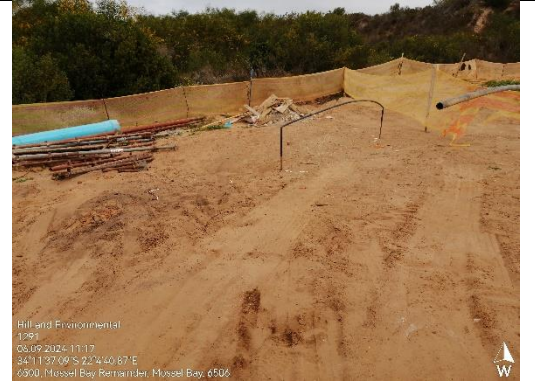
| 15. Natural vegetation and alien clearing | <p>The surrounding area (fynbos) on the eastern side (east of the access road) and south-western side of the site and WWTW are highly sensitive and are to be regarded as No-Go areas.</p> <ol style="list-style-type: none"> <li>1. The development footprint must be pegged and demarcated in consultation with the ECO to avoid any disturbance of the sensitive vegetation areas.</li> <li>2. During the construction phase, demarcate/fence off the development footprint. Restrict all construction activities, such as stockpiling and parking, to already disturbed areas away from natural vegetation. The contractor(s)</li> </ol> | <p>Development footprint was pegged and vegetation within the development footprint was cleared. <b>Sensitive areas as identified in the EMPr (outside the development footprint) are avoided.</b></p> <p>Topsoil is stockpiled for rehabilitation phase.</p> <p>Subsoil for backfilling is stockpiled in an already disturbed area and is demarcated (kikuyu grass and parking area) with orange netting.</p> <p>Invasive aliens within the development footprint were removed. The (at least) 5m</p> | <p>Full and Environmental<br/>1289<br/>05/09/2024-11:17<br/>34°11'27.09"S 22°44'07"E<br/>7090, Mussel Bay Remandier, Mussel Bay, 6506</p> <p>The development footprint is demarcated with orange netting fence.</p> |

| | <p>must be made aware of the sensitive surroundings. The fynbos outside the footprint must be declared a 'no-go' area and not be disturbed in any way.</p> <p>3. Topsoil rescued for use in the rehabilitation phase.</p> <p>4. Rehabilitate/revegetate all the disturbed surfaces after construction completed. Especially the newly created slopes directly behind the WWTW - erosion control measures will be required on the steep slopes, such as silt fences, logs or netting, to slow down runoff and potential erosion. Mulching and seeding with indigenous grass seed during rehabilitation phase.</p> <p>5. Engage in alien clearing (at least 5m around the site).</p> | <p>wide strip around the site is still to be cleared – ECO to guide to ensure compliance with NEMA and NEM:BA.</p> | |
