## ENVIRONMENTAL MONITORING REPORT NO.9 FOR Pinnacle Point WWTW Upgrade, Mossel Bay Municipality

**PINNACLE POINT WWTW UPGRADE  
ENVIRONMENTAL MONITORING REPORT NO 9**

## **Environmental Monitoring Report No. 9**

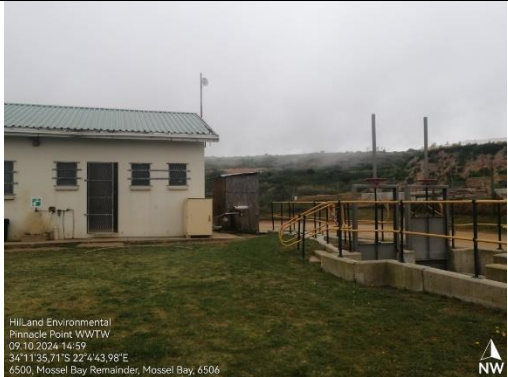
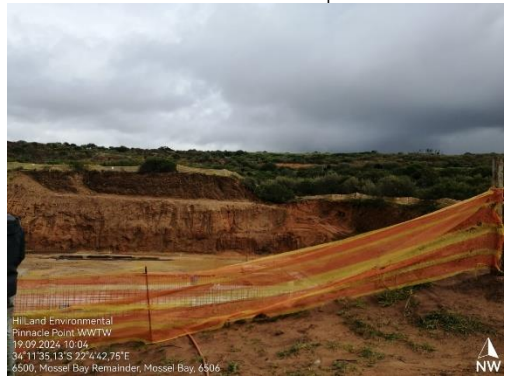
| Item | Management / Mitigation Measure | Compliance/ Notes | Photographic record (where applicable) |
|---|---|---|---|
| 2. Site establishment | <ol style="list-style-type: none"> <li>The specific location for the construction site camp, storage of materials, ablation facilities, shall be identified in consultation with the ECO and must be clearly demarcated.</li> <li>Stockpiling of both natural and manufactured materials shall be restricted to the permanent and temporary stockpile areas identified by the Project Manager / Consulting Engineer and the ECO.</li> <li>Vegetation removal shall be kept to the minimum.</li> <li>Topsoil to be rescued and stockpiled for use during rehabilitation.</li> <li>No fauna or flora must be disturbed/damaged or removed outside the development footprint.</li> </ol> | <ol style="list-style-type: none"> <li>Site camp (including ablation facility) and construction material stockpile area are within the existing wastewater treatment works facility.</li> <li>Subsoil for backfilling is stockpiled in an already disturbed area and is demarcated (kikuyu grass and parking area) with orange netting.</li> <li>Vegetation clearing was limited to the development footprint - <b>DONE</b>.</li> <li>Topsoil is stockpiled within the existing WWTW facility.</li> <li>Disturbance is currently limited to the development footprint (The top layer of material next to the excavation site consists of historic dumped material (prior to the commencement of this project). The waste material layer is unpredictable due to its unknown composition and thus it poses an unknown risk (stability) and may collapse and expand beyond the development footprint).</li> </ol> <p><b>The top layer of dumped material that is within the disturbance footprint (orange netting) has been removed to create a bench cut to catch the material in case of collapses.</b></p> | <p>Hilland Environmental<br/>Pinnacle Point WWTW<br/>09/10/2024 14:59<br/>34°11'35.71"S 22°44'43.98"E<br/>6500, Mossel Bay Remainder, Mossel Bay, 6506</p> <p>Ablution facilities in the site camp.</p> <p>Hilland Environmental<br/>Pinnacle Point WWTW<br/>19/09/2024 10:04<br/>34°11'35.13"S 22°44'42.75"E<br/>6500, Mossel Bay Remainder, Mossel Bay, 6506</p> <p>Construction and excavations are limited to demarcated development footprint (orange netting).</p> |

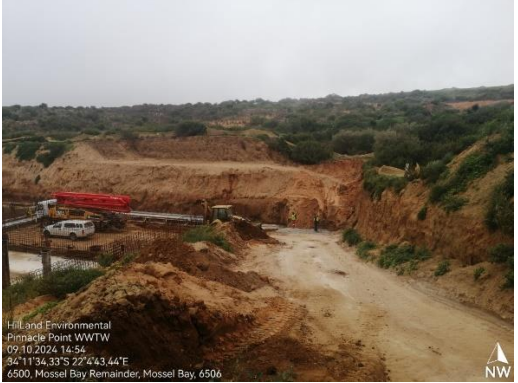
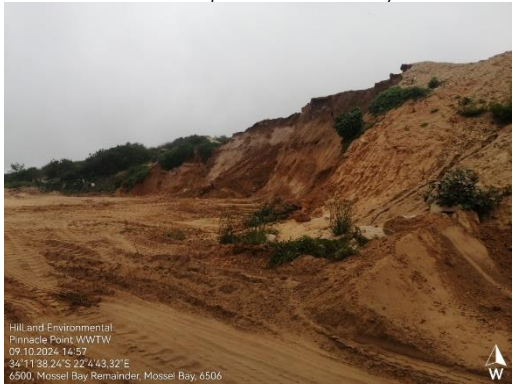
| | | <p><b>All construction activity is to remain within the approved development footprint and deviation from the approved SDP/EA will require approval from DEA&amp;DP.</b></p> | <p>Hill and Environmental<br/>Pinnacle Point WWTW<br/>09-10-2024 14:54<br/>34°11'34.33"S 22°43'44"E<br/>6500, Mossel Bay Remainder, Mossel Bay, 6506</p> <p>Historic dumped material (uncertain stability) has been excavated and reshaped (bench cut) within the disturbance footprint for site safety.</p> <p>Hill and Environmental<br/>Pinnacle Point WWTW<br/>09-10-2024 14:57<br/>34°11'38.24"S 22°43'32"E<br/>6500, Mossel Bay Remainder, Mossel Bay, 6506</p> <p>Subsoil stockpile used for backfilling.</p> |

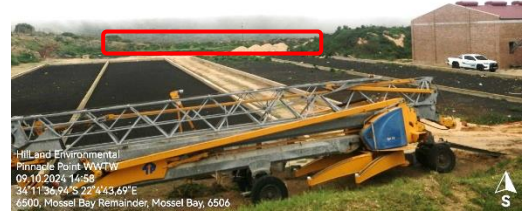
| | | | <p>Hilland Environmental<br/>Pinnacle Point WWTP<br/>09/10/2024 14:58<br/>34°11'36.94\"S 22°44'43.49\"E<br/>6500, Mossel Bay Remainder, Mossel Bay, 6506</p> <p>Topsoil stockpiled in a berm.</p> |

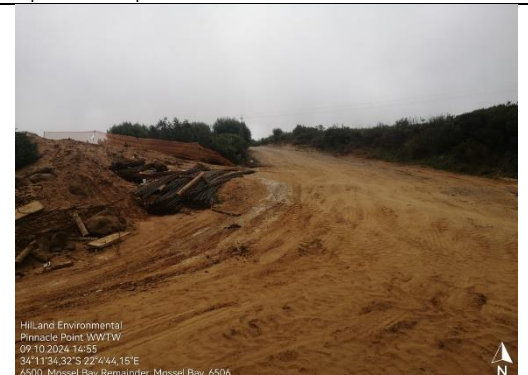
| 3. Access and traffic control | Existing access track shall be used | Existing access tracks are being used and maintained. | <p>Hilland Environmental<br/>Pinnacle Point WWTP<br/>09/10/2024 14:55<br/>34°11'34.32\"S 22°44'15\"E<br/>6500, Mossel Bay Remainder, Mossel Bay, 6506</p> |

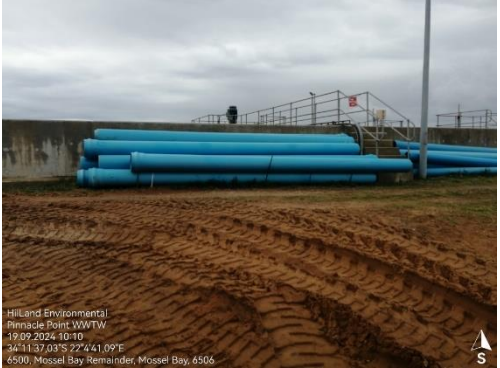
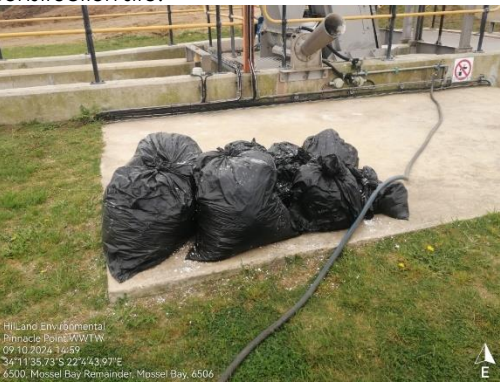
| <p>5. Site and waste management</p> | <ol style="list-style-type: none"> <li>1. Storage areas for potentially contaminating materials shall be roofed with impervious material (or double bagged in a skip until removed).</li> <li>2. Waste bins/skips must be used for all waste and litter. Waste bins must have lids to prevent content from blowing away or accumulating rainwater. Skips should be covered with netting.</li> <li>3. The burning and dumping of waste are forbidden.</li> <li>4. At least one chemical toilet must be made available on site for every 15 workers. All workers will be required to use the chemical toilet(s).</li> </ol> | <ol style="list-style-type: none"> <li>1. Storage of hazardous material (if any) as per the contractor's method statement and within the existing site camp.</li> <li>2. The waste storage area is fenced off and litter bins are available at the site camp.</li> <li>3. No burning or burying of waste noted or reported to the ECO.</li> <li>4. Portable- and permanent toilets area available on site.</li> </ol> <p>The top layer of material next to the excavation site consists of historic dumped material (prior to the commencement of this project). The waste material layer is unpredictable due to its unknown composition and thus it poses an unknown risk (stability) and may collapse and expand beyond the development footprint.</p> <p><b>The top layer of dumped material that is within the disturbance footprint (orange netting) has been removed to create a bench cut to capture the material in case of collapses.</b></p> <p><b>All construction activity is to remain within the approved development footprint and deviation from the approved SDP/EA will require approval from DEA&amp;DP.</b></p> | <p>Hilland Environmental<br/>Pinnacle Point WWTW<br/>19.09.2024 10:10<br/>34°11'37.03"S 22°44'1.09"E<br/>4500, Mossel Bay Remainder, Mossel Bay, 6506</p> <p>Storage of material within the demarcated construction site.</p> <p>Hilland Environmental<br/>Pinnacle Point WWTW<br/>09.10.2024 14:59<br/>34°11'35.73"S 22°44'3.97"E<br/>4500, Mossel Bay Remainder, Mossel Bay, 6506</p> <p>Litter kept in bins in the site camp – full litter bags removed regularly.</p> |

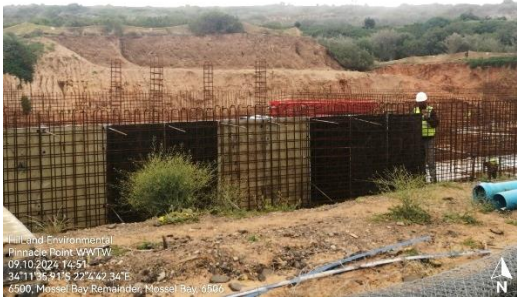
| | | | <p> <small> Pinnacle Point WWTP<br/> 09/10/2024 14:51<br/> 34°11'54.91"S 27°42'34"E<br/> 4500, Pinnacle Point WWTP, Pinnacle Point WWTP </small> </p> <p>Bench cut into the slope (within the demarcated development footprint) to make the working area safer from potential collapse.</p> |

The construction of the clarifier walls is complete and is being backfilled. The construction of the reactor is ongoing. The contractor has removed the top layer of historic dumped material that is **within the disturbance footprint** and created a bench cut for a safe working area. The contractor and engineer must constantly monitor the slope and report any failures to the ECO immediately.

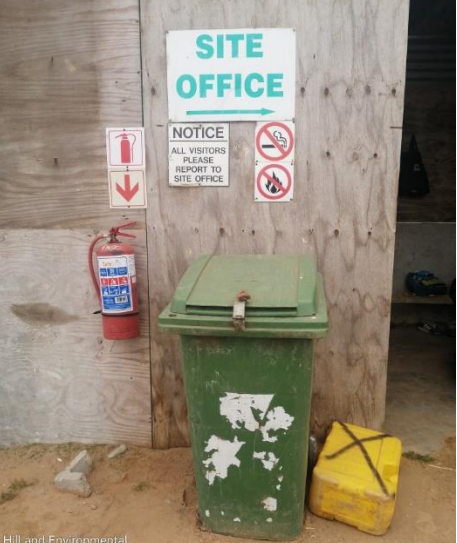
| 7. Fire prevention and control | <p>1. Any welding or other sources of heating of materials shall be done in a controlled environment and under appropriate supervision</p> <p>2. Working fire extinguisher to be available on site.</p> <p>3. No smoking will be allowed on site, in particular in areas within or adjacent to natural vegetation, except in designated smoking points.</p> | <p>1. No environmental issues noted or reported to the ECO.</p> <p>2. As per the contractor's method statement and as seen on site during ECO inspection.</p> <p>3. No smoking on site noted during ECO site inspection. Dedicated smoking area to be provided at the site camp.</p> | <p>Hilland Environmental<br/>Pinnacle Point WWTW<br/>09.10.2024 15:02<br/>34°11'36.47"S 22°44'3.55"E<br/>6500 Mossel Bay Remainder Mossel Bay 6506</p> |

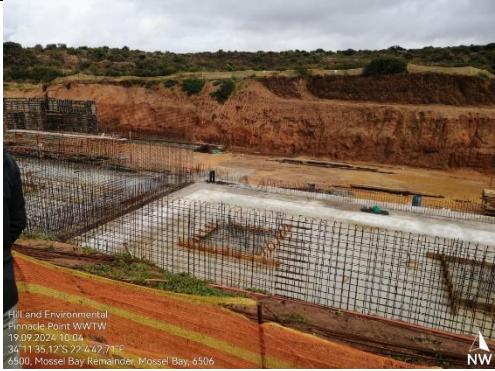
| 15. Natural vegetation and alien clearing | <p>The surrounding area (fynbos) on the eastern side (east of the access road) and south-western side of the site and WWTW are highly sensitive and are to be regarded as No-Go areas.</p> <ol style="list-style-type: none"> <li>1. The development footprint must be pegged and demarcated in consultation with the ECO to avoid any disturbance of the sensitive vegetation areas.</li> <li>2. During the construction phase, demarcate/fence off the development footprint. Restrict all construction activities, such as stockpiling and parking, to already disturbed areas away from natural vegetation. The contractor(s) must be made aware of the sensitive surroundings. The fynbos outside the footprint must be declared a 'no-go' area and not be disturbed in any way.</li> <li>3. Topsoil rescued for use in the rehabilitation phase.</li> <li>4. Rehabilitate/revegetate all the disturbed surfaces after construction completed. Especially the newly created slopes directly behind the WWTW - erosion control measures will be required on the steep slopes, such as silt fences, logs or netting, to slow down runoff and potential erosion. Mulching and seeding with indigenous grass seed during rehabilitation phase.</li> <li>5. Engage in alien clearing (at least 5m around the site).</li> </ol> | <p>Development footprint was pegged and vegetation within the development footprint was cleared. <b>Sensitive areas as identified in the EMPr (outside the development footprint) are avoided.</b></p> <p>Topsoil is stockpiled for rehabilitation phase.</p> <p>Subsoil for backfilling is stockpiled in an already disturbed area and is demarcated (kikuyu grass and parking area) with orange netting.</p> <p>Invasive aliens within the development footprint were removed. The (at least) 5m wide strip around the site is still to be cleared – ECO to guide to ensure compliance with NEMA and NEM:BA.</p> | <p>The development footprint is demarcated with orange netting fence.</p> |
