## ENVIRONMENTAL MONITORING REPORT NO.13

Pinnacle Point WWTW Upgrade, Mossel Bay Municipality

**MOS25.1291.15**

**20 February 2025 and 13 March 2025**

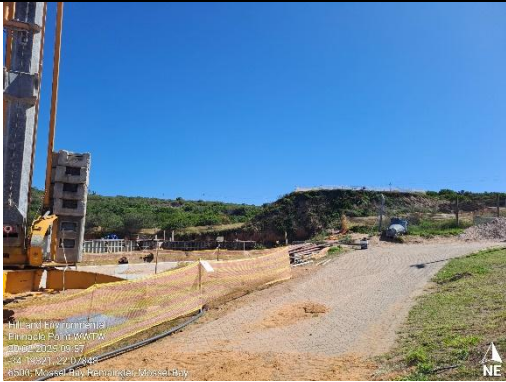
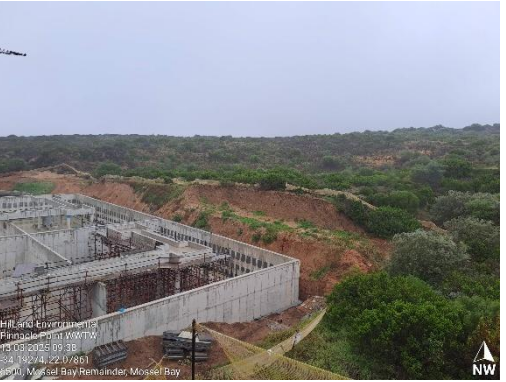
| Item | Management / Mitigation Measure | Compliance/ Notes | Photographic record (where applicable) |
|---|---|---|---|
| 2. Site establishment | <ol style="list-style-type: none"> <li>1. The specific location for the construction site camp, storage of materials, ablution facilities, shall be identified in consultation with the ECO and must be clearly demarcated.</li> <li>2. Stockpiling of both natural and manufactured materials shall be restricted to the permanent and temporary stockpile areas identified by the Project Manager / Consulting Engineer and the ECO.</li> <li>3. Vegetation removal shall be kept to the minimum.</li> <li>4. Topsoil to be rescued and stockpiled for use during rehabilitation.</li> <li>5. No fauna or flora must be disturbed/damaged or removed outside the development footprint.</li> </ol> | <ol style="list-style-type: none"> <li>1. Site camp (including ablution facility) and construction material stockpile area are within the wastewater treatment works facility – fenced off area.</li> <li>2. Subsoil for backfilling is stockpiled in an already disturbed area (kikuyu grass and parking area) and is demarcated with orange netting. Subsoil material is used for backfilling around the clarifier and reactor.</li> <li>3. Vegetation clearing was limited to the development footprint - <b>DONE</b>.</li> <li>4. Topsoil is stockpiled within the existing WWTW facility – behind the dry beds.</li> <li>5. Disturbance is currently limited to the development footprint. The top layer of material next to the excavation site consists of historic dumped material (prior to the commencement of this project). The waste material layer is unpredictable due to its unknown composition and thus it poses an unknown risk (stability) and may collapse and expand beyond the development footprint.</li> </ol> <p><b>All construction activity must remain within the approved development footprint and deviation from the approved SDP/EA will require approval from DEA&amp;DP – no environmental issues were noted during this reporting period.</b></p> | <p>Construction and excavations are limited to demarcated development footprint (orange netting).</p> |

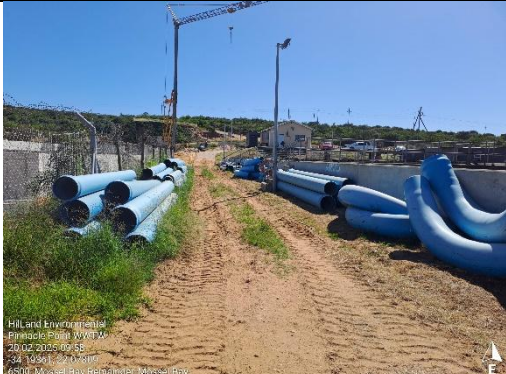
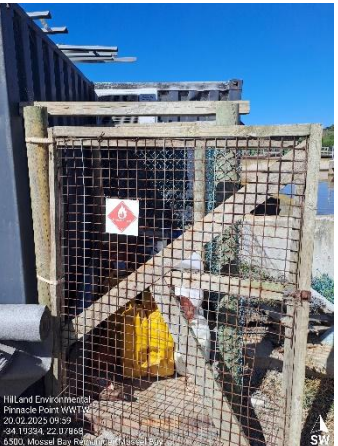
| 5. Site and waste management | <ol style="list-style-type: none"> <li>1.Storage areas for potentially contaminating materials shall be roofed with impervious material (or double bagged in a skip until removed).</li> <li>2. Waste bins/skips must be used for all waste and litter. Waste bins must have lids to prevent content from blowing away or accumulating rainwater. Skips should be covered with netting.</li> <li>3.The burning and dumping of waste are forbidden.</li> <li>4. At least one chemical toilet must be made available on site for every 15 workers. All workers will be required to use the chemical toilet(s).</li> </ol> | <ol style="list-style-type: none"> <li>1.Storage of hazardous material (if any) as per the contractor's method statement and within the existing site camp – as seen on site during the recent ECO site visit.</li> <li>2. Litter bins (closable) are available at the site camp.</li> <li>3.No burning or burying of waste noted or reported to the ECO.</li> <li>4.Portable- and permanent toilets are available on site.</li> </ol> | <p>Storage of material within the demarcated construction site.</p> <p>Storage of flammable materials</p> |

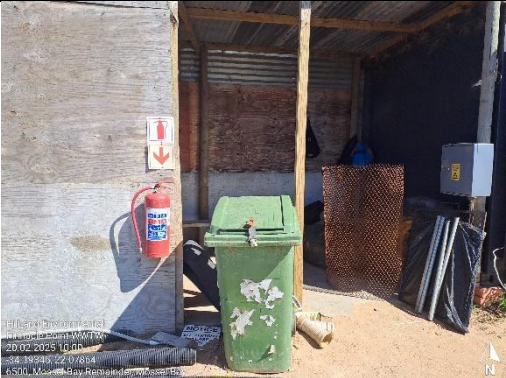
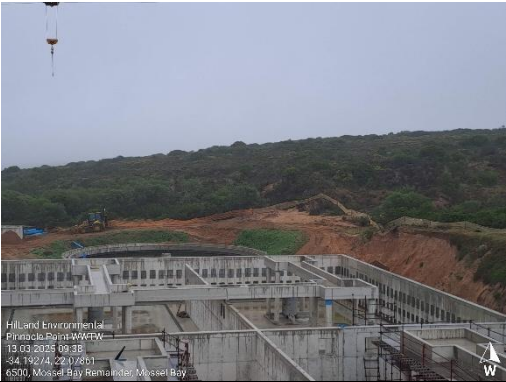
| | | | <div data-bbox="1581 193 2085 572"><p>13 03 2025 09:38<br/>-34.19214, 22.41786<br/>6500, Mossel Bay Remandee, Mossel Bay</p></div> <div data-bbox="1581 576 2085 627"><p>Litter kept in bins in the site camp – full litter bags removed regularly).</p></div> <div data-bbox="1581 651 2085 1034"><p>13 03 2025 09:38<br/>-34.19214, 22.41786<br/>6500, Mossel Bay Remandee, Mossel Bay</p></div> |

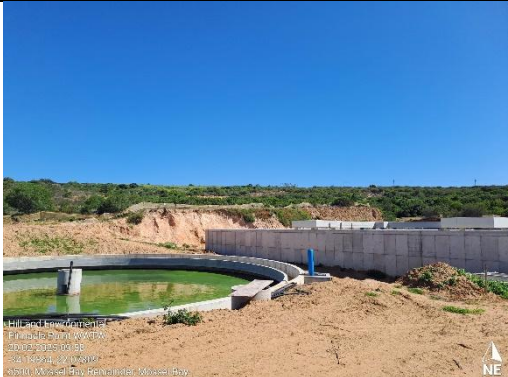
| | | | <p>Bench cut into the slope (<b>within the demarcated development footprint</b>) to make the working area safer from potential collapse.</p> |
