## ENVIRONMENTAL MONITORING REPORT NO.14

Pinnacle Point WWTW Upgrade, Mossel Bay Municipality

## PINNACLE POINT WWTW UPGRADE ENVIRONMENTAL MONITORING REPORT NO 14

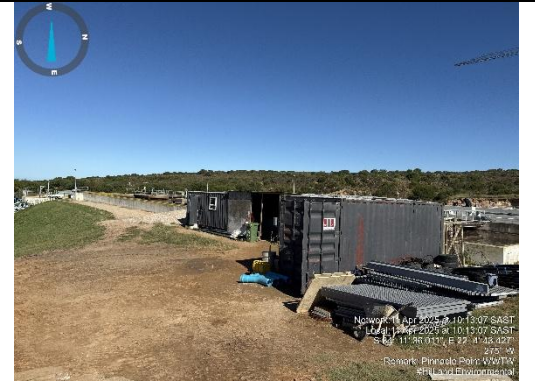
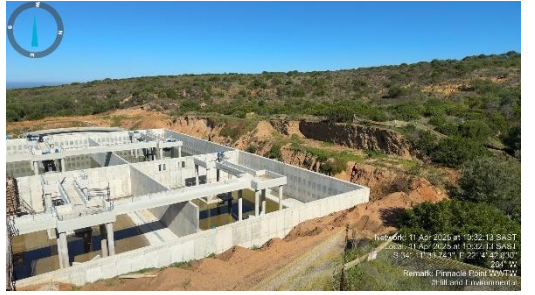
| Item | Management / Mitigation Measure | Compliance/ Notes | Photographic record (where applicable) |
|---|---|---|---|
| 2. Site establishment | <ol style="list-style-type: none"> <li>1. The specific location for the construction site camp, storage of materials, ablution facilities, shall be identified in consultation with the ECO and must be clearly demarcated.</li> <li>2. Stockpiling of both natural and manufactured materials shall be restricted to the permanent and temporary stockpile areas identified by the Project Manager / Consulting Engineer and the ECO.</li> <li>3. Vegetation removal shall be kept to the minimum.</li> <li>4. Topsoil to be rescued and stockpiled for use during rehabilitation.</li> <li>5. No fauna or flora must be disturbed/damaged or removed outside the development footprint.</li> </ol> | <ol style="list-style-type: none"> <li>1. Site camp (including ablution facility) and construction material stockpile area are within the wastewater treatment works facility – fenced off area.</li> <li>2. Subsoil for backfilling is stockpiled in an already disturbed area (kikuyu grass and parking area) and is demarcated with orange netting. Subsoil material is used for backfilling around the clarifier and reactor.</li> <li>3. Vegetation clearing was limited to the development footprint - <b>DONE</b>.</li> <li>4. Topsoil is stockpiled within the existing WWTW facility – behind the dry beds.</li> <li>5. Disturbance is currently limited to the development footprint. The top layer of material next to the excavation site consists of historic dumped material (prior to the commencement of this project). The waste material layer is unpredictable due to its unknown composition and thus it poses an unknown risk (stability) and may collapse and expand beyond the development footprint.</li> </ol> <p><b>All construction activity must remain within the approved development footprint and deviation from the approved SDP/EA will require approval from DEA&amp;DP – no environmental issues were noted during this reporting period.</b></p> | |

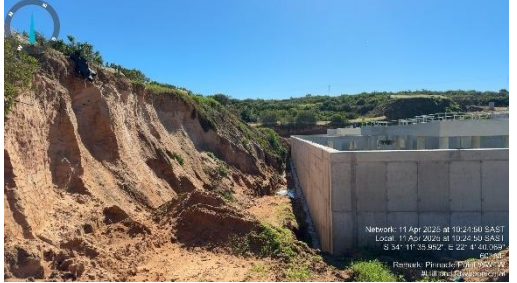
| | | | <p>Construction and excavations are limited to demarcated development footprint (orange netting at the top of the cut slope).</p> |

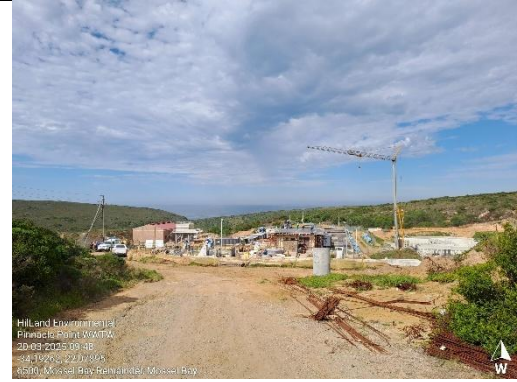
| 3. Access and traffic control | Existing access track shall be used | Existing access tracks are being used and maintained. | |

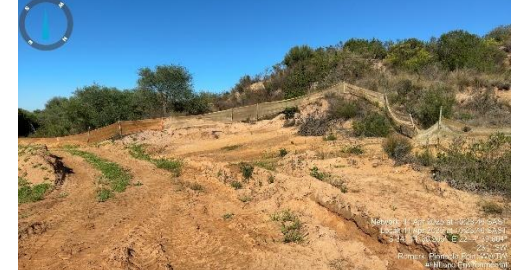
| 4. Contaminated water control | No contaminated water from the construction site, shall be discharged into the environment. Any contaminated water shall be disposed of in an appropriate disposal facility. | <p>No contaminated water was noted during site inspections.</p> <p>There is a temporary stormwater diversion trench above the clarifier.</p> | |

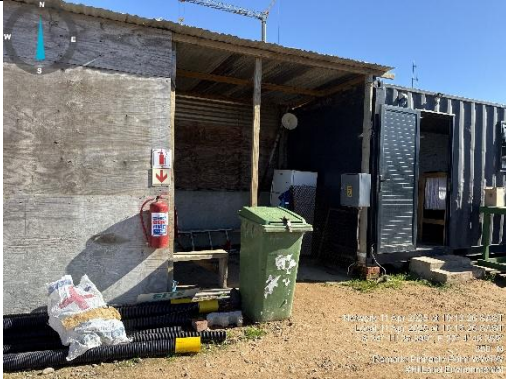
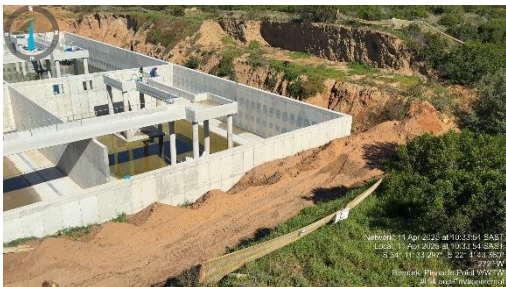
| <p>5. Site and waste management</p> | <ol style="list-style-type: none"> <li>1. Storage areas for potentially contaminating materials shall be roofed with impervious material (or double bagged in a skip until removed).</li> <li>2. Waste bins/skips must be used for all waste and litter. Waste bins must have lids to prevent content from blowing away or accumulating rainwater. Skips should be covered with netting.</li> <li>3. The burning and dumping of waste are forbidden.</li> <li>4. At least one chemical toilet must be made available on site for every 15 workers. All workers will be required to use the chemical toilet(s).</li> </ol> | <ol style="list-style-type: none"> <li>1. Storage of hazardous material (if any) as per the contractor's method statement and within the existing site camp – as seen on site during the recent ECO site visit.</li> <li>2. Litter bins (closable) are available at the site camp.</li> <li>3. No burning or burying of waste noted or reported to the ECO.</li> <li>4. Portable- and permanent toilets are available on site.</li> </ol> | <p>Litter kept in bins in the site camp</p> <p>Bench cut into the slope (<b>within the demarcated development footprint</b>) to make the working area safer from potential collapse.</p> |

The construction of the clarifier is complete, and it has been backfilled. The construction of the outer walls of the reactors is complete and backfilling can start once the water tests have been completed. Construction of the division box and pump station is complete. Shaping of the slope behind the reactors should preferably be completed before the high rainfall season starts to avoid potential slope failure and soil erosion.

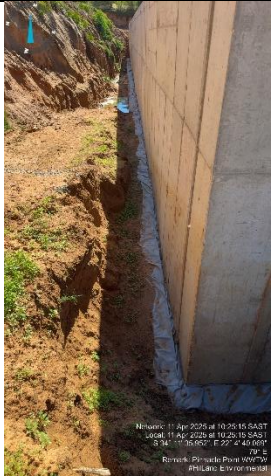
| | | | <p>Subsoil drain behind the reactor wall.</p> |

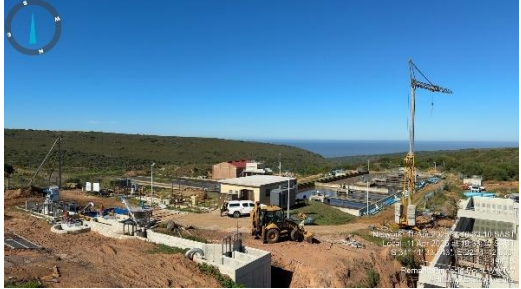
| 8 & 9. Noise and Dust control | The contractor shall be responsible for the control of dust arising from the operations. | <p>No dust or noise issues noted or reported to the ECO.</p> <p>Dust management to be implemented as per the contractor's method statement when necessary – no dust related issues recorded during this period.</p> | <p>No dust issues noted during ECO inspections.</p> |

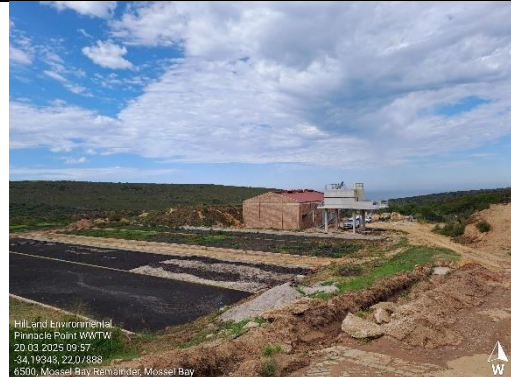
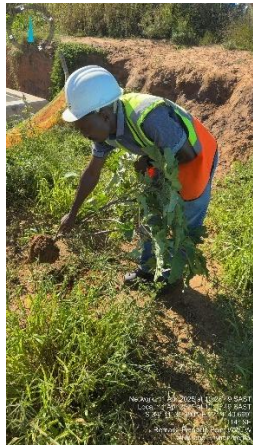
| <p>15. Natural vegetation and alien clearing</p> | <p>The surrounding area (fynbos) on the eastern side (east of the access road) and south-western side of the site and WWTW are highly sensitive and are to be regarded as No-Go areas.</p> <ol style="list-style-type: none"> <li>1. The development footprint must be pegged and demarcated in consultation with the ECO to avoid any disturbance of the sensitive vegetation areas.</li> <li>2. During the construction phase, demarcate/fence off the development footprint. Restrict all construction activities, such as stockpiling and parking, to already disturbed areas away from natural vegetation. The contractor(s) must be made aware of the sensitive surroundings. The fynbos outside the footprint must be declared a 'no-go' area and not be disturbed in any way.</li> <li>3. Topsoil rescued for use in the rehabilitation phase.</li> <li>4. Rehabilitate/revegetate all the disturbed surfaces after construction completed. Especially the newly created slopes directly behind the WWTW - erosion control measures will be required on the steep slopes, such as silt fences, logs or netting, to slow down runoff and potential erosion. Mulching and seeding with indigenous grass seed during rehabilitation phase.</li> <li>5. Engage in alien clearing (at least 5m around the site).</li> </ol> | <p>Development footprint was pegged and vegetation within the development footprint was cleared. <b>Sensitive areas as identified in the EMPr (outside the development footprint) are avoided.</b></p> <p>Topsoil is stockpiled for rehabilitation phase.</p> <p>Subsoil for backfilling is stockpiled in an already disturbed area and is demarcated (kikuyu grass and parking area) with orange netting – some of stockpile material have already been used for backfilling.</p> <p>Invasive aliens within the development footprint were removed. The (at least) 5m wide strip around the site is still to be cleared – ECO to guide to ensure compliance with NEMA and NEM:BA.</p> <p>Rehabilitation will be done once construction is complete.</p> | <p>Topsoil stockpile behind the dry beds</p> <p>Ongoing alien clearing</p> |
