## Environmental Monitoring Report No.17 for Pinnacle Point WWTW Upgrade, Mossel Bay Municipality

**MOS25.1291.19**

**PINNACLE POINT WWTW UPGRADE  
ENVIRONMENTAL MONITORING REPORT NO 17**

## **Environmental Monitoring Report No. 17**

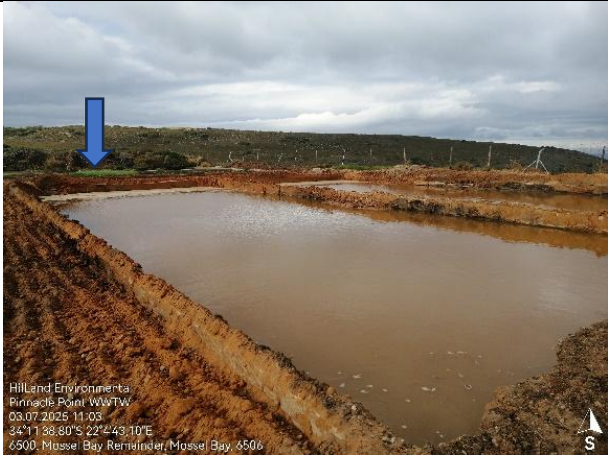
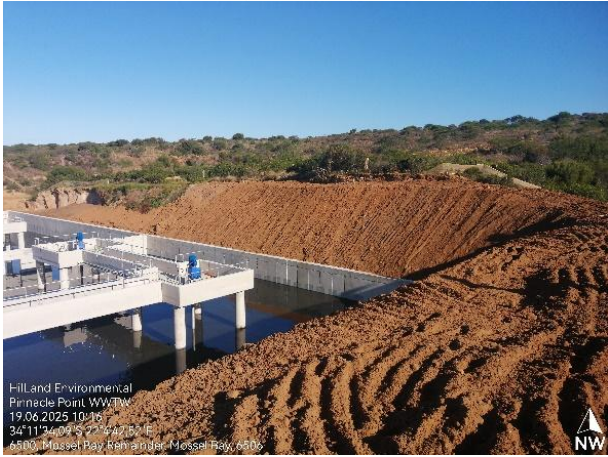
| | | | <div data-bbox="1487 193 2092 651"><p>Hill and Environmental<br/>Pinnacle Point WWTP<br/>03.07.2025 11:03<br/>34°11'38.80"S 22°44'10"E<br/>6500, Mossel Bay Remainder/Mossel Bay, 6506</p><p>S</p></div> <p>Topsoil stockpile.</p> <div data-bbox="1487 676 2092 1134"><p>Hill and Environmental<br/>Pinnacle Point WWTP<br/>19.06.2025 10:16<br/>34°11'34.09"S 22°44'20"E<br/>6500, Mossel Bay Remainder/Mossel Bay, 6506</p><p>NW</p></div> <p>Construction and excavations are limited to demarcated development footprint (orange netting at the top of the cut slope).</p> |

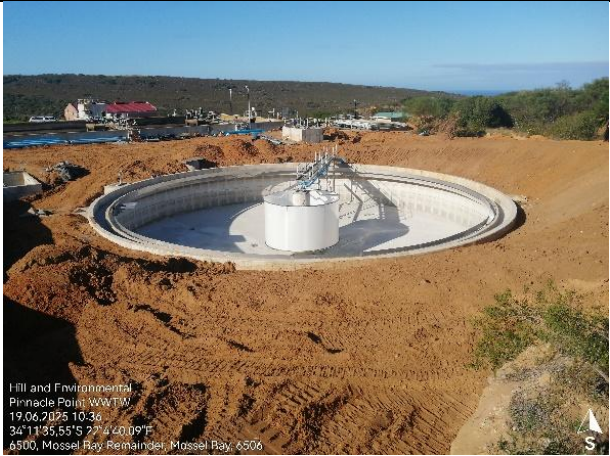
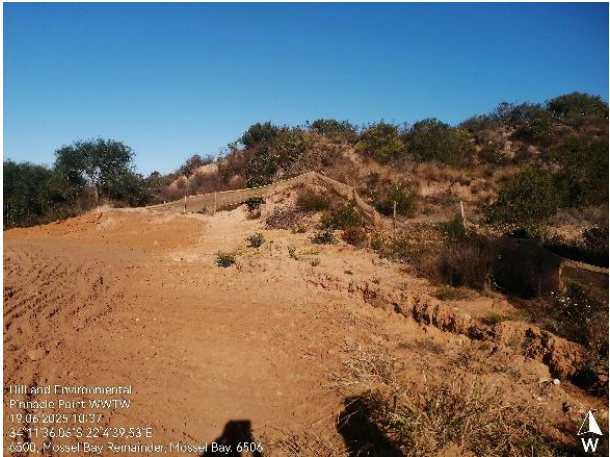
| | | | <div><p>Hill and Environmental<br/>Pinnacle Point WWTW<br/>19.06.2025 10:36<br/>34°11'35.55"S 22°42'09"E<br/>6500, Mossel Bay Remainder, Mossel Bay, 6506</p></div> <div><p>Hill and Environmental<br/>Pinnacle Point WWTW<br/>19.06.2025 10:37<br/>34°11'36.06"S 22°42'39.53"E<br/>6500, Mossel Bay Remainder, Mossel Bay, 6506</p><p>Orange netting fence in place.</p></div> |

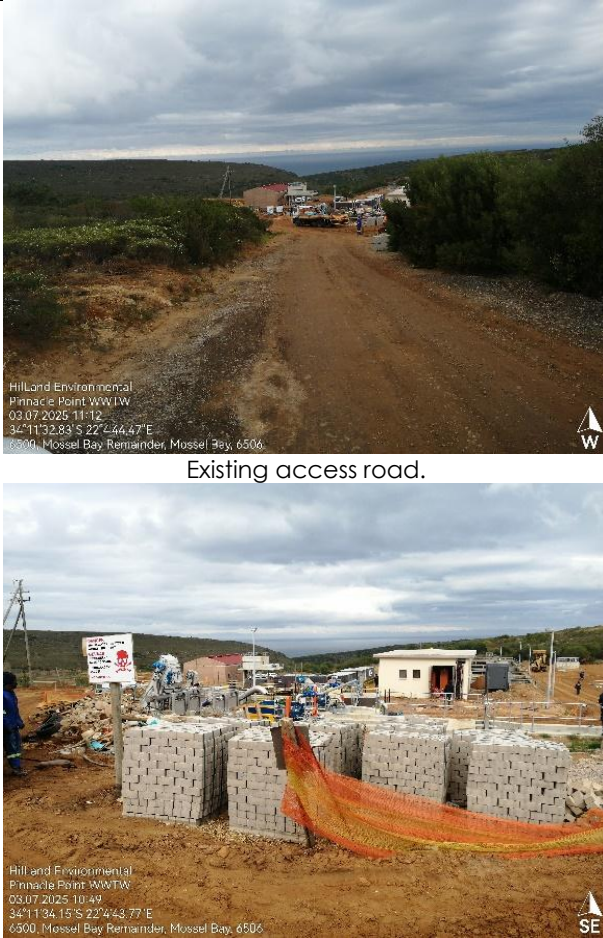
| <p>3. Access and traffic control</p> | <p>Existing access track shall be used</p> | <p>Existing access tracks are being used and maintained.</p> | <p>Hill and Environmental<br/>Pinnacle Point WWTP<br/>03.07.2025 11:12<br/>34°11'32.83" S 22°44.47" E<br/>6300, Mossel Bay Remainder, Mossel Bay, 6506</p> <p>Existing access road.</p> <p>Hill and Environmental<br/>Pinnacle Point WWTP<br/>03.07.2025 10:49<br/>34°11'34.15" S 22°44.377" E<br/>6300, Mossel Bay Remainder, Mossel Bay, 6506</p> <p>Safety signs at the site entrance.</p> |

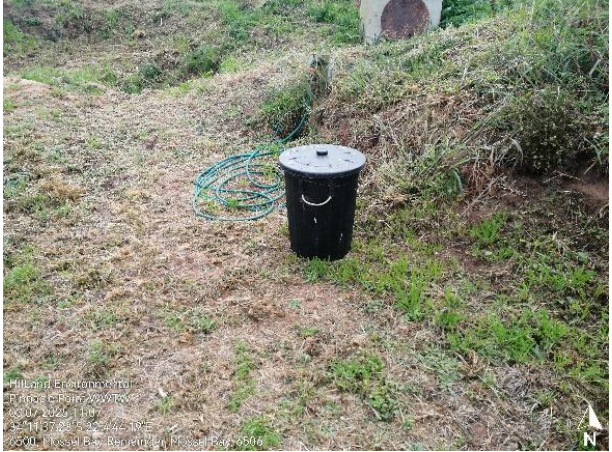
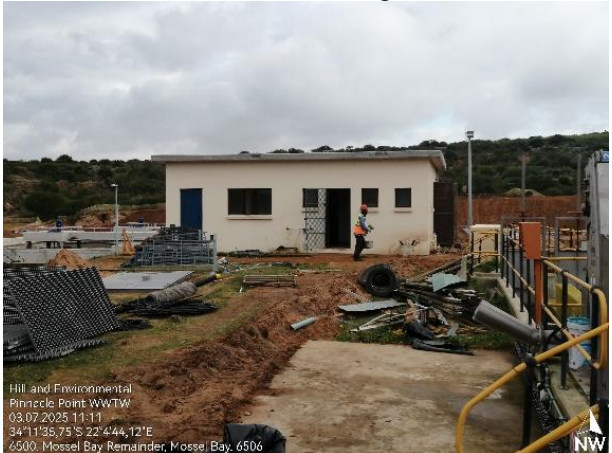
| <p>5. Site and waste management</p> | <p>1. Storage areas for potentially contaminating materials shall be roofed with impervious material (or double bagged in a skip until removed).</p> <p>2. Waste bins/skips must be used for all waste and litter. Waste bins must have lids to prevent content from blowing away or accumulating rainwater. Skips should be covered with netting.</p> <p>3. The burning and dumping of waste are forbidden.</p> <p>4. At least one chemical toilet must be made available on site for every 15 workers. All workers will be required to use the chemical toilet(s).</p> | <p>1. Storage of hazardous material (if any) as per the contractor's method statement and within the existing site camp – as seen on site during the recent ECO site visit.</p> <p>2. Litter bins (closable) are available at the site camp and the site.</p> <p>3. No burning or burying of waste noted or reported to the ECO – the pieces of off-cut concrete must not be buried/covered on site.</p> <p>4. Portable- and permanent toilets are available on site.</p> | <p>Hill and Environmental<br/>Pinnacle Point WWTW<br/>03.07.2025 11:11<br/>34°11'35.75"S 22°44'12"E<br/>6500 Mossel Bay Remainder, Mossel Bay, 6506</p> <p>Waste bins stationed throughout the site.</p> <p>Hill and Environmental<br/>Pinnacle Point WWTW<br/>03.07.2025 11:11<br/>34°11'35.75"S 22°44'12"E<br/>6500 Mossel Bay Remainder, Mossel Bay, 6506</p> <p>Permanent ablution facility on site.</p> |

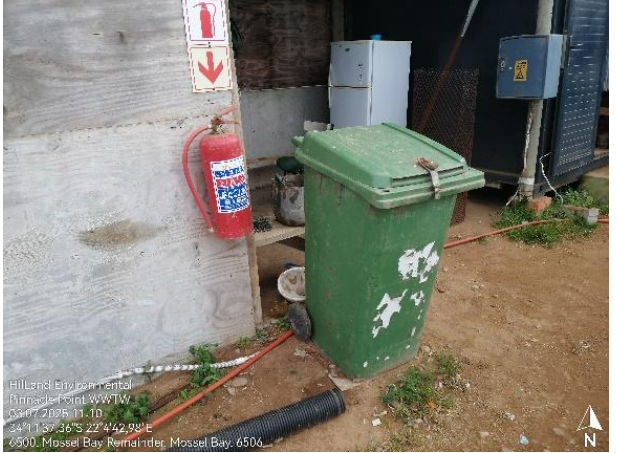
| 7. Fire prevention and control | <p>1. Any welding or other sources of heating of materials shall be done in a controlled environment and under appropriate supervision</p> <p>2. Working fire extinguisher to be available on site.</p> <p>3. No smoking will be allowed on site, in particular in areas within or adjacent to natural vegetation, except in designated smoking points.</p> | <p>1. No environmental issues noted or reported to the ECO.</p> <p>2. In place as per the contractor's method statement and as seen on site during ECO inspection.</p> <p>3. No smoking noted on site during ECO site inspection. Cigarette disposal bin to be provided at the site camp.</p> | <p>Hilland Environmental<br/>Pinnacle Point WWTW<br/>03/07/2025 11:10<br/>34°11'36"S 22°44'29"E<br/>6500, Mossel Bay Remainder, Mossel Bay, 6506</p> <p>Fire extinguisher on site</p> |

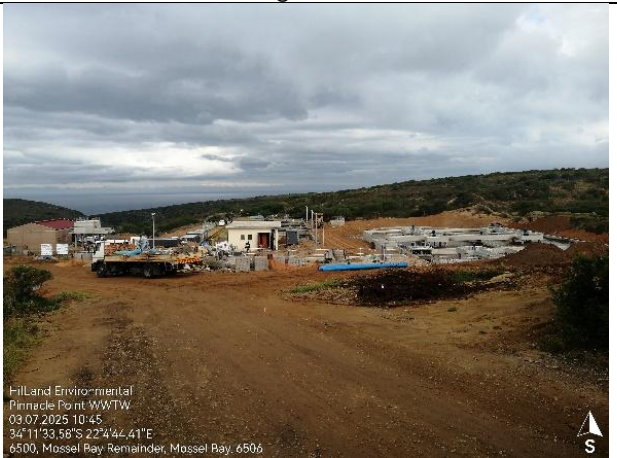
| 8 & 9. Noise and Dust control | <p>The contractor shall be responsible for the control of dust arising from the operations.</p> | <p>No dust or noise issues noted or reported to the ECO.</p> <p>Dust management to be implemented as per the contractor's method statement <b>when necessary</b> – no dust related issues recorded during this period.</p> | <p>Hilland Environmental<br/>Pinnacle Point WWTW<br/>03/07/2025 10:45<br/>34°11'33.58"S 22°44'41"E<br/>6500, Mossel Bay Remainder, Mossel Bay, 6506</p> <p>No dust issues noted during ECO inspections.</p> |
