## Environmental Monitoring Report No.18 for Pinnacle Point WWTW Upgrade, Mossel Bay Municipality

**PINNACLE POINT WWTW UPGRADE  
ENVIRONMENTAL MONITORING REPORT NO 18**

## **Environmental Monitoring Report No. 18**

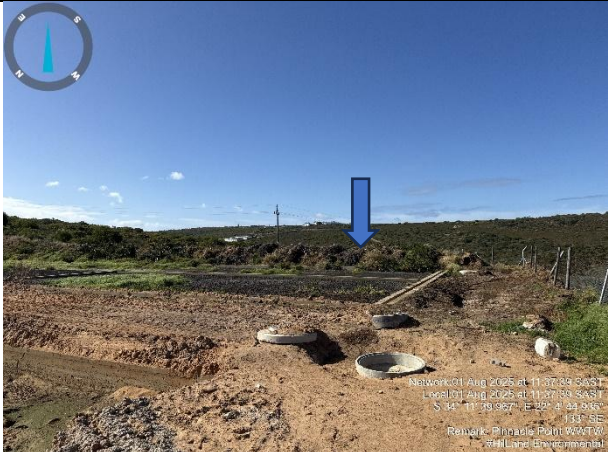
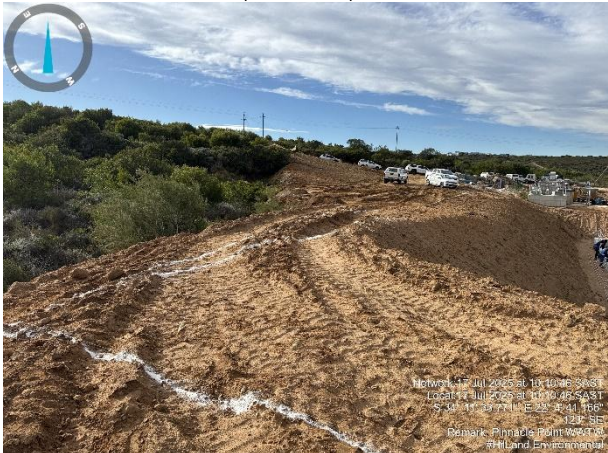
| | | | <div data-bbox="1487 193 2092 647"><p>Network 1 Aug 2025 at 11:37:54 SAST<br/>Location 1 Aug 2025 at 11:37:54 SAST<br/>S 44° 11' 39.927" E 25° 4' 34.945"<br/>134° SE<br/>Demarc Pinpoint Point 054700<br/>Mall Land Environmental</p></div> <p>Topsoil stockpile.</p> <div data-bbox="1487 675 2092 1129"><p>Network 11 Jul 2025 at 16:46:56 SAST<br/>Location 11 Jul 2025 at 16:46:56 SAST<br/>S 40° 54' 29.741" E 33° 2' 41.186"<br/>124° SE<br/>Demarc Pinpoint Point 054700<br/>Mall Land Environmental</p></div> <p>Construction and excavations are limited to demarcated development footprint – new fence position was pegged on site.</p> |

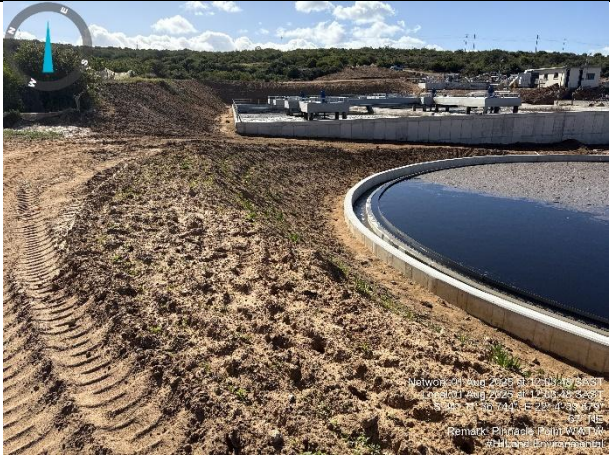
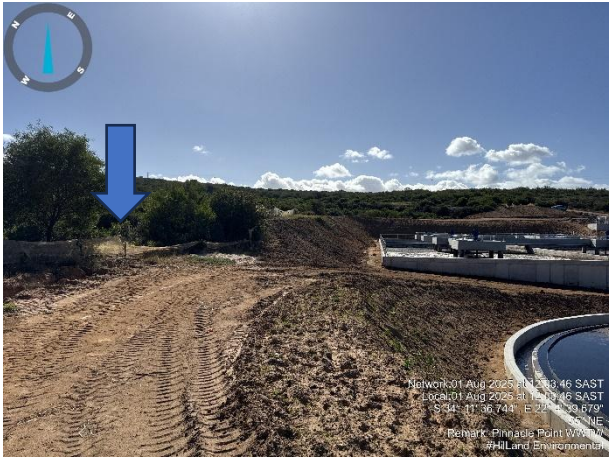
| | | | <div><p>Network: 01 Aug 2025 01:33:49 SAST<br/>Local: 01 Aug 2025 01:33:49 SAST<br/>S: 34° 41' 36.743" E: 22° 53' 0.679"<br/>Zone: 35NE<br/>Datum: Pinnacles Point WGS84<br/>Hill and Environmental</p></div> <div><p>Network: 01 Aug 2025 01:33:46 SAST<br/>Local: 01 Aug 2025 01:33:46 SAST<br/>S: 34° 41' 36.743" E: 22° 53' 0.679"<br/>Zone: 35NE<br/>Datum: Pinnacles Point WGS84<br/>Hill and Environmental</p></div> <div>Orange netting fence still in place.</div> |

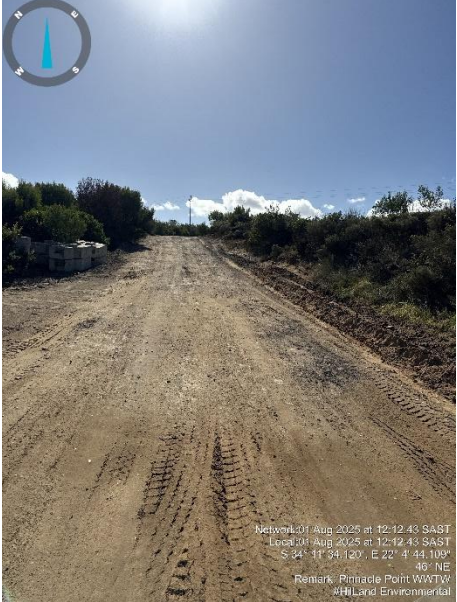
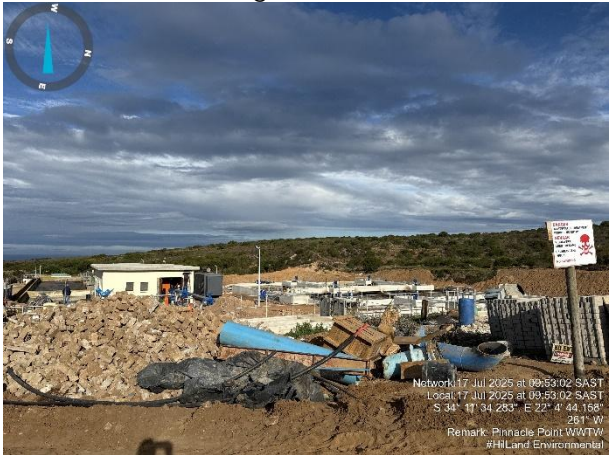
| <p>3. Access and traffic control</p> | <p>Existing access track shall be used</p> | <p>Existing access tracks are being used and maintained.</p> | <div data-bbox="1563 197 2018 802"> <p>Network: 01 Aug 2025 at 12:12:43 SAST<br/> Location: 01 Aug 2025 at 12:12:43 SAST<br/> S 34° 41' 34.120", E 22° 4' 44.100"<br/> 45° NE<br/> Remark: Pinnacle Point WWTW<br/> #Hiland Environmental</p> </div> <p>Existing access road.</p> <div data-bbox="1487 831 2096 1287"> <p>Network: 17 Jul 2025 at 09:53:02 SAST<br/> Location: 17 Jul 2025 at 09:53:02 SAST<br/> S 34° 11' 34.283", E 22° 4' 44.158"<br/> 261° W<br/> Remark: Pinnacle Point WWTW<br/> #Hiland Environmental</p> </div> <p>Safety signs at the site entrance.</p> |

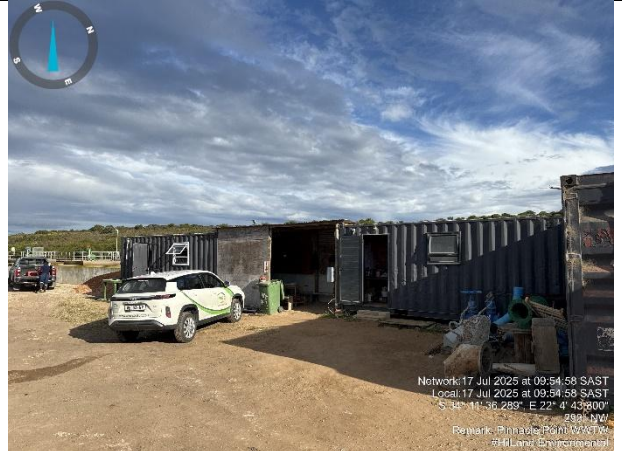
| 5. Site and waste management | <ol style="list-style-type: none"> <li>1. Storage areas for potentially contaminating materials shall be roofed with impervious material (or double bagged in a skip until removed).</li> <li>2. Waste bins/skips must be used for all waste and litter. Waste bins must have lids to prevent content from blowing away or accumulating rainwater. Skips should be covered with netting.</li> <li>3. The burning and dumping of waste are forbidden.</li> <li>4. At least one chemical toilet must be made available on site for every 15 workers. All workers will be required to use the chemical toilet(s).</li> </ol> | <ol style="list-style-type: none"> <li>1. Storage of hazardous material (if any) as per the contractor's method statement and within the existing site camp – as seen on site during the recent ECO site visit.</li> <li>2. Litter bins (closable) are available at the site camp and the site.</li> <li>3. No burning or burying of waste noted or reported to the ECO – the pieces of off-cut concrete must not be buried/covered on site.</li> <li>4. Portable- and permanent toilets are available on site.</li> </ol> | <p>Network: 17 Jul 2025 at 09:54:58 SAST<br/> Local: 17 Jul 2025 at 09:54:58 SAST<br/> S: 34° 14' 56.289" E: 22° 14' 38.000"<br/> Remark: Pinna Point, 2590 m<br/> 944 Lines, 5790000000</p> |

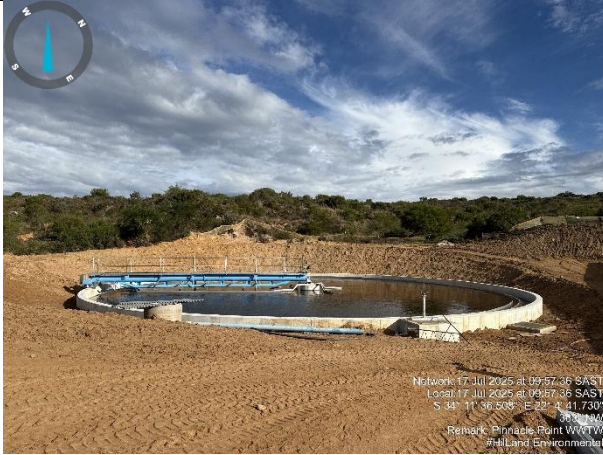
| 8 & 9. Noise and Dust control | The contractor shall be responsible for the control of dust arising from the operations. | <p>No dust or noise issues noted or reported to the ECO.</p> <p>Dust management to be implemented as per the contractor's method statement <b>when necessary</b> – no dust related issues recorded during this period.</p> | <p>Network 17 Jul 2025 at 09:57:35 SAST<br/> Local 17 Jul 2025 at 09:57:35 SAST<br/> S 44° 11' 36.538" E 22° 4' 41.730"<br/> 205.110<br/> Remark: Pinnacle Point VWCOT<br/> 2nd Land Government</p> <p>No dust issues noted during ECO inspections.</p> |

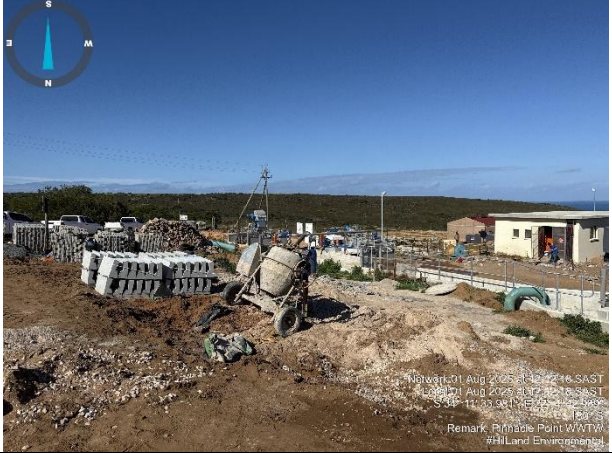
| 12. Concrete management | <ol style="list-style-type: none"> <li>1. Ready-mix concrete should preferably be used.</li> <li>2. Cement and other potential environmental pollutants shall be stored in a dry lockable container.</li> <li>3. Mixing of mortar and concrete must take place on an impermeable substratum.</li> <li>4. Lined, concrete, effluent catchpits must be created where on-site mixing takes place.</li> </ol> | <p>Stand mixer and ready mix are used, hand mixing is done on a non-permeable layer (plastic sheet). Current cement mixing is confined to one location – <i>this area will have to be rehabilitated.</i></p> <p>Cement is stored in the site camp and in a container.</p> <p>Concrete off-cuts to be collected and disposed of at an authorized disposal site and not be buried/covered on site.</p> | <p>Nowat: 01 Aug 2025 8:10:22:16 SAST<br/> 29.971 Aug 2025 8:37:52:16 SAST<br/> 30.011 Aug 2025 8:52:16 SAST<br/> Remark: P. Made Point WWTW<br/> W. H. Land Engineering</p> |

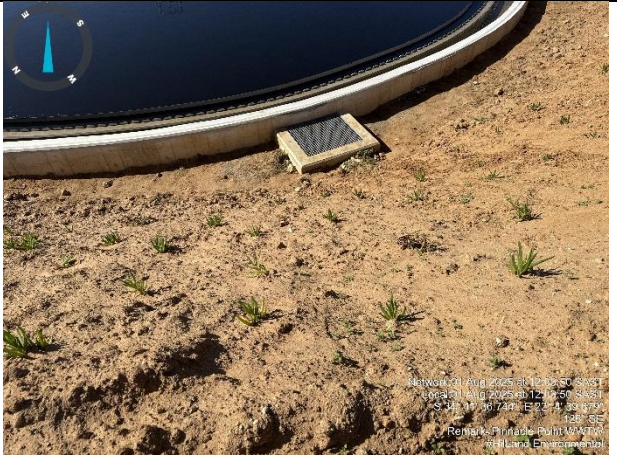
| 13. Site closure / rehabilitation phase | <p>All equipment and temporary facilities shall be removed from the site within one week after completion of construction activities.</p> <p>The contractor must remove all oil, cement spills and waste within one week after completion of construction on the site.</p> <p>The contractor must repair disturbed areas (e.g. deep tracks left by construction vehicles) within one week after completing construction on a site.</p> <p>Areas compacted by vehicles during construction shall be scarified or ripped, if necessary, to allow penetration of plant roots and the re-growth of natural vegetation if outside the boundaries of the site footprint.</p> <p>Locally indigenous plant species shall be used for rehabilitation.</p> <p>Vegetative cover shall be encouraged to take place in as short a time as possible.</p> | <p><b>Still in construction phase.</b></p> <p>Ongoing – off-cuts to be removed and not buried.</p> <p>Backfilling with subsoil only and not rubble.</p> <p>Topsoil to be placed back (on top) of the shaped slope and seeded with the grass seed mix.</p> <p><i>Carpabrotus</i> cuttings have been planted on sections of the slope.</p> | <p>Rehabilitation on backfilled slopes has begun (<i>Carpobrotus spp</i> have been planted).</p> |

Suitable erosion protection to be installed to prevent soil erosion on the newly shape slope – silt fences/ sandbags / haybales etc. to tie in with the stormwater plan – awaiting the stormwater plan from the engineers to confirm that it complies with the EMPr (requested via email).

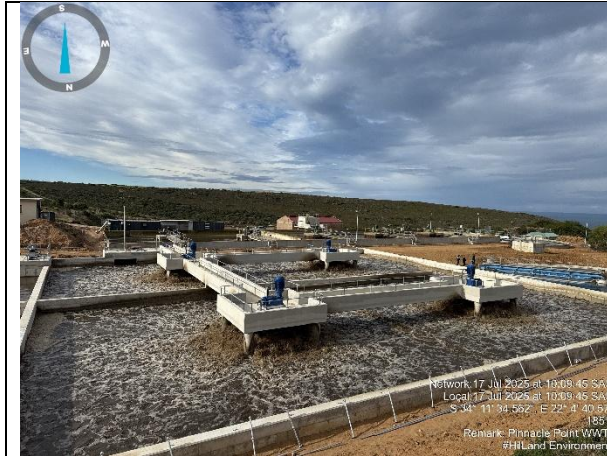
Reactors are being tested

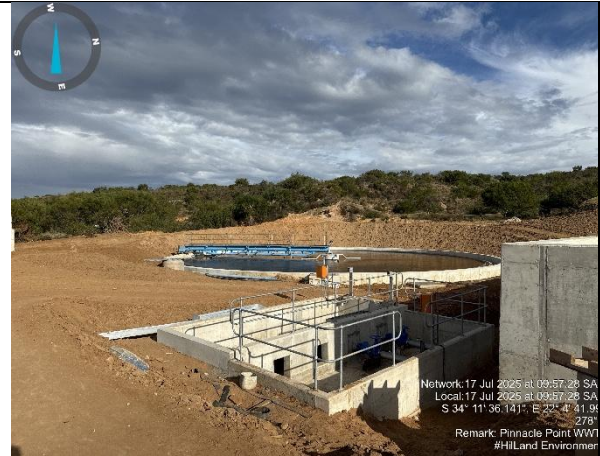
Pumpstation concrete work complete

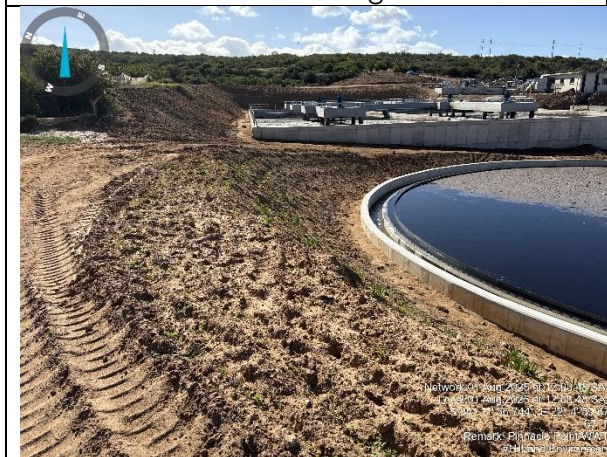
Slope rehabilitation
