## ENVIRONMENTAL MONITORING REPORT #47

KRAAIBOSCH PARK (PORTION 370 AND 371), GEORGE

| <b>Report Period</b> | July 2024 |

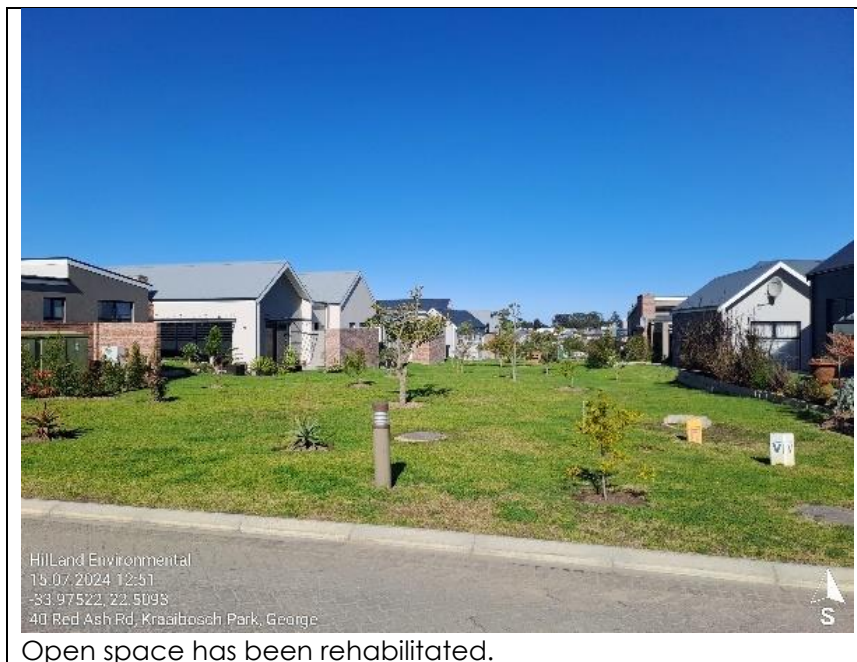
- *Landscape areas are compliant with these conditions. The open space has been rehabilitated.*
- *There was a query regarding the positioning of the indigenous trees that have been planted. It was confirmed that indigenous trees are being planted as part of the estates landscaping within the road reserve and internal open space (parks).*

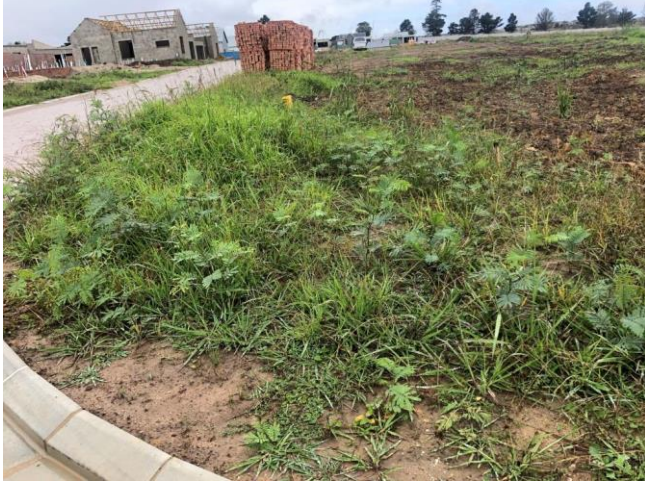
The Pampas grass, black wattles, bramble and bugweed in the wetlands and stormwater channels must be eradicated.

Black wattle on the road verges.

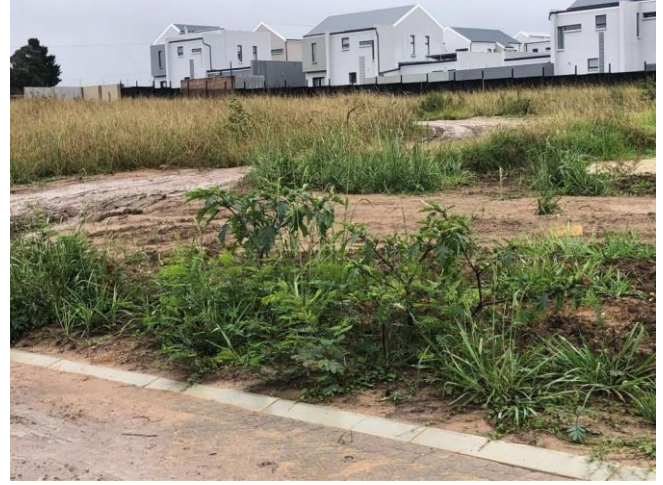
*Datura* spp. In the road reserve must be removed.

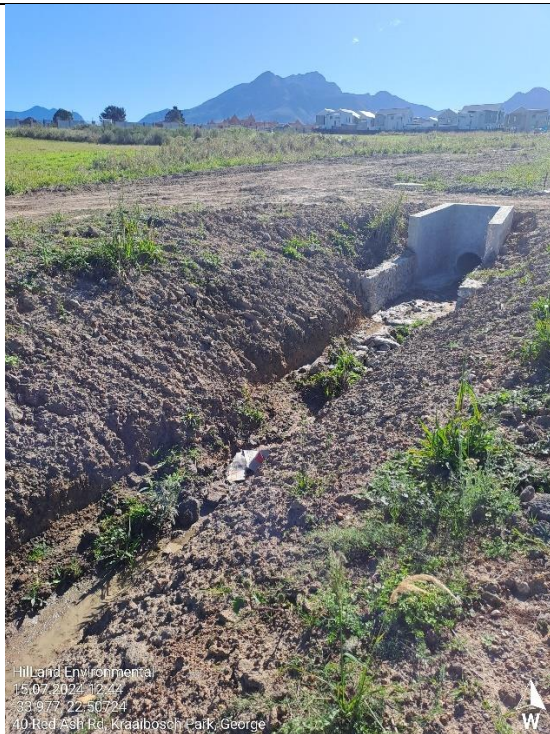
Sandbags must be continuously maintained in the stormwater outlet to reduce erosion.

Completed stormwater channels are to be monitored for any signs of soil erosion. If any erosion occurs it must be fixed straight away and suitable erosion protection must then be installed and maintained - *the silt fences/sandbags placed across channel must be monitored and maintained (remove silt and litter/debris by hand).*

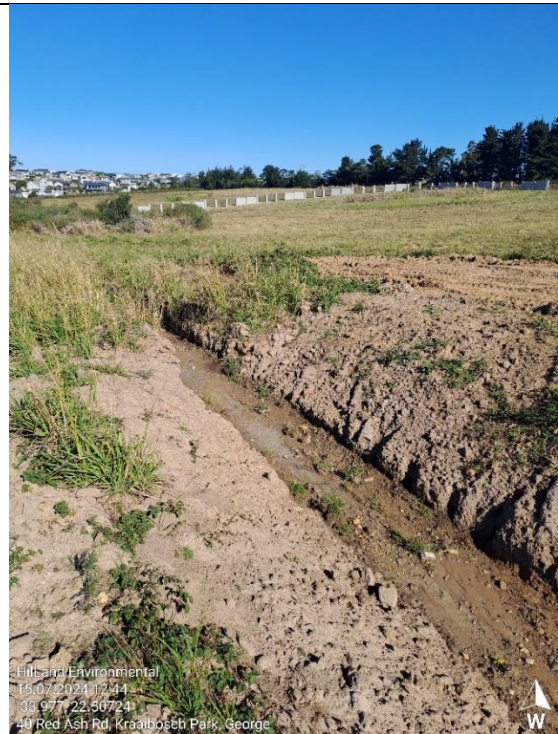
The sides of the stormwater outlets must be monitored for erosion while they are still revegetating.

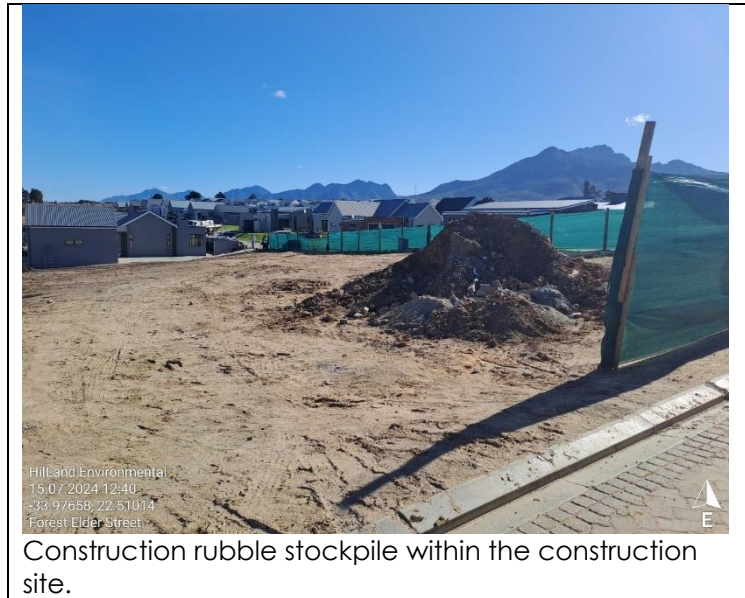
The construction rubble stockpile is in the future development area and small stockpile (within the demarcated construction site) – *skips and rubble must be regularly removed/emptied. The stockpile(s) are removed regularly. Regular litter picking must be done at each site and at the site camp to ensure that all wind-blown litter is kept inside a bin.*
