## ENVIRONMENTAL MONITORING REPORT #48

KRAAIBOSCH PARK (PORTION 370 AND 371), GEORGE

| <b>Report Period</b> | August 2024 |

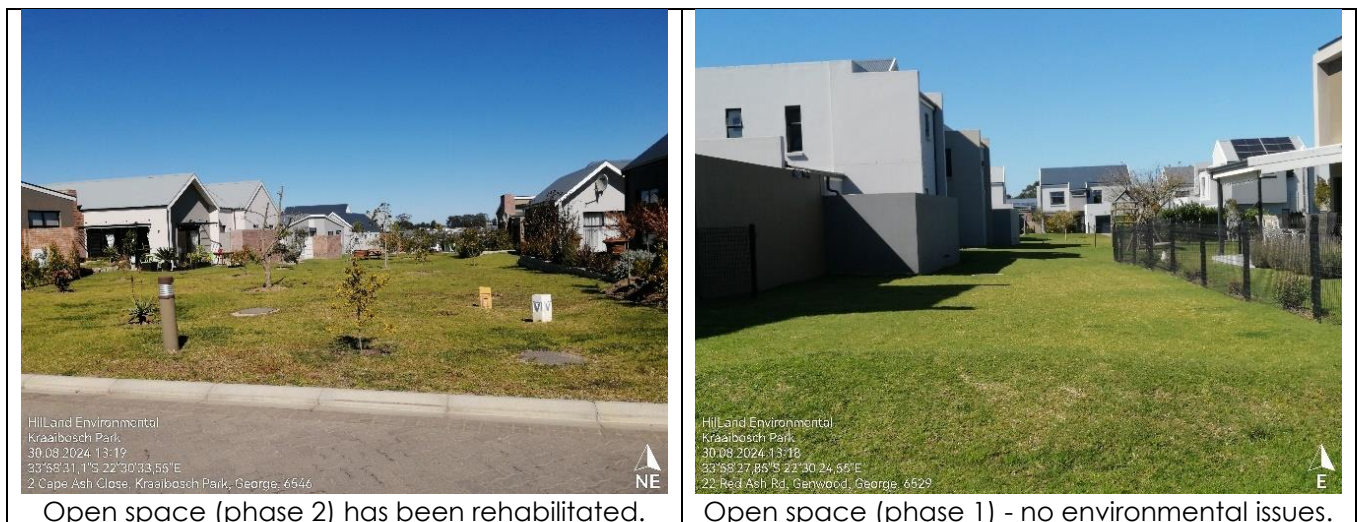
- *Landscape areas are compliant with these conditions. The open space has been rehabilitated.*

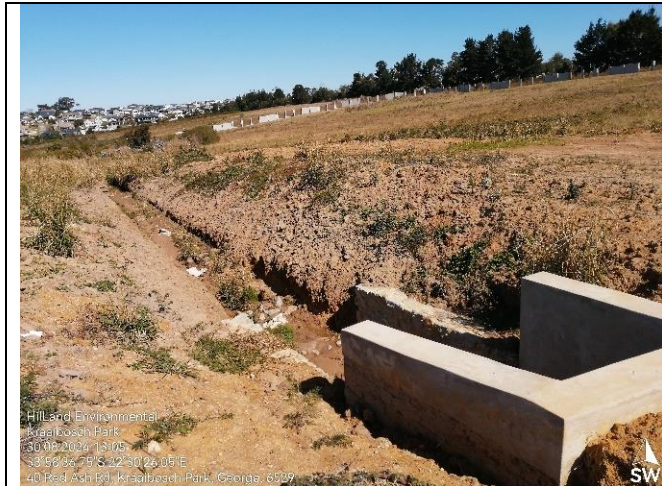
The main sewer (bulk) line connects to the municipal sewer line in the southern portion of the property. The sewer line was installed next to the wetland (buffer area) area as delineated by the specialist. Vegetation on the pipeline route consisted mainly of grasses. No bulbs were observed to rescue – *the sewer line has been installed and must now be rehabilitated by raking the compacted soil loose, adding a layer of topsoil, sowing locally indigenous grass seeds (kweek and buffalo grass). It is recommended that soil erosion protection is installed (hessian sausages filled with mulch - or small berms) are to be placed horizontally across the sewer line to prevent erosion while the natural vegetation reestablishes.*

Stormwater outlets - sandbags (silt management) must be continuously maintained to reduce erosion and siltation downstream.

| Phase 1 – 3 – Operational Phase Conditions | | | |
|---|---|---|---|
| Adequate erosion control measures must be implemented as required. | <b>Yes</b> | <b>No</b> | Ongoing monitoring of the stormwater outlets that have been handed over to the HOA. Ensure that the sandbags or silt fences are in place and functioning. Silt fences to be upright and silt buildup to be removed. Sandbags to be across the flow path to slow runoff water and capture silt.<br><b>No</b> – the erosion damage on the sewer line in phase 3 must be rehabilitated and suitable erosion protection must be installed to prevent future erosion issues. |

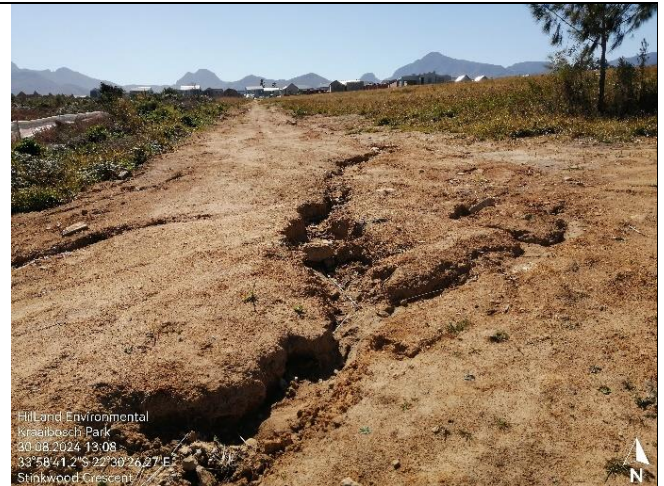
Phase 3 – sewer line must be rehabilitated and adequate erosion protection must be installed.

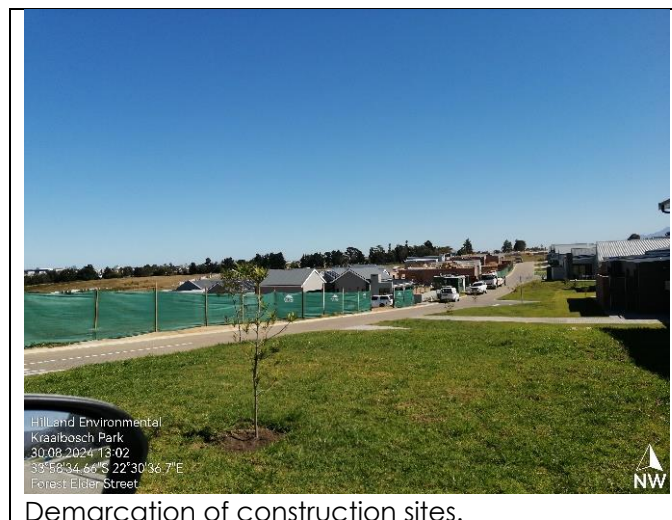
*Regular inspections of the stormwater inlets and outlets for silt and litter buildup and cleaning when necessary. Stormwater inlets to be protected from silt by placing sandbags to capture silt before entering the inlet structure. These "silt traps" must be cleaned regularly – this is an ongoing reminder to prevent silt ingress into the stormwater system.*

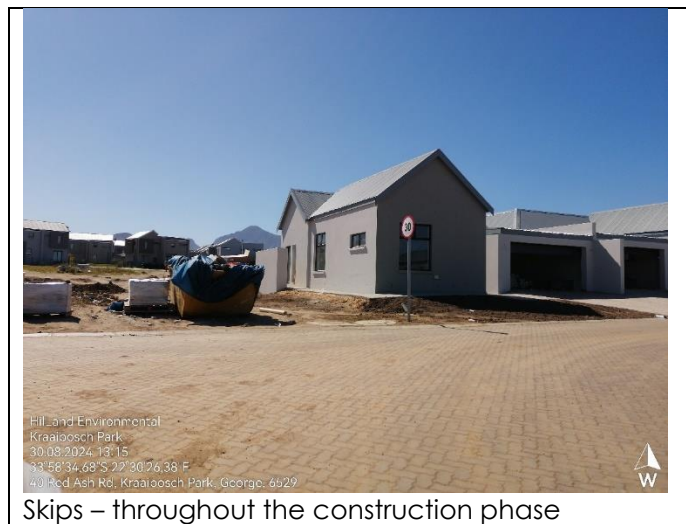
The construction rubble stockpile is in the future development area next to the site camp – *skips and rubble must be regularly removed/emptied. The stockpile(s) are removed regularly. Regular litter picking must be done at each site and at the site camp to ensure that all wind-blown litter is kept inside a bin.*

Skips – throughout the construction phase
