## ENVIRONMENTAL MONITORING REPORT #49

KRAAIBOSCH PARK (PORTION 370 AND 371), GEORGE

| <b>Report Period</b> | September 2024 |

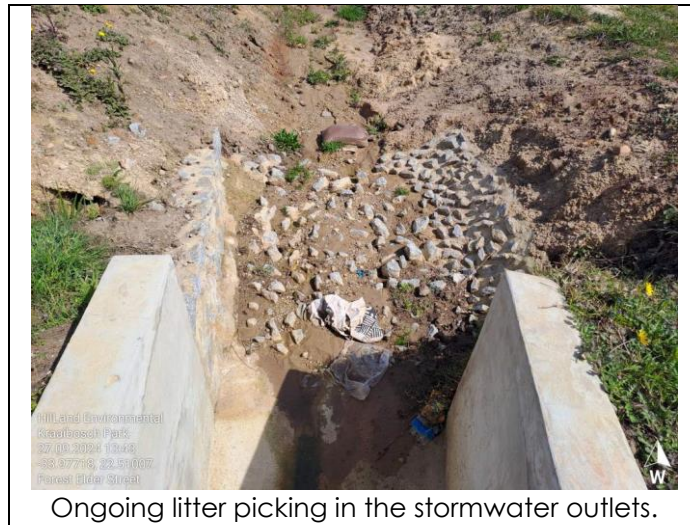
Ongoing litter picking in the stormwater outlets.

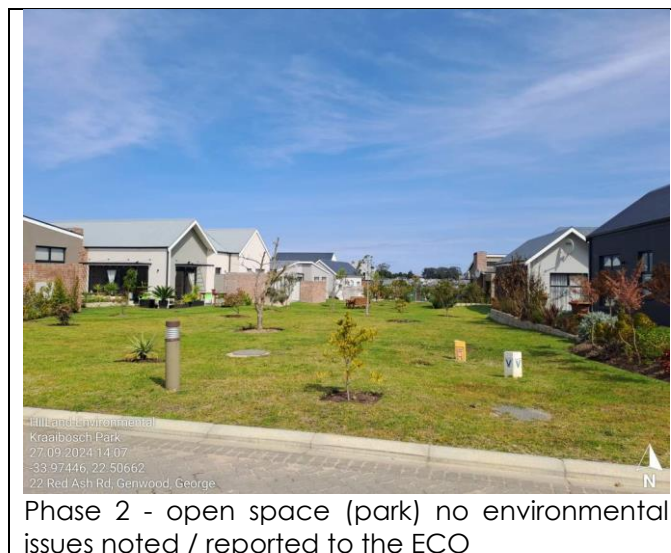
Phase 2 - open space (park) no environmental issues noted / reported to the ECO

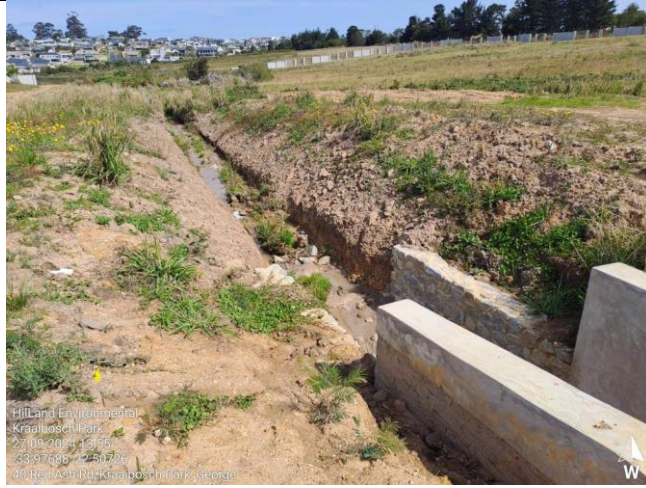
Stormwater outlets - sandbags (silt management) must be continuously maintained to reduce erosion and siltation downstream.

Completed stormwater channels are to be monitored for any signs of soil erosion. If any erosion occurs it must be fixed straight away and suitable erosion protection must then be installed and maintained - *the silt fences/sandbags placed across channel must be monitored and maintained (remove silt and litter/debris by hand).*

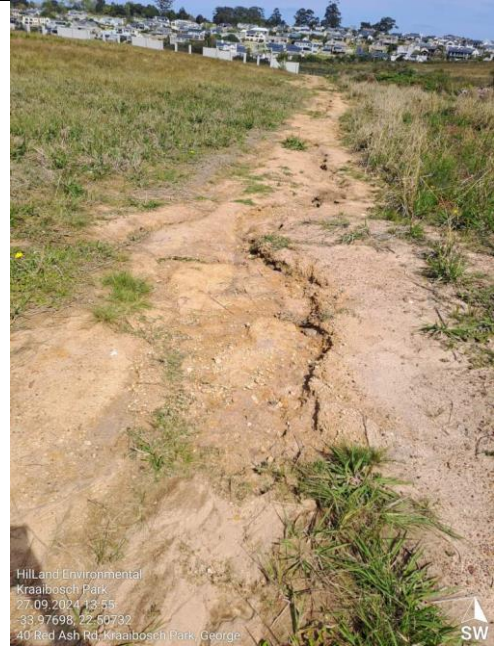
The main sewer (bulk) line connects to the municipal sewer line in the southern portion of the property. The sewer line was installed next to the wetland (buffer area) area as delineated by the specialist. Vegetation on the pipeline route consisted mainly of grasses. No bulbs were observed to rescue – *the sewer line has been installed and must now be rehabilitated by raking the compacted soil loose, adding a layer of topsoil, sowing locally indigenous grass seeds (kweek and buffalo grass). It is recommended that soil erosion protection is installed (hessian sausages filled with mulch - or small berms) are to be placed horizontally across the sewer line to prevent erosion while the natural vegetation reestablishes.* – **this has been an outstanding item in terms of the EMP and must be resolved, otherwise a fine in terms of the EMP will be issued to the Developer.**

Phase 3 – sewer line must be rehabilitated and adequate erosion protection must be installed.

| Phase 1 – 3 – Operational Phase Conditions | | | |
|---|---|---|---|
| Adequate erosion control measures must be implemented as required. | Yes | No | Ongoing monitoring of the stormwater outlets that have been handed over to the HOA. Ensure that the sandbags or silt fences are in place and functioning. Silt fences to be upright and silt buildup to be removed. Sandbags to be across the flow path to slow runoff water and capture silt.<br><b>No</b> – the erosion damage on the sewer line in phase 3 must be rehabilitated and suitable erosion protection must be installed to prevent future erosion issues. |

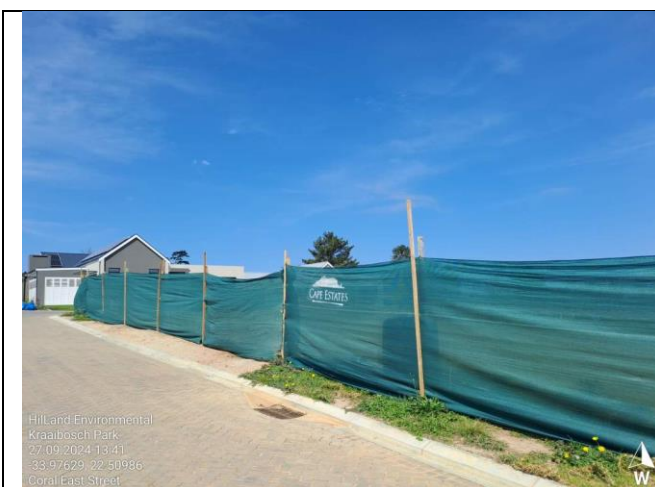
The construction sites (houses under construction) are to be demarcated to prevent unauthorized entry after working hours. The demarcation netting must remain in place for the duration of the construction period – *not all sites have demarcation, but no encroachment into the internal open space is noted.*

Demarcation of the construction sites.

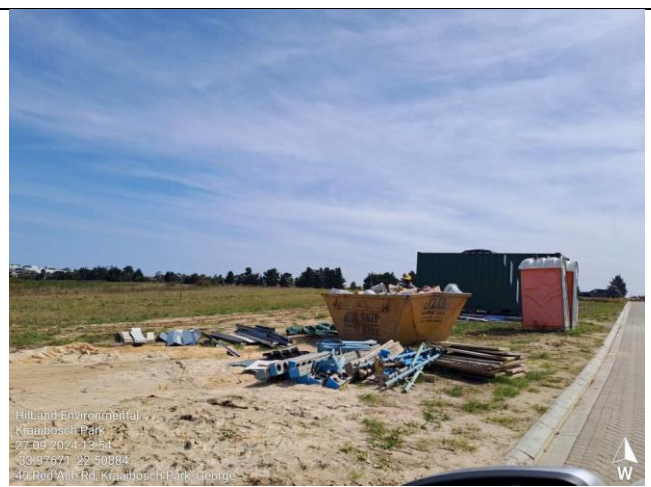
House contractor's construction site camp must remain outside NO-GO/sensitive areas. This will prevent encroachment into internal green/open space which is not allowed – *Current site camp and office is within a future development zone.*

Contractors site camp – future development erf.  
Skips and toilets throughout construction site
