## ENVIRONMENTAL MONITORING REPORT # 50

KRAAIBOSCH PARK (PORTION 370 AND 371), GEORGE

| Report Period | October 2024 |

**ENVIRONMENTAL MONITORING REPORT No. 50 – KRAAIBOSCH PARK  
(PORTION 370 AND 371), GEORGE  
FOR OCTOBER 2024**

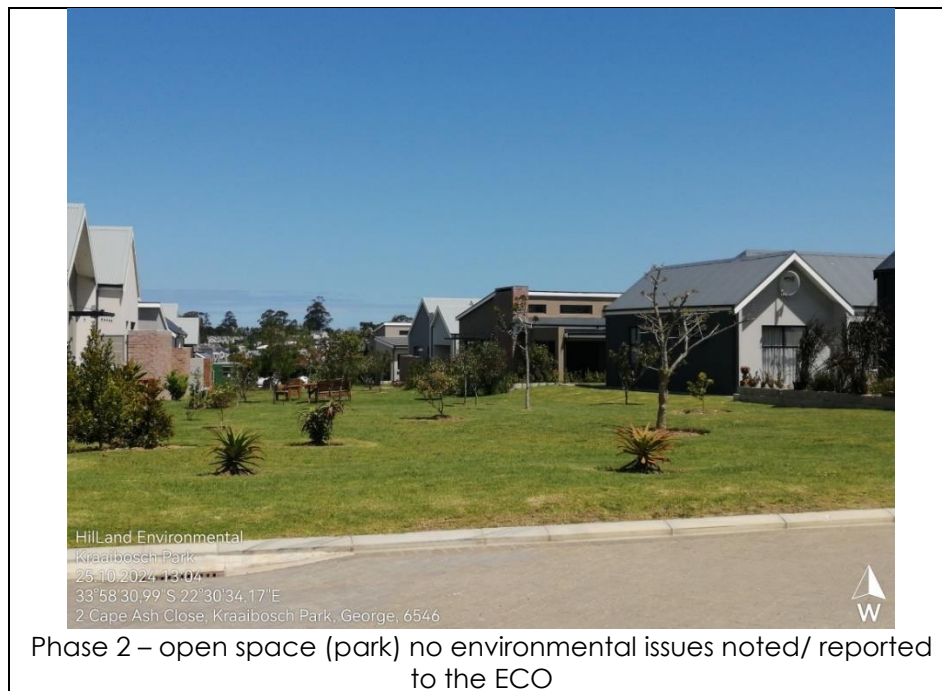
- *Landscape areas are compliant with these conditions. The open space has been rehabilitated.*
- *No listed alien invasive vegetation in gardens were noted during this reporting period.*

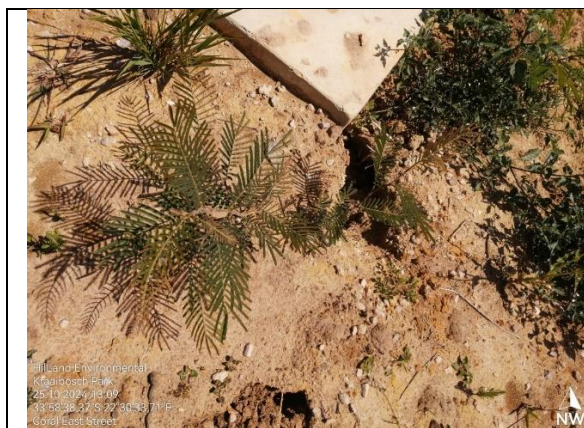
Black wattle seedlings

The pampas grass, black wattles, brambles and bugweed in the wetlands and stormwater channels must be eradicated. **Regular follow-up inspections (terrain manager) are required to ensure proper eradication of the invasives. Invasive alien plants in the construction phase to be managed by the building contractor.**

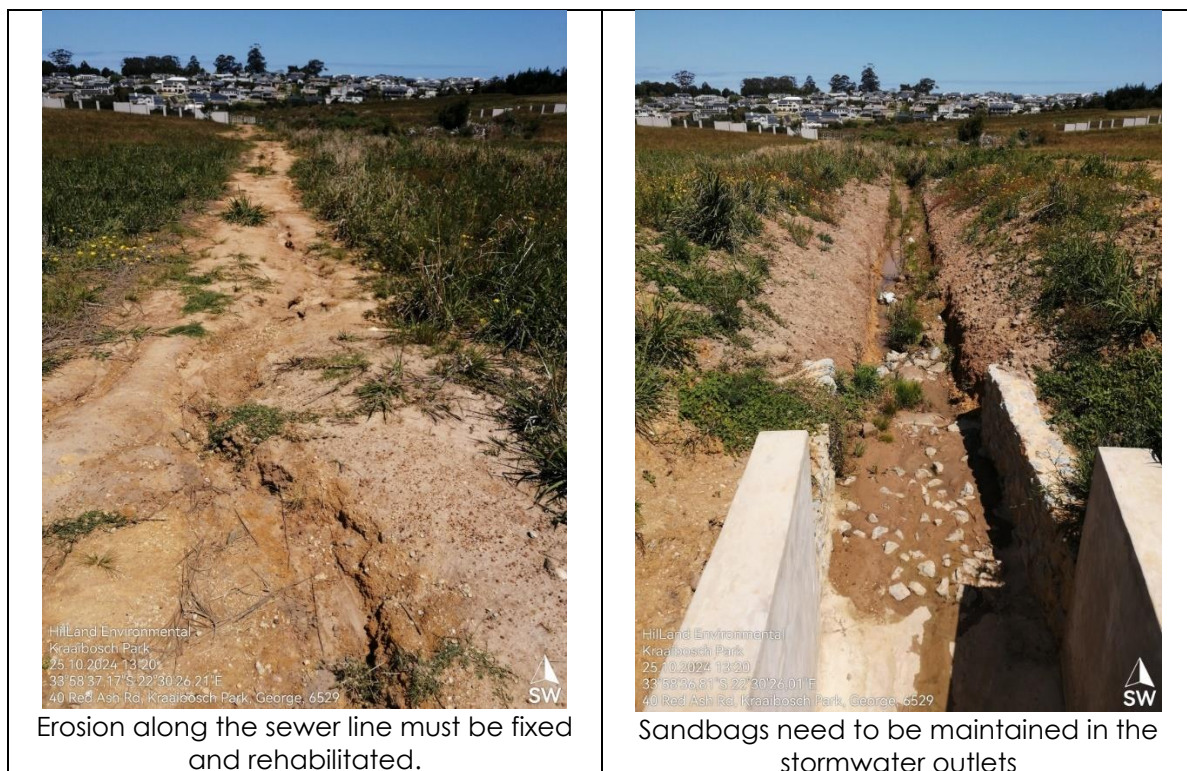
Completed stormwater channels are to be monitored for any signs of soil erosion. If any erosion occurs it must be fixed straight away and suitable erosion protection must then be installed and maintained – *the silt fences sandbags paced across channels must be monitored and maintained (remove silt and litter/ debris by hand) – ongoing requirement when there is active construction taking place.*

The main sewer (bulk) line connects to the municipal sewer line in the southern portion of the property. The sewer line was installed next to the wetland (buffer area) area as delineated by the specialist – *rehabilitation of the disturbance footprint is still outstanding and must be completed otherwise a fine will be issued to the holder/developer.*
