## THE CONSTRUCTION OF RESERVOIR FOR MOSSEL BAY AREA ON THE FARM VAALE VALLEY 219, MOSSEL BAY ENVIRONMENTAL MONITORING REPORT NO. 2

**MOS21/472/27**

**19 March 2021**

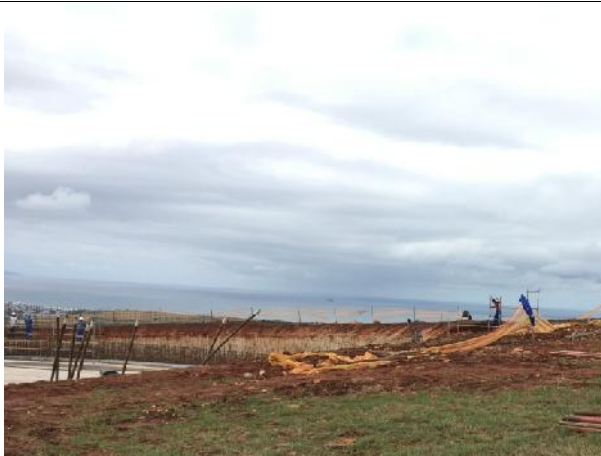
No-Go demarcation is in place. It was noted that the current orange netting at the top excavation area is not sturdy enough to prevent the cattle from pushing it over. **It was suggested that a stronger, more stable fence be installed to prevent the cattle from entering the excavation/construction area. THIS IS NOW URGENT AND THE**

2021.03.17 – The No-Go demarcation around the excavation area is insufficient.

**CONTRACTOR MUST PROVIDE FEEDBACK BY WEDNESDAY 24 MARCH 2021.** The ECO monitors maintenance and adherence to the demarcation during site inspections.

The contractor should ensure that the construction site (excavation area) is demarcated appropriately to prevent the farm animals from entering the site. Regular litter picking is mandatory. Environmental induction will be done with all staff members on site as soon as possible.

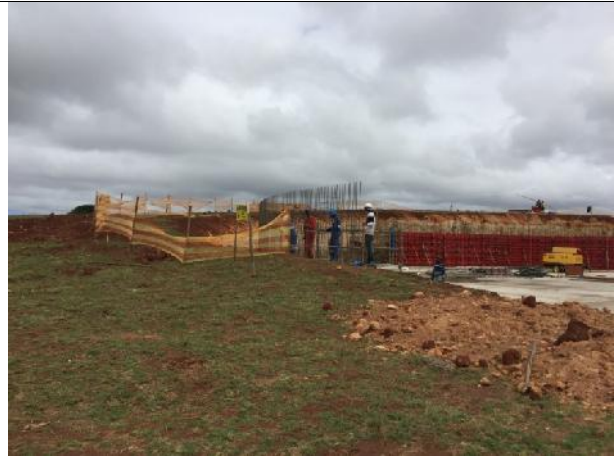
2021.03.17 – The orange netting is only installed on the southern edge, where the deepest excavated area is.

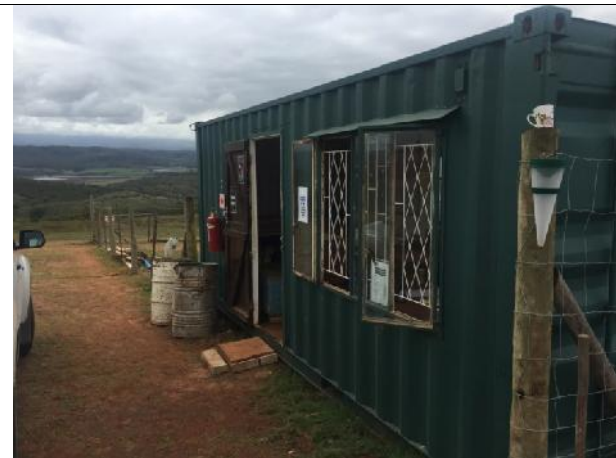
The site camp is fenced off correctly and set up in an area that is not within or adjacent a sensitive natural area.

2021.03.17 – Site camp office

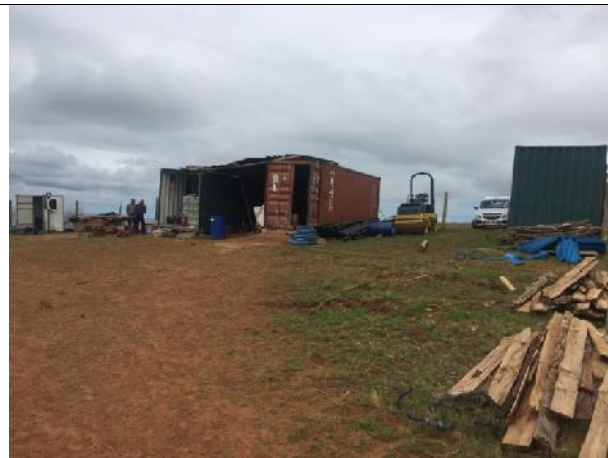
2021.03.17 – Site camp

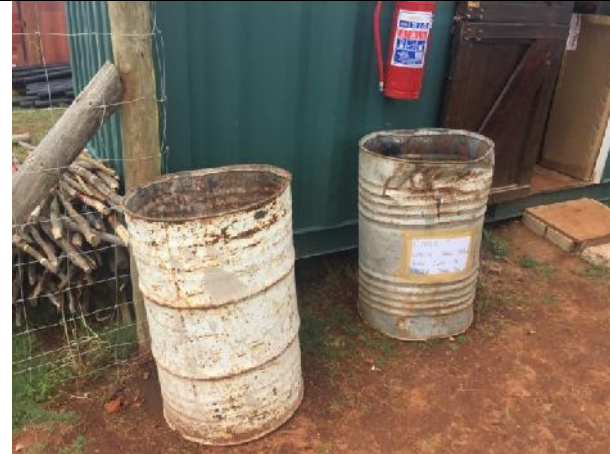
Adequate litter bins are provided at the site camp and littering issues should be covered in regular “toolbox” talks with all staff members. **There are a lot of cigarette butts scattered all over the site. This issue needs to be addressed and managed as soon as possible – separate suitable containers for cigarette but disposal is required throughout the site.** Alternatively, the contractor should create a designated smoking area with suitable bins.

2021.03.17 – A litter bin is located in the site camp

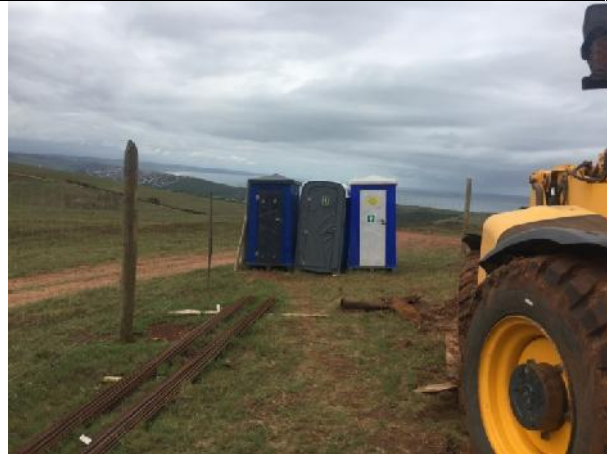
Portable toilet facilities are available on site for male and female construction workers.

2021.03.17 – On-site ablution facilities

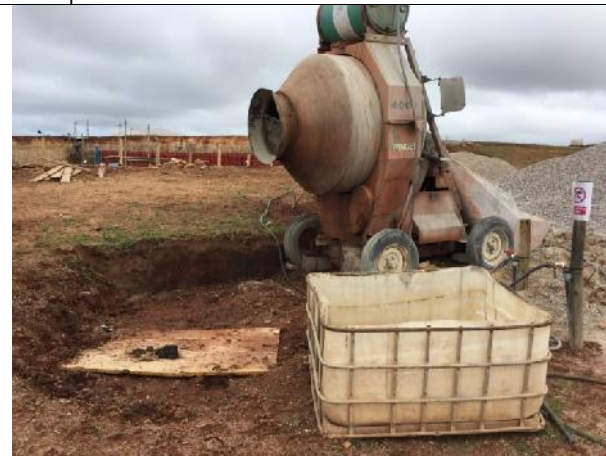
A bunded concrete mixing area, which is lined with a non-permeable layer, was created for small patchwork. The contractor should ensure that the contaminated

2021.03.17 – Concrete mixing area

runoff water is always contained and disposed of at an authorised disposal facility. Major works will be done with Ready-mix concrete – please note that the Ready-mix trucks are not allowed to rinse out anywhere on site.
