## THE CONSTRUCTION OF RESERVOIR AND ASSOCIATED INFRASTRUCTURE FOR MOSSEL BAY AREA ON THE FARM VAALE VALLEY 219, MOSSEL BAY

### ENVIRONMENTAL MONITORING REPORT NO. 7

ENVIRONMENTAL MONITORING REPORT NO. 7 – AUGUST 2021

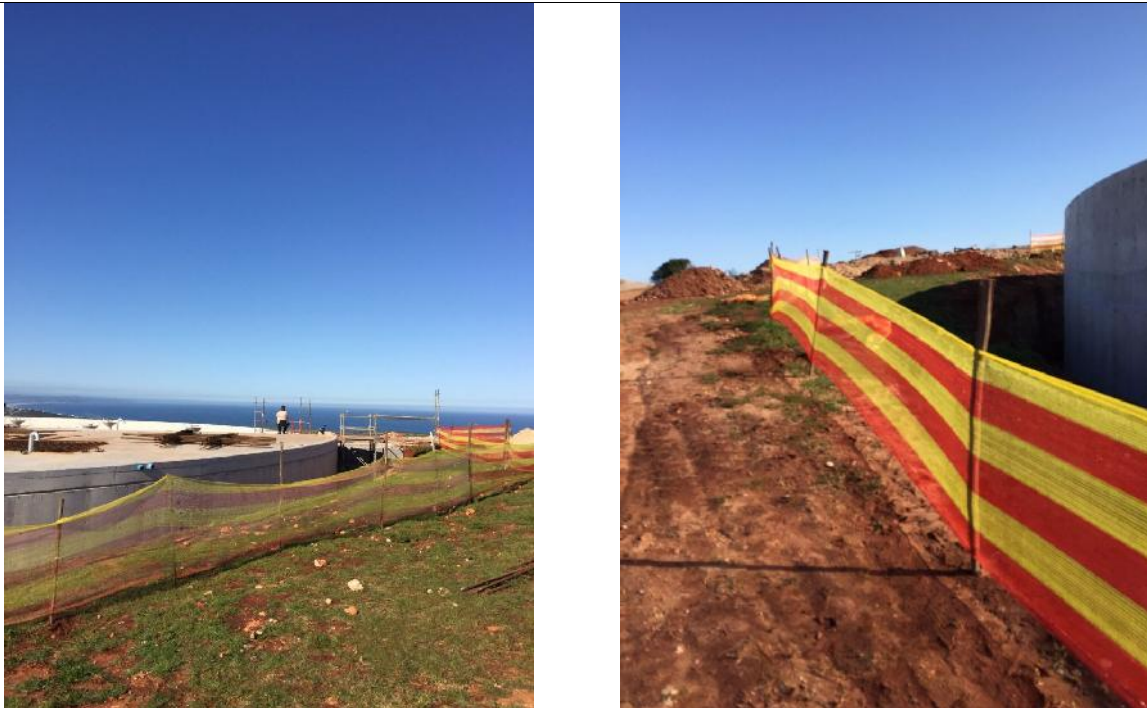
2021.08.23 – The demarcation is in place. The contractor must ensure that it is maintained and fully upright before leaving the site each day.

It was recommended that the item for installation of the reservoir boundary fence must be prioritised to prevent the farm animals from entering the construction site – It was discussed at the previous site meeting and the contractor will try to prioritize this item.

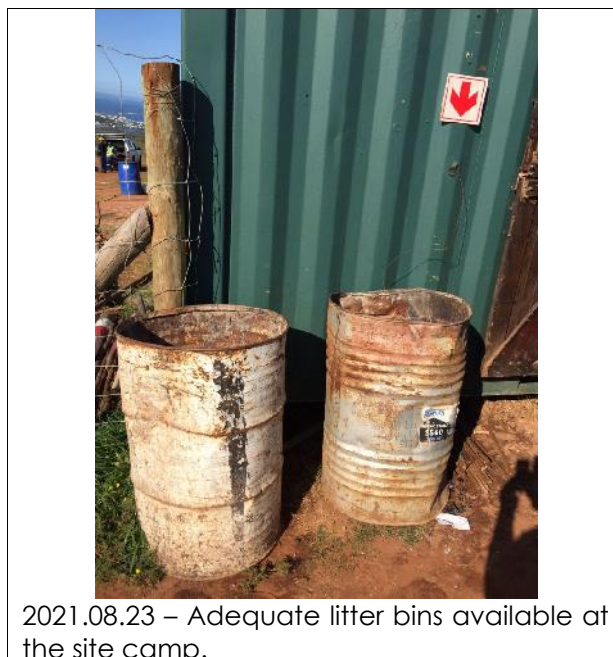
2021.08.23 – Adequate litter bins available at the site camp.

Adequate litter bins are provided at the site camp and littering issues should be covered in regular “toolbox” talks with all staff members. The contractor is now doing **daily litter picking** to keep the site neat and tidy.

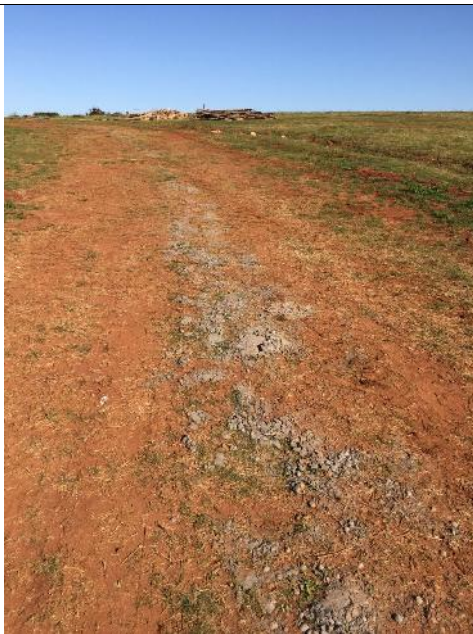
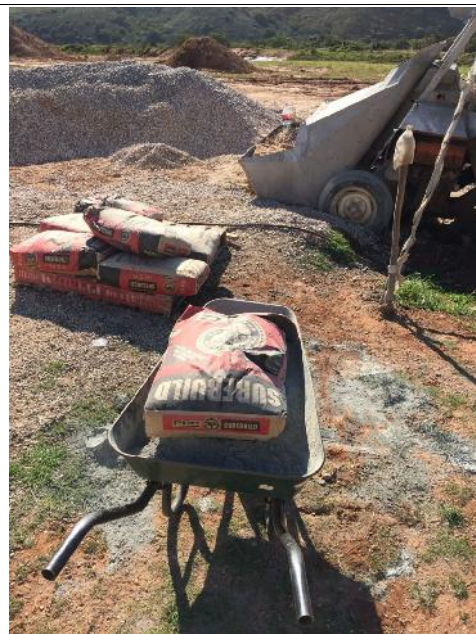
2021.08.23 – the contractor is reminded that the spilled cement and cement mixing areas must be cleaned up.

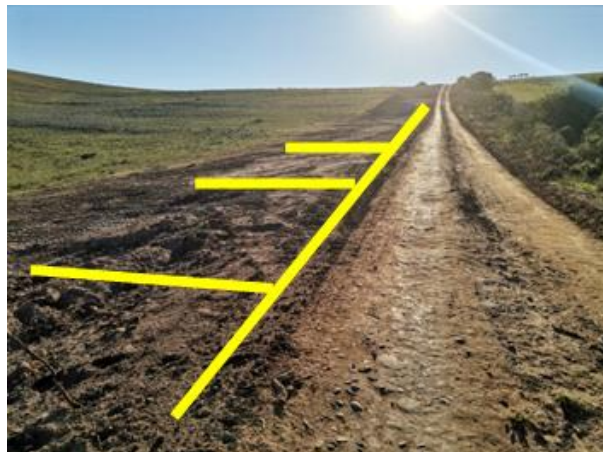
The area on the left of the track requires additional erosion protection to prevent potential future erosion. This can be done by creating small horizontal soil berms (yellow lines in the photo below) that will slow runoff water.

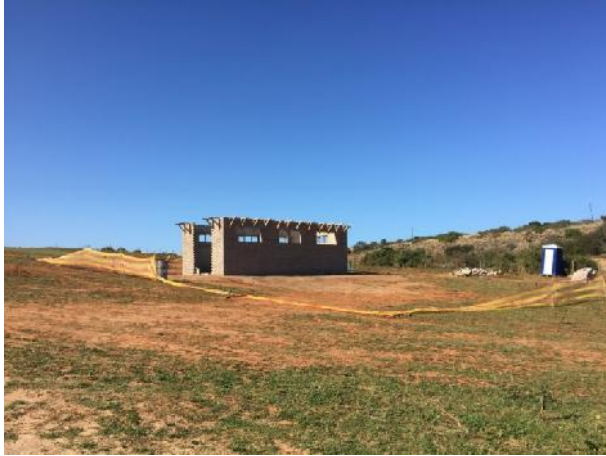
2021.08.11 – The contractor is reminded that the orange netting must be fully upright when not working in that area.

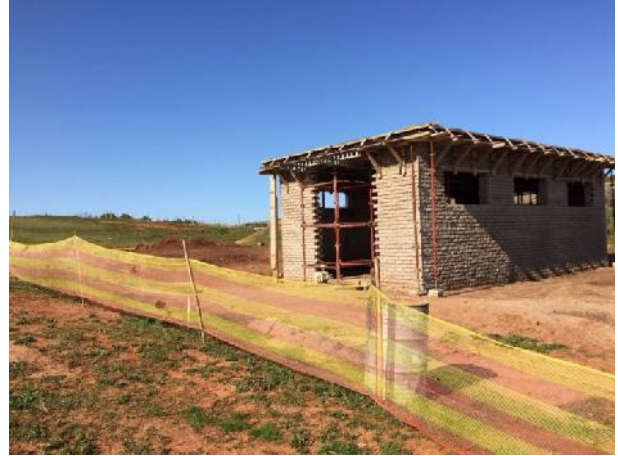
2021.08.23 – The No-Go demarcation around the pumpstation.

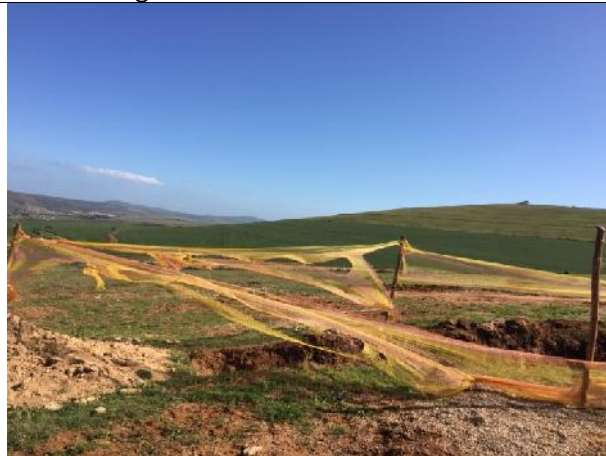
2021.08.11 – The orange netting must be fully upright – especially when there are cattle in the same camp.

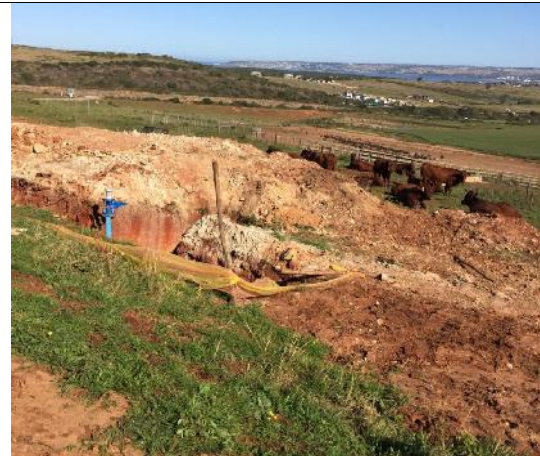
2021.08.23 – The contractor is reminded that orange netting must be used to demarcate deep trenches, **especially in the camps where the cattle are grazing.**

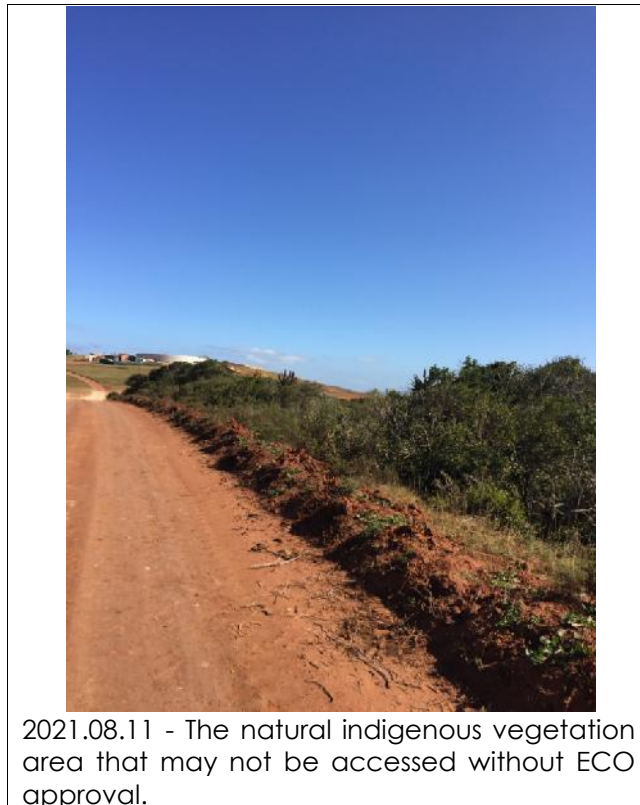
**No demarcation was installed along the natural vegetation section – there is no evidence of access into this area.** The contractor is reminded that no staff may access the natural indigenous vegetation area (at the top of the hill and towards the reservoir).

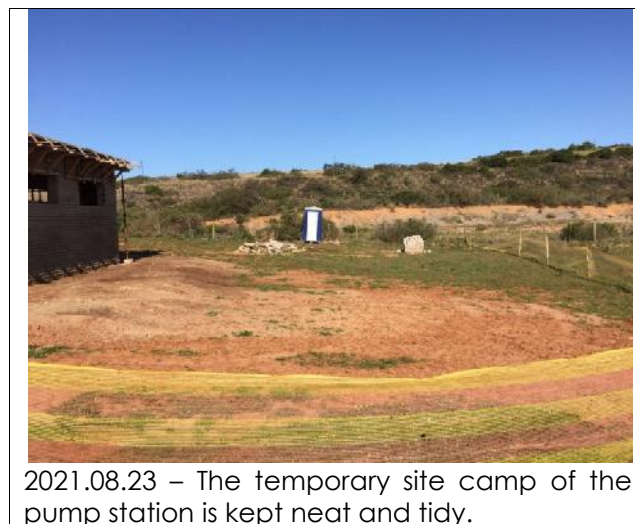
The site camp is located at the top of the hill (same site camp as for the Reservoir construction) and is fenced off acceptably and set up in an area that is not within or adjacent a sensitive natural area.

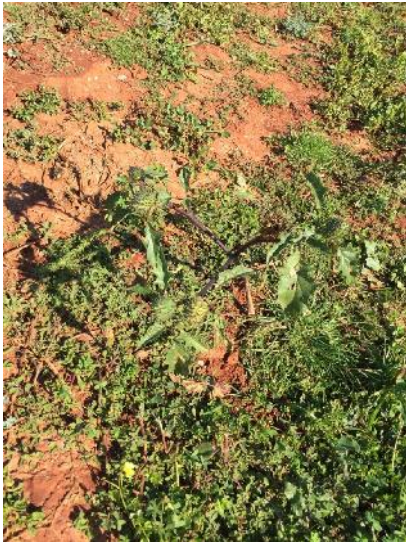
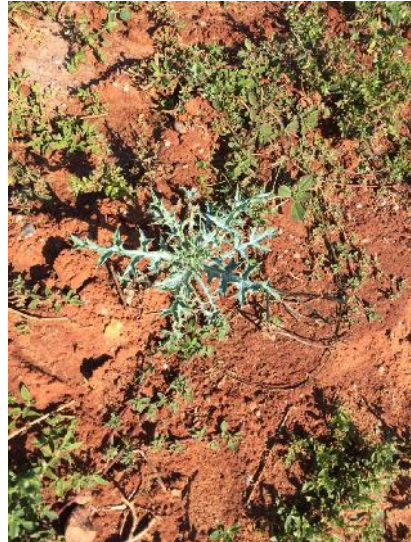
2021.08.23 – The contractor must ensure that the listed invasive alien plants in the fenced off area around the pump station are eradicated – these plants can be removed by hand/shovel and disposed of at the appropriate disposal facility.
