## ANNEXURE A – SITE PHOTOGRAPHS

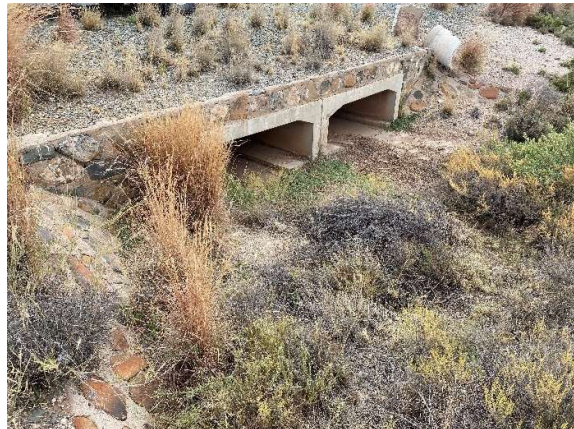
Culverts upgraded with new concrete structures, erosion control, and clearing of vegetation along TR 16/8.

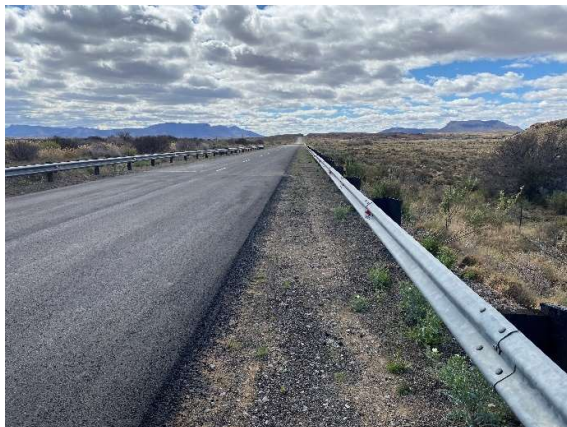
Newly installed guardrails at B4611: TR16/8 at Km 46.11 (Gabriel Stream).

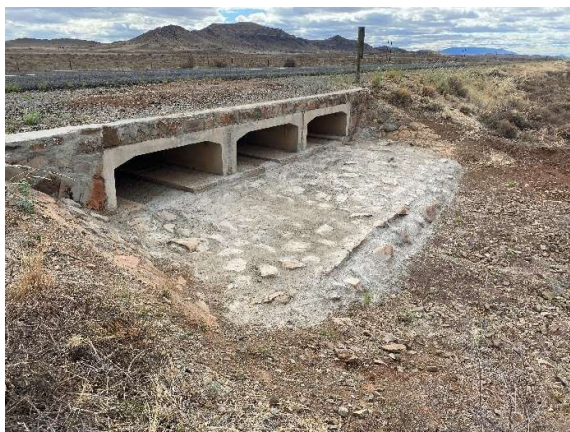
Culvert upgraded with repaired concrete and new stone-pitching, daylighting and vegetation clearance.

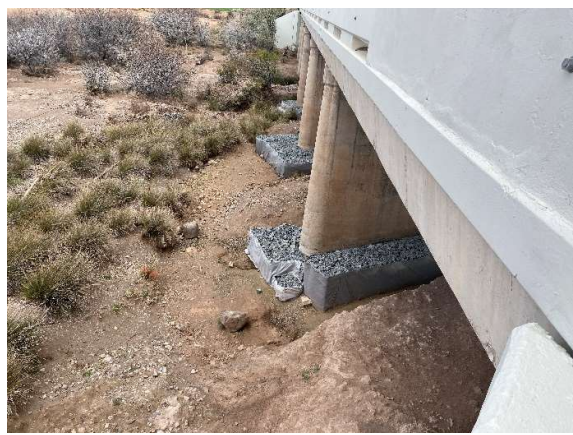
Concrete repairs and erosion protection works (gabion reinforcements) at piers and embankments.

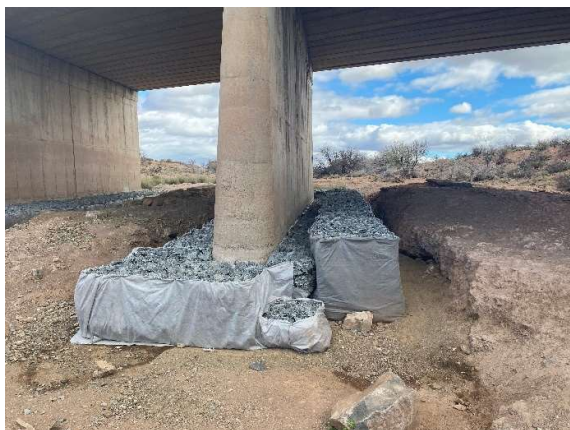
Concrete repairs and erosion protection works (gabion reinforcements) at piers and embankments.

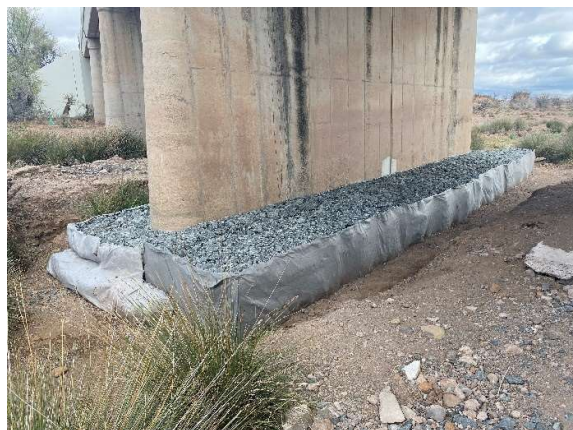
Concrete repairs and erosion protection works (gabion reinforcements) at piers and embankments.

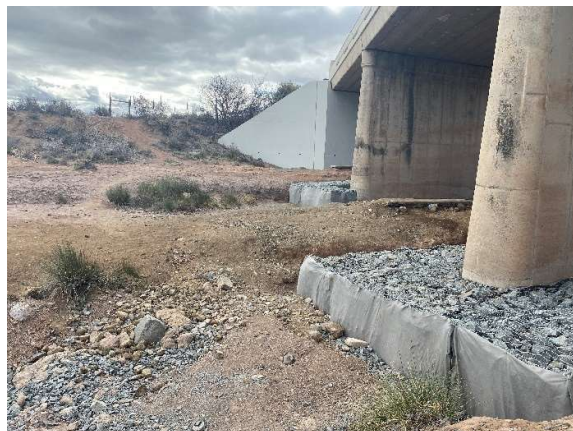
Concrete repairs and erosion protection works (gabion reinforcements) at piers and embankments.

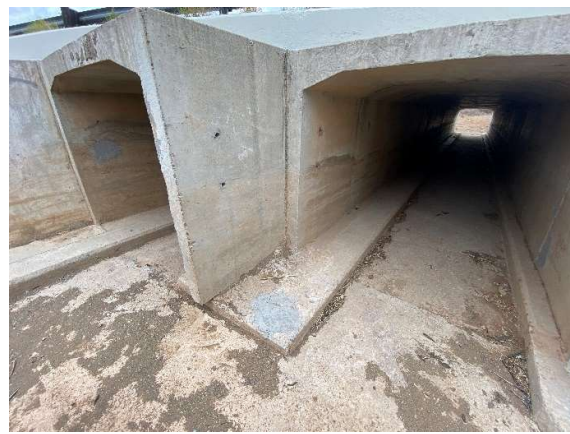
Culvert upgraded with concrete repairs apron slabs and cut off walls at culverts on inlet and crack repairs.

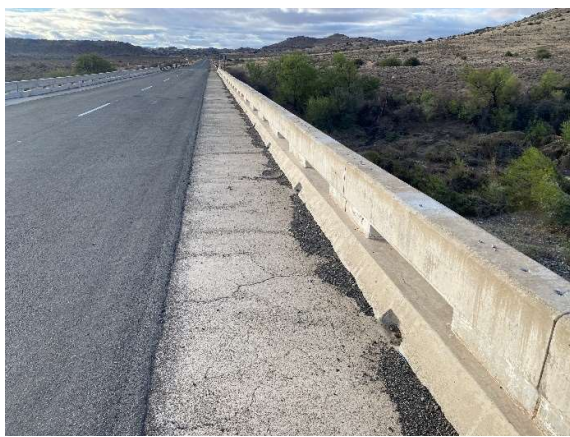
Current condition of the Buffalo River bridge at Km 26.94 along the TR16/9.

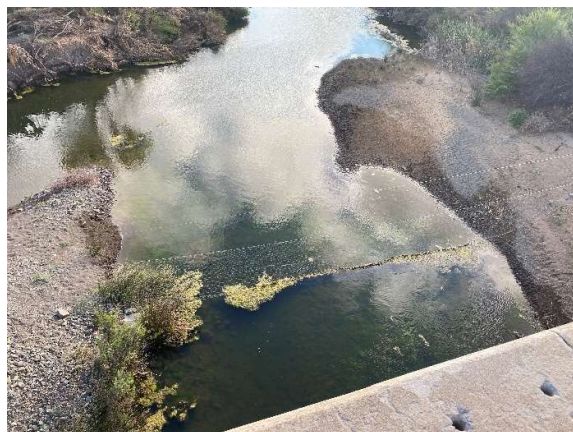
Downstream of the Buffalo River bridge as seen from the deck of the bridge.

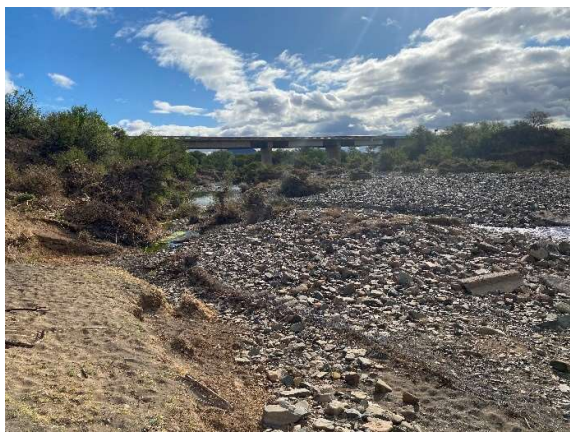
From the bypass road as seen downstream towards the Buffalo River bridge.

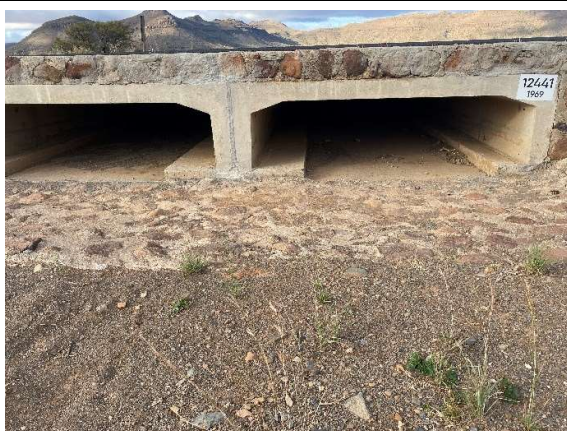
Culvert upgraded along the TR16/9 with repaired concrete and stone-pitching maintained.

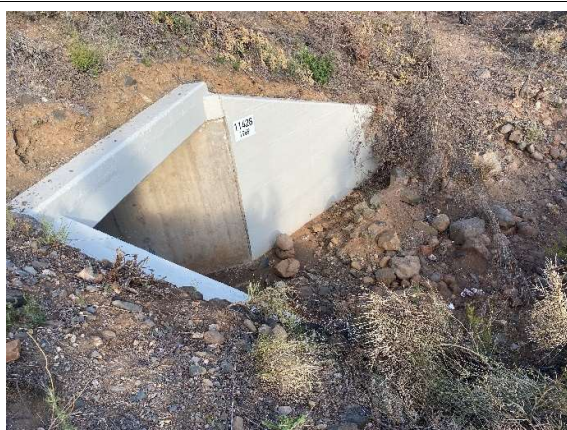
Culverts upgraded with new concrete structures, erosion control, and clearing of vegetation.

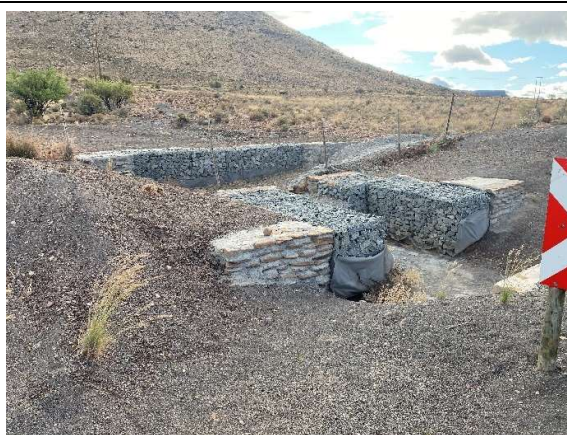
Newly installed gabion baskets for sediment within the road reserve at approximately Km 34.6 on TR 16/9.
