**PERIODIC MAINTENANCE OF TR 83/1, KM 25.78 TO  
KM 34.00 AND KM 48.50 TO KM 58.00, TR 83/2 FROM  
KM 0 TO KM 11,16 AND KM 15.25 TO KM 23.01, MR  
365 FROM KM 0 TO KM 14.12, AND TR 31/5 FROM  
KM 0.42 TO KM 0.90, BETWEEN RIVERSDALE TO  
LADISMITH, WESTERN CAPE.**

**FINAL CLOSURE EXTERNAL ENVIRONMENTAL AUDIT  
REPORT IN TERMS OF REGULATION 34 OF THE NEMA  
EIA REGULATIONS, 2014 (AS AMENDED).**

DEA&DP Ref: 16/3/3/1/D5/16/0005/22

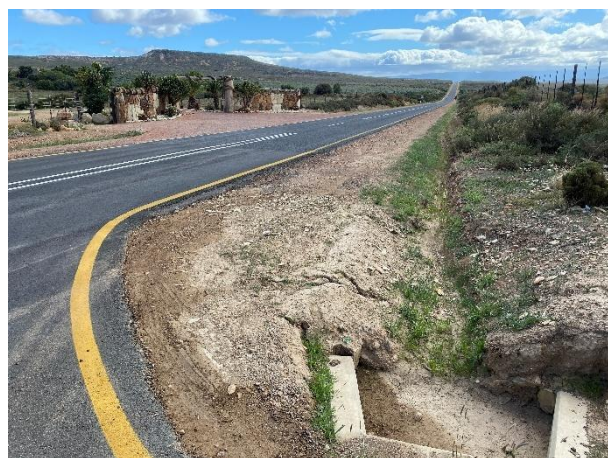
Condition of the road reserve at TR 83/1 km 25.78.

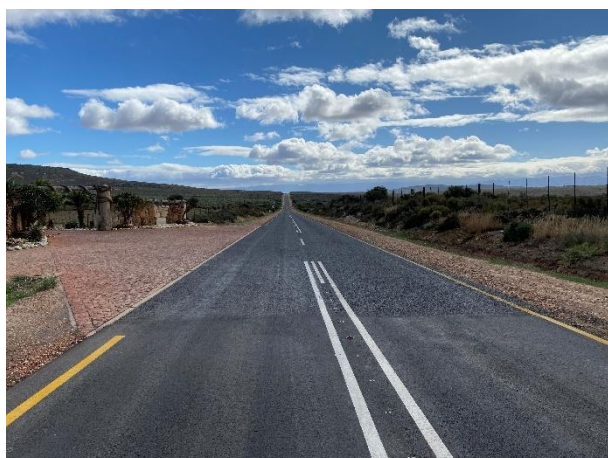
Condition of the newly surfaced road and road reserve at TR 83/1 km 25.78.

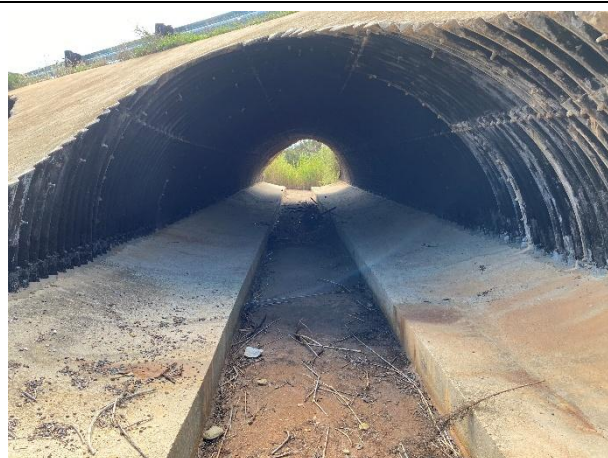
Trimming and removal of dense vegetation at the inlet and outlet and removal of silt deposits inside the barrel.

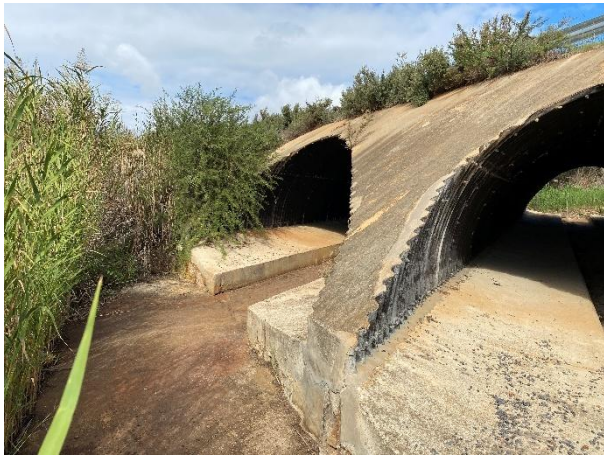
Trimming and removal of dense vegetation at the inlet and outlet and removal of silt deposits inside the barrel.

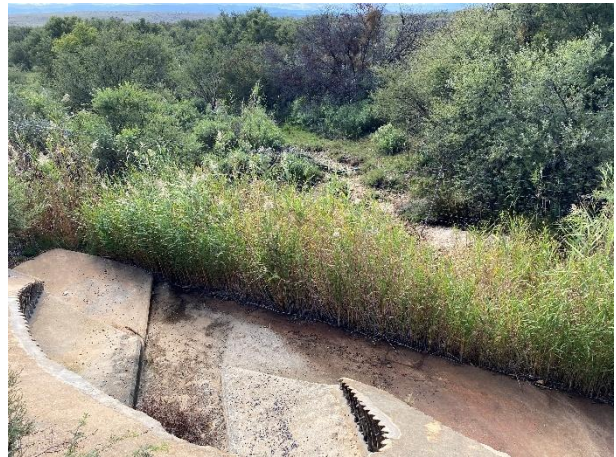
Trimming and removal of dense vegetation at the inlet and outlet and removal of silt deposits inside the barrel.

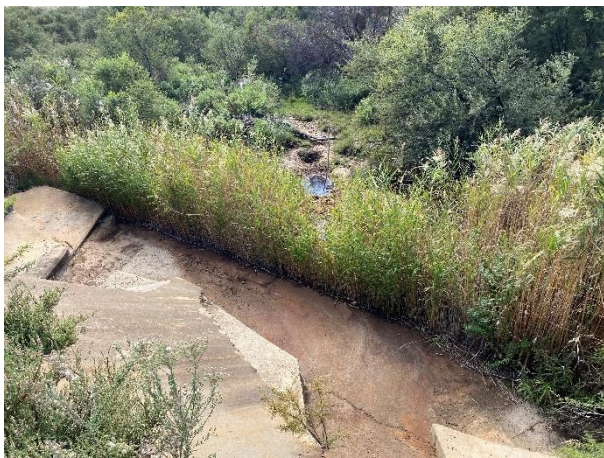
Trimming and removal of dense vegetation at the inlet and outlet and removal of silt deposits inside the barrel.

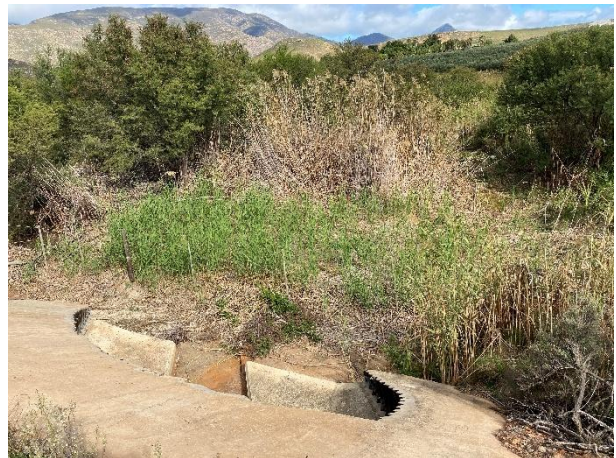
Trimming and removal of dense vegetation at the inlet and outlet and removal of silt deposits inside the barrel.

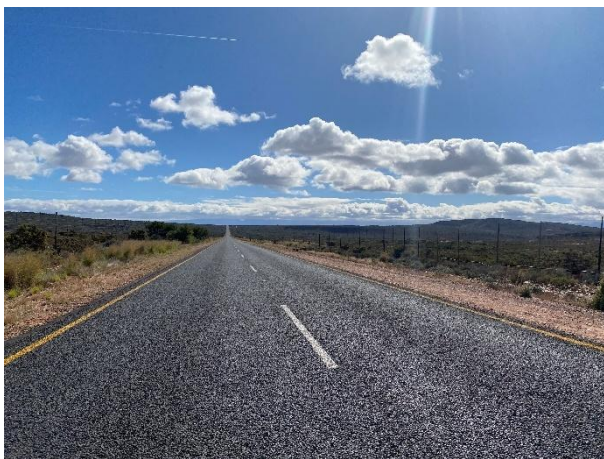
Condition of the newly surfaced road and road reserve at TR 83/1 km 29.

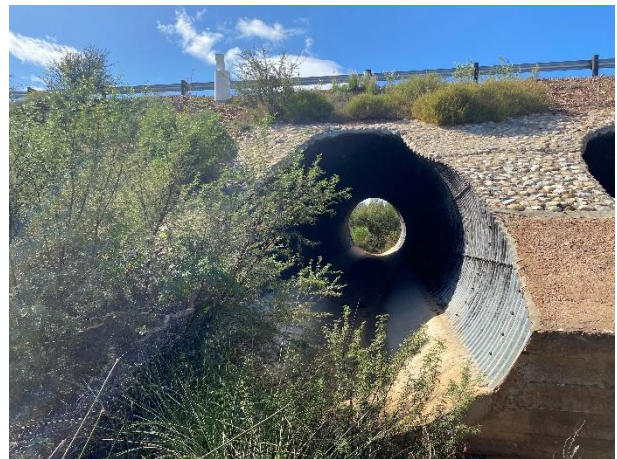
Condition of the vegetation along Culvert 10874.

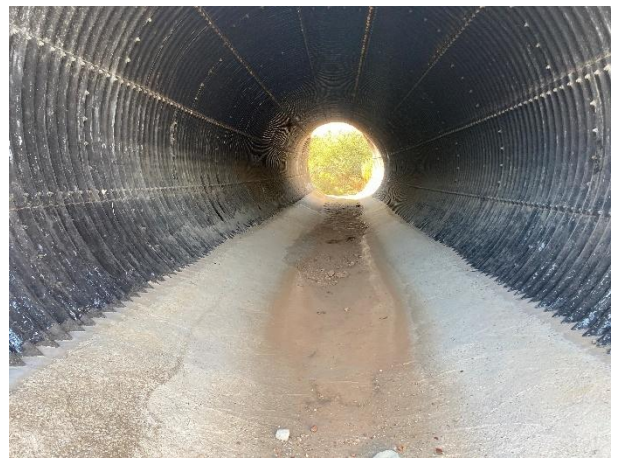
Removal of silt deposits inside the barrel and carting thereof to spoil.

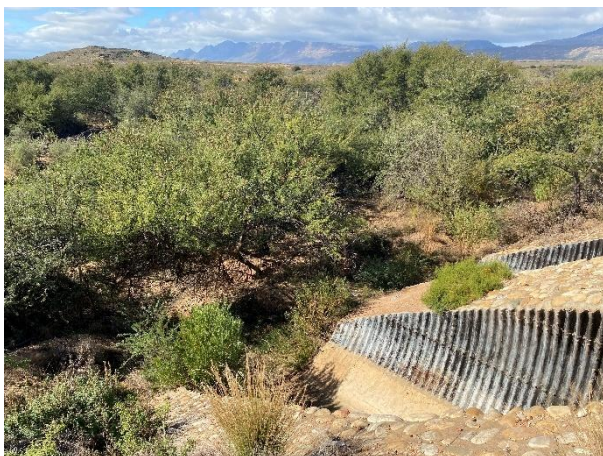
Condition of the vegetation along Culvert 10874.

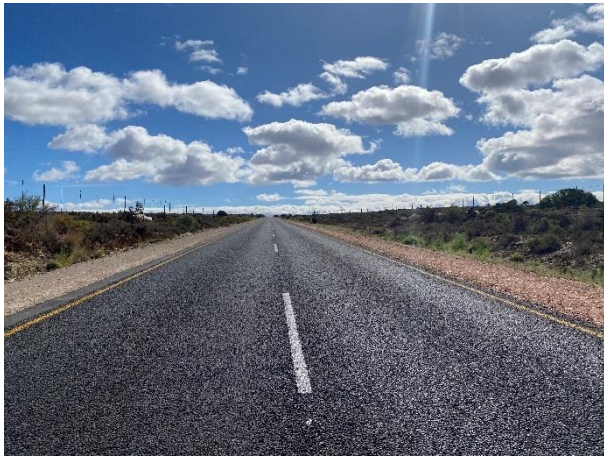
Condition of the newly surfaced road and road reserve at TR 83/1 km 30.

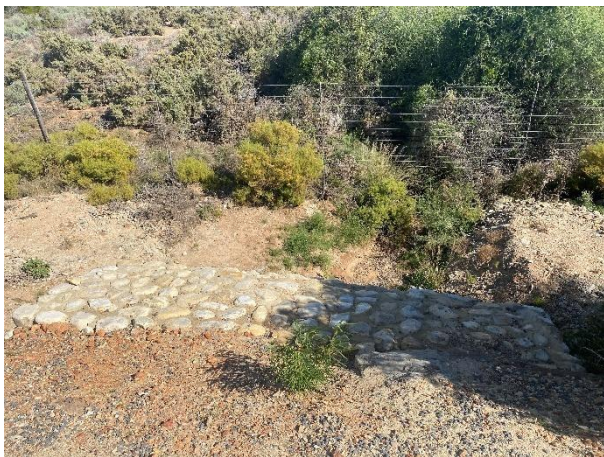
Condition of the vegetation surrounding Culvert 10692 at km 30.63

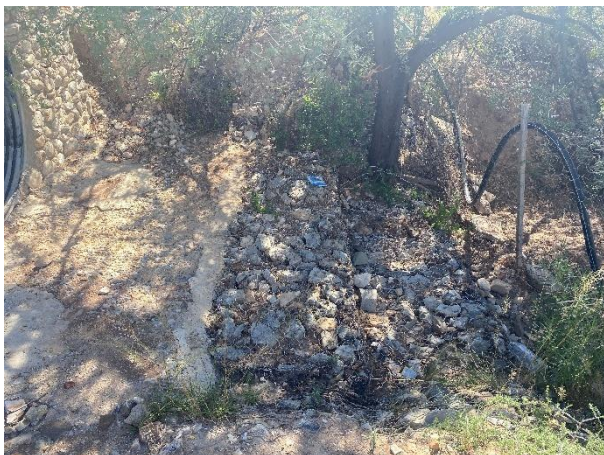
Gabion steps extending downward from the culvert to stabilise the slope and manage water flow.

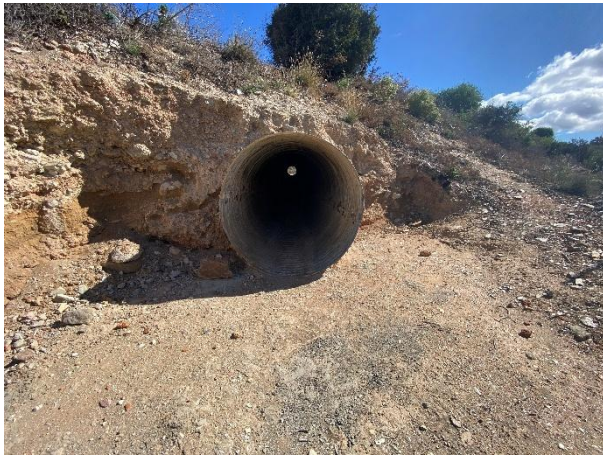
Clearance of accumulation of debris and silt deposits within the barrel.

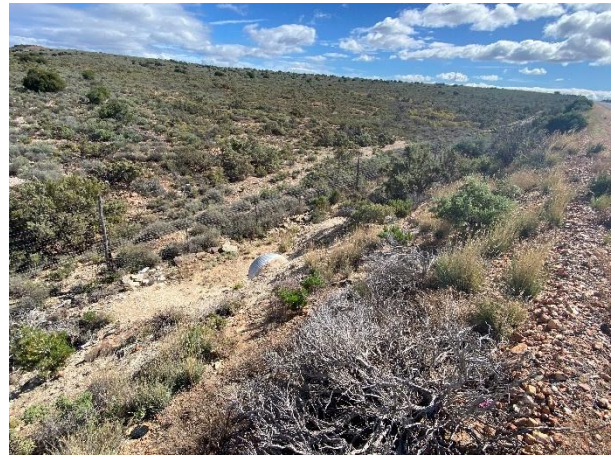
Condition of the vegetation surrounding Culvert 10692 at km 30.63

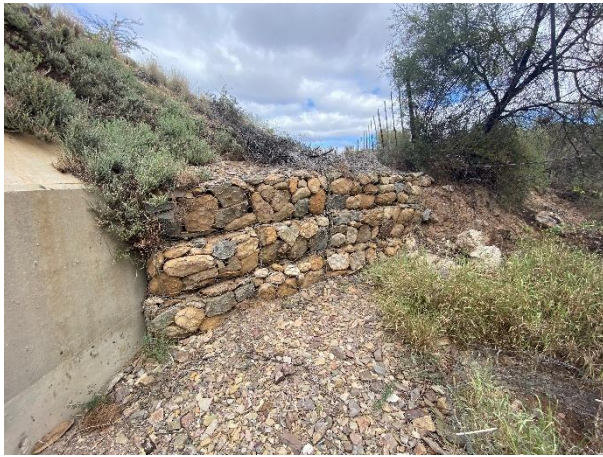
Installation of gabion baskets along the waterway and embankments to prevent further scouring and erosion.

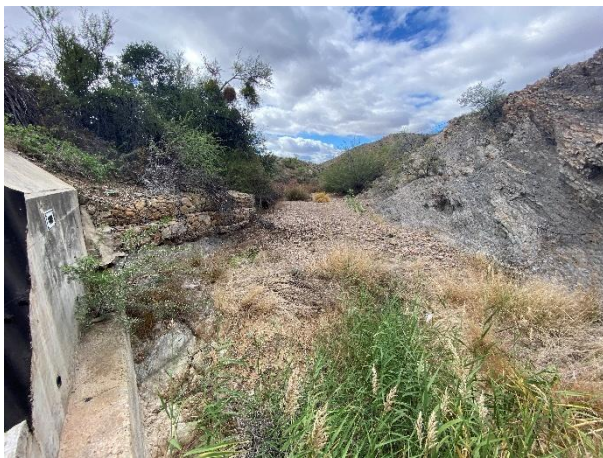
Installation of gabion baskets along the waterway and embankments to prevent further scouring and erosion.

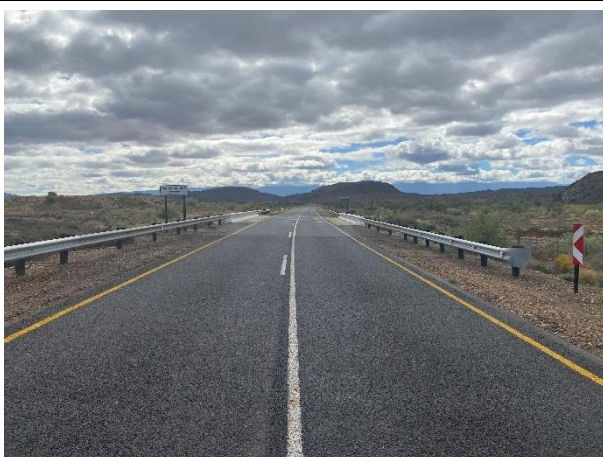
Condition of the newly installed guardrails and road surface at Culvert Bridge 5090.

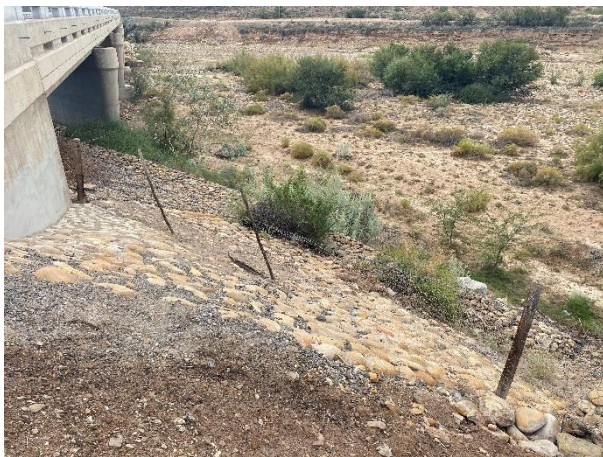
Condition of the vegetation surrounding the bridge.  
Fencing in place.

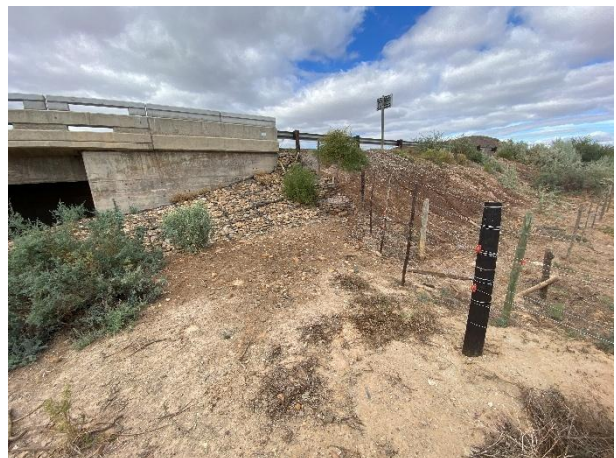
Condition of the vegetation surrounding the bridge.  
Fencing in place.

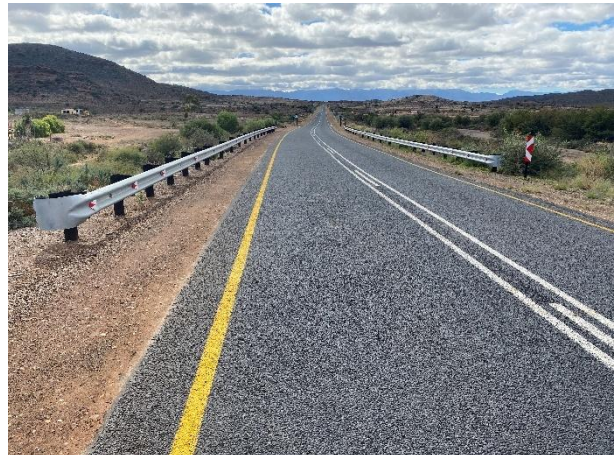
Condition of the newly installed guardrails and road surface at Culvert 10867.

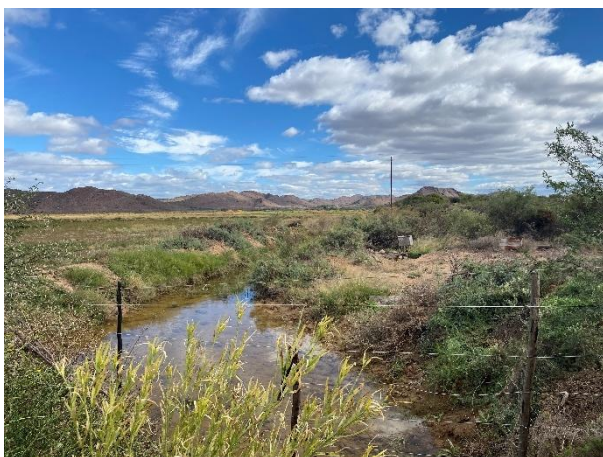
Condition of the vegetation surrounding the culvert. Fencing in place.

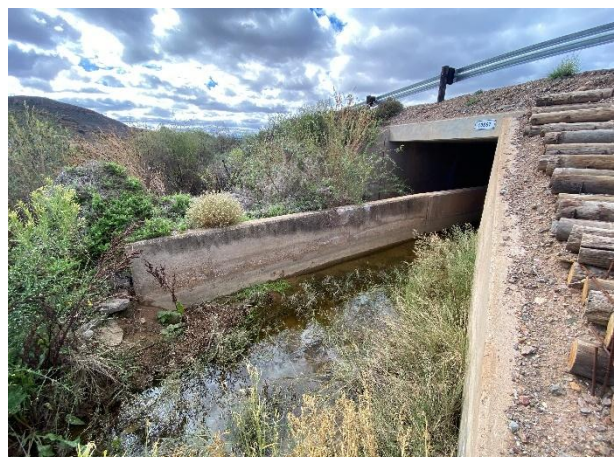
Concrete culvert outlet with vegetated channel and timber-reinforced embankment slope.

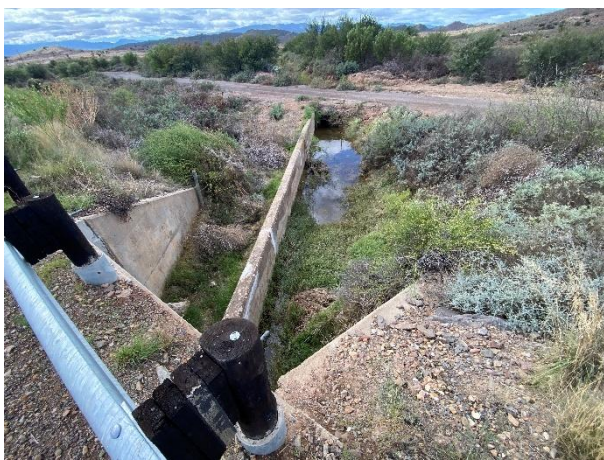
Condition of the vegetation surrounding the culvert.  
Fencing in place.

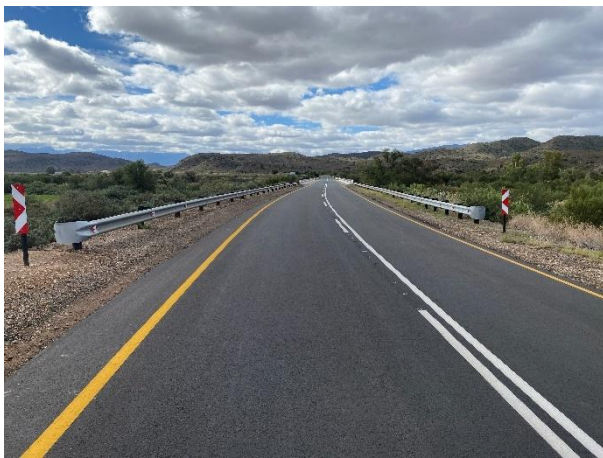
Condition of the newly installed guardrails and road surface.

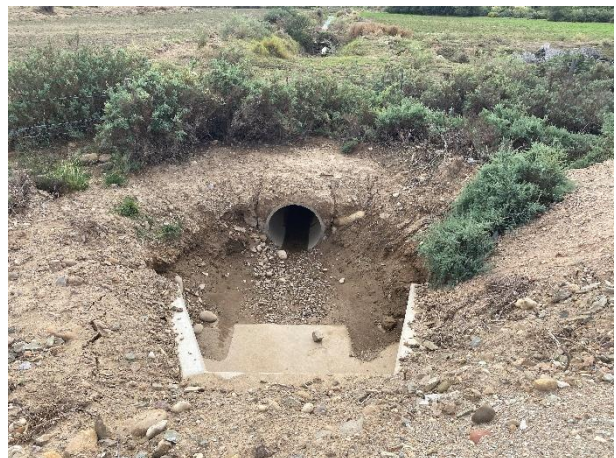
Inlet of the small stormwater system adjacent to bridge 4837.

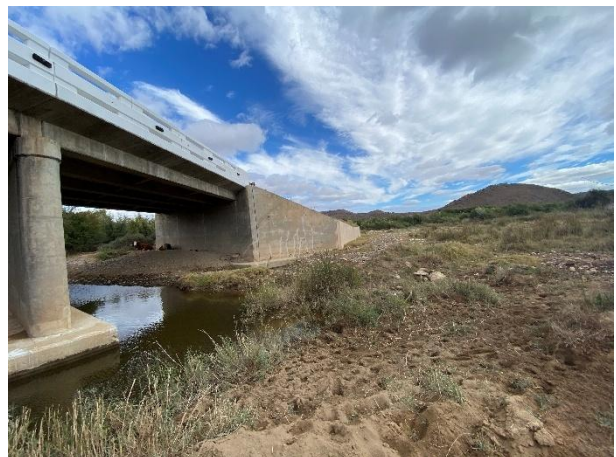
Condition of the vegetation surrounding the bridge.

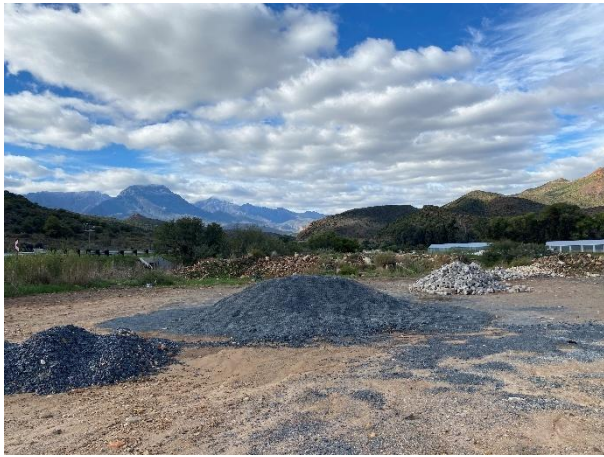
Condition of the construction camp with remained material stockpiles.

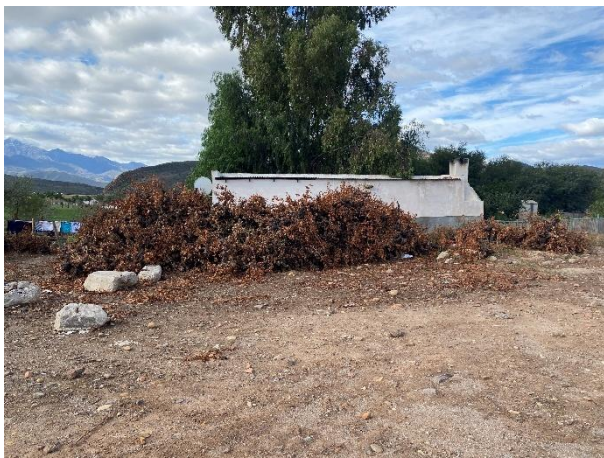
Vegetation debris located at the construction camp.

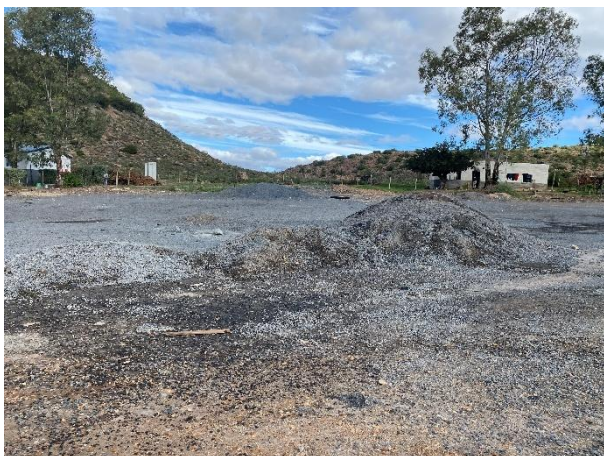
Remaining material stockpiles at the construction camp.

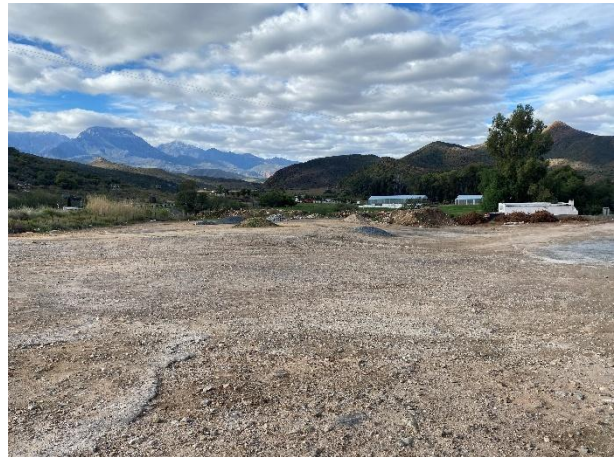
Remaining material stockpiles at the construction camp.

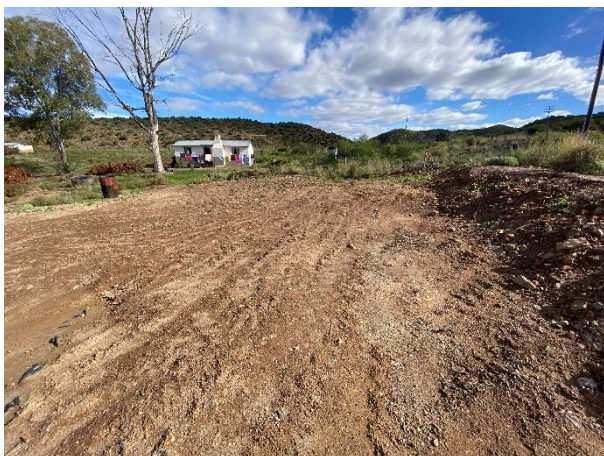
Condition of the former bitumen storage area within the construction camp.

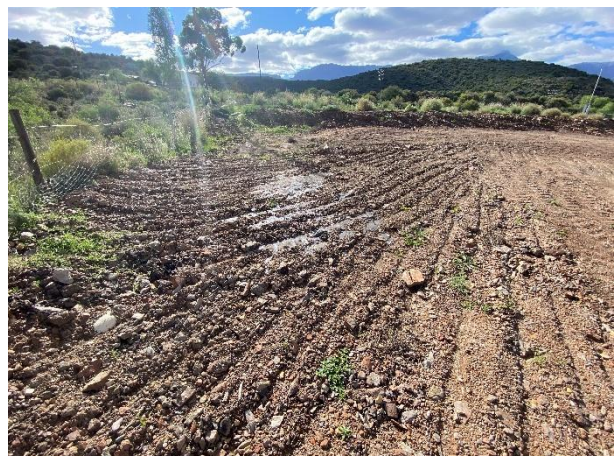
Condition of the former bitumen storage area within the construction camp.

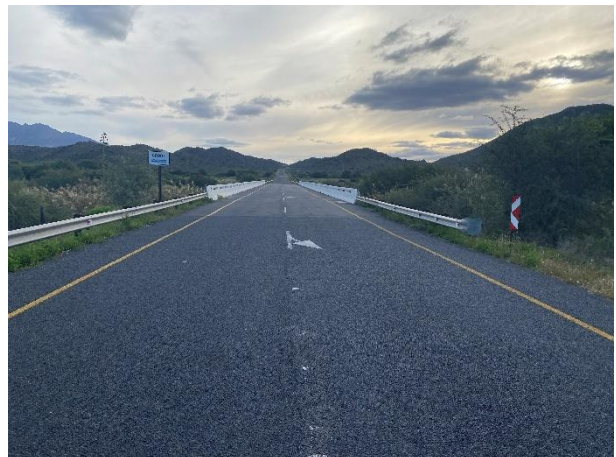
Condition of the newly installed guardrails and road surface at bridge 5490.

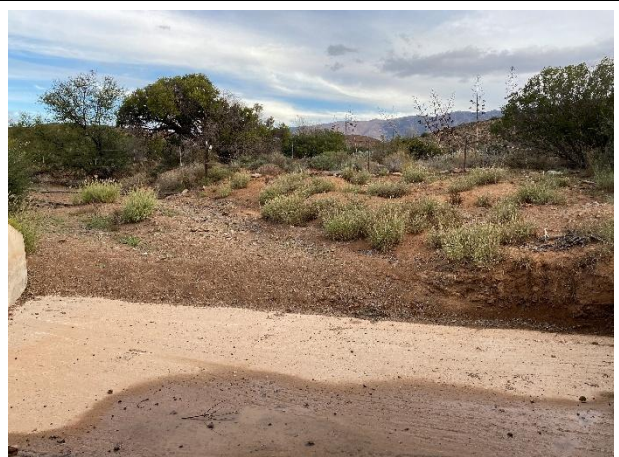
Removal of vegetation overgrowth and silt deposits.

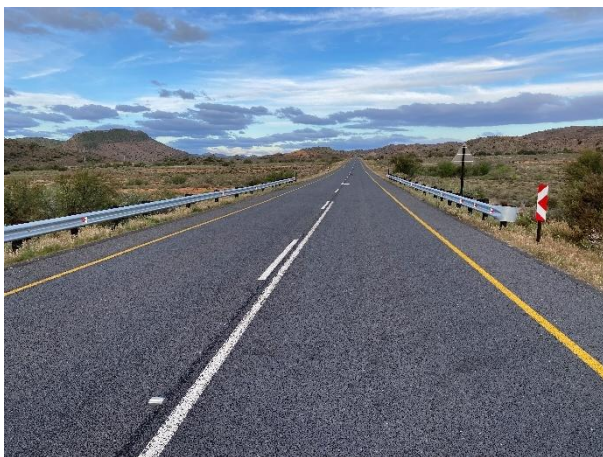
### Culvert un-numbered: TR83/2 at km 20.37

Condition of the newly installed guardrails and road surface.

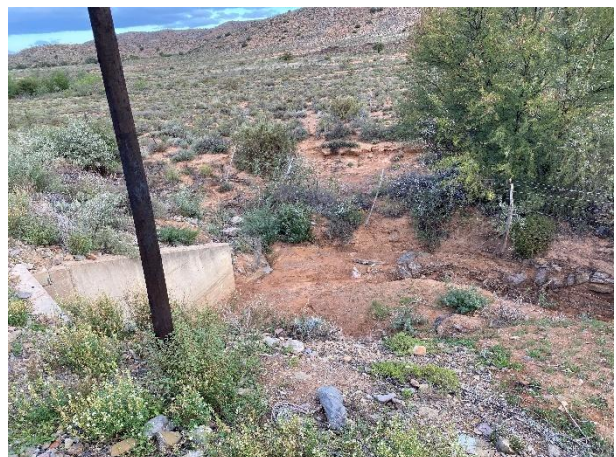
Condition of the vegetation surrounding the culvert. Fencing in place.

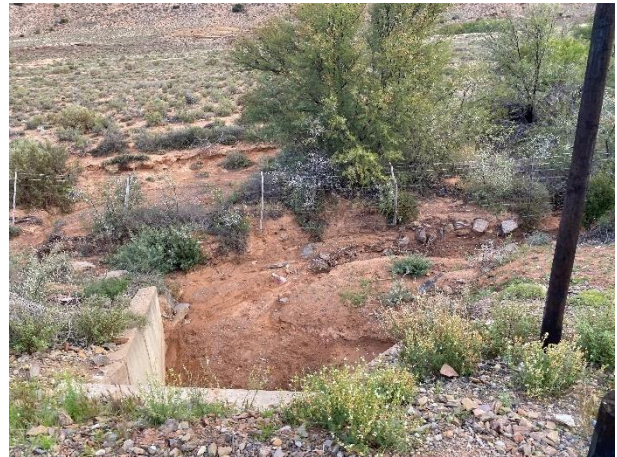
Condition of the vegetation surrounding the culvert. Fencing in place.

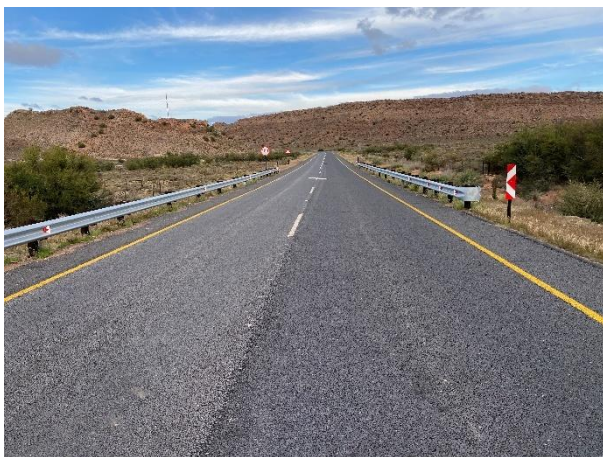
### Culvert 10977: TR83/2 at km 22.25

Condition of the newly installed guardrails and road surface.

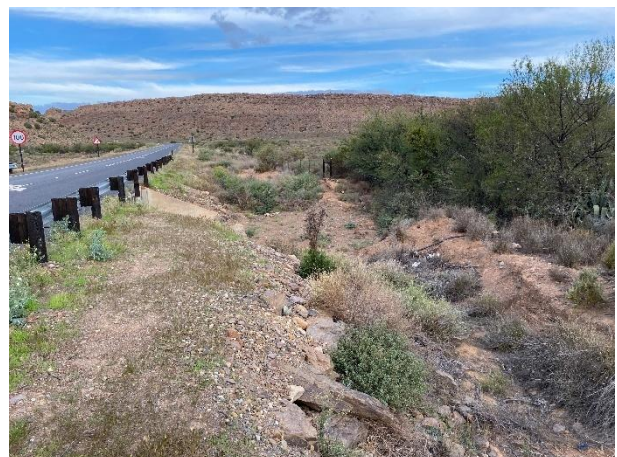
Backfill of the eastern and western cell.

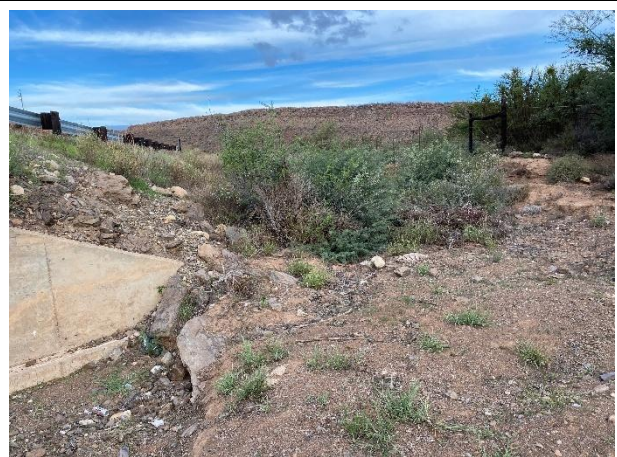
Backfill of the eastern and western cell.

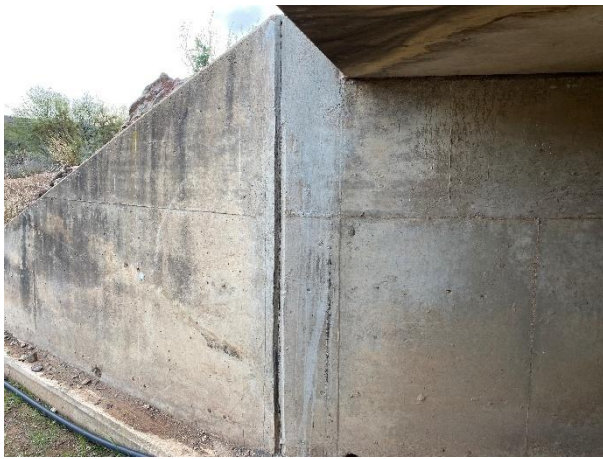
Cracks repaired with a cementitious repair compound.

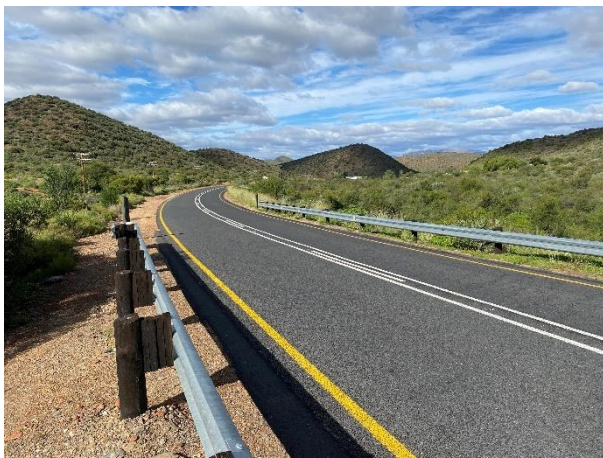
Condition of the newly installed guardrails and road surface.

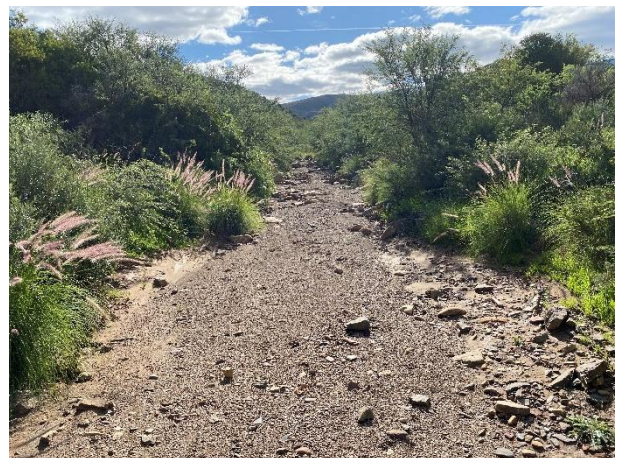
Cleared vegetation and removed debris in the waterway.

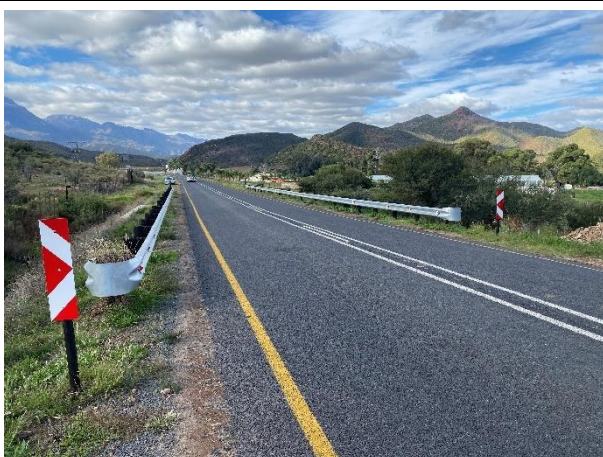
Condition of the newly installed guardrails and road surface.

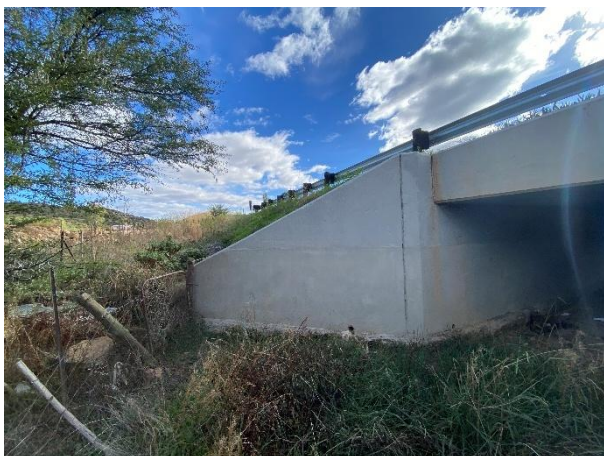
Concrete spalling and cracks repaired with an epoxy repair mortar.

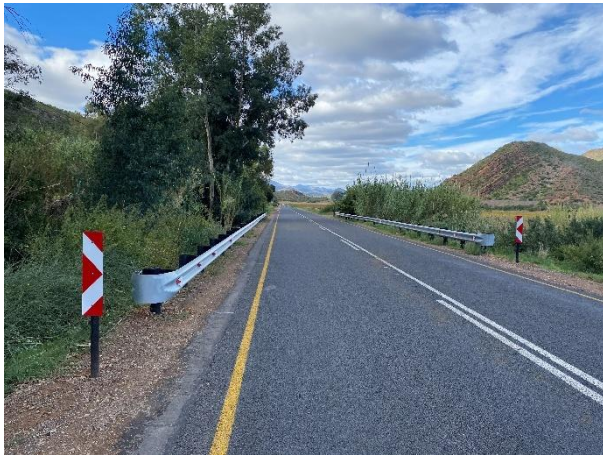
Condition of the newly installed guardrails and road surface.

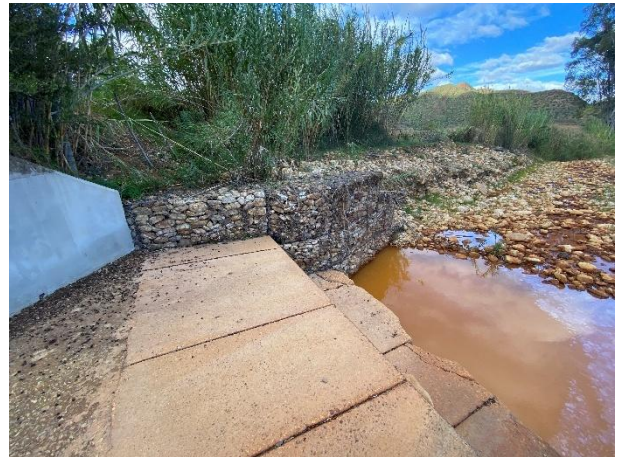
Removal of vegetation at wingwalls and the installation of gabion boxes.

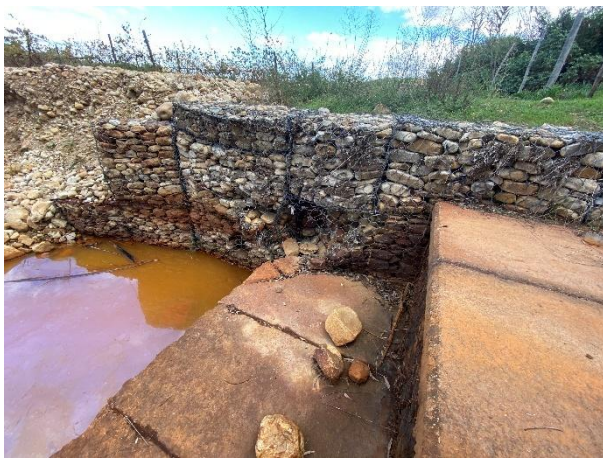
Removal of vegetation at wingwalls and the installation of gabion boxes.

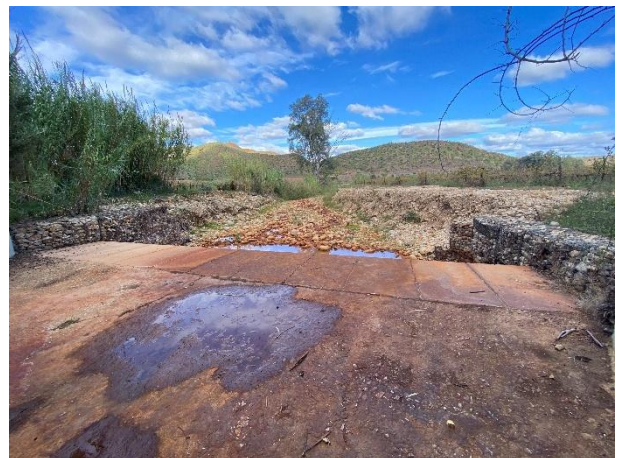
Removal of vegetation at wingwalls and the installation of gabion boxes.

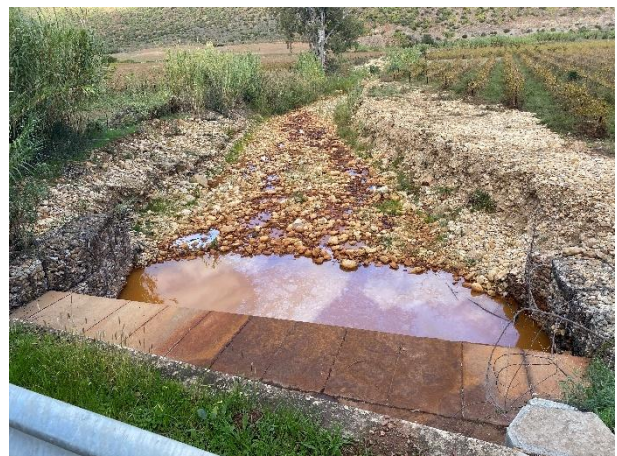
Removal of vegetation at wingwalls and the installation of gabion boxes.

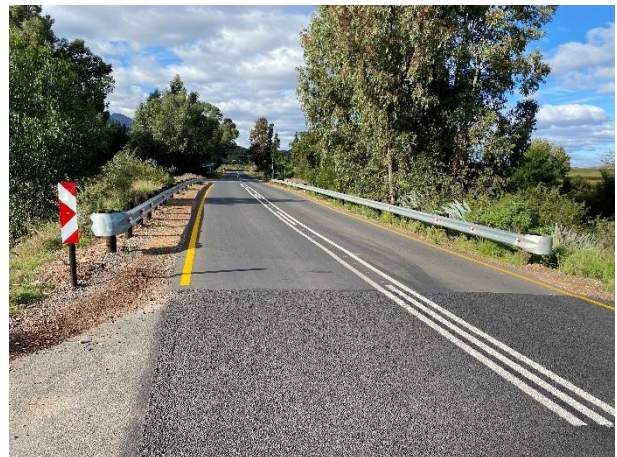
Condition of the newly installed guardrails and road surface.

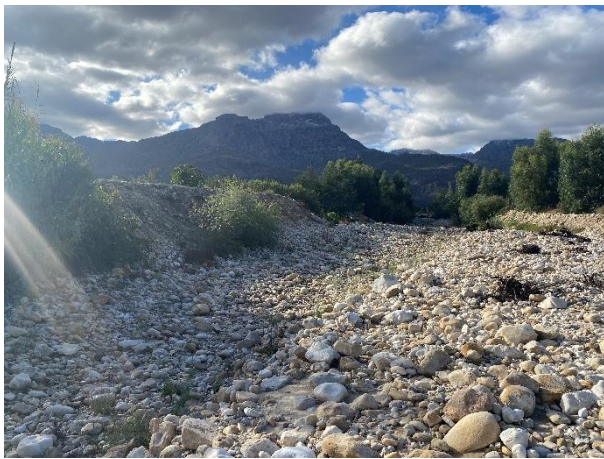
Condition of the vegetation surrounding the culvert.

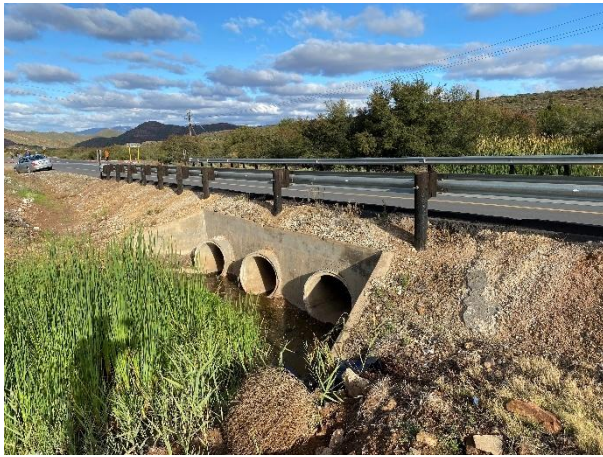
Repaired culvert.

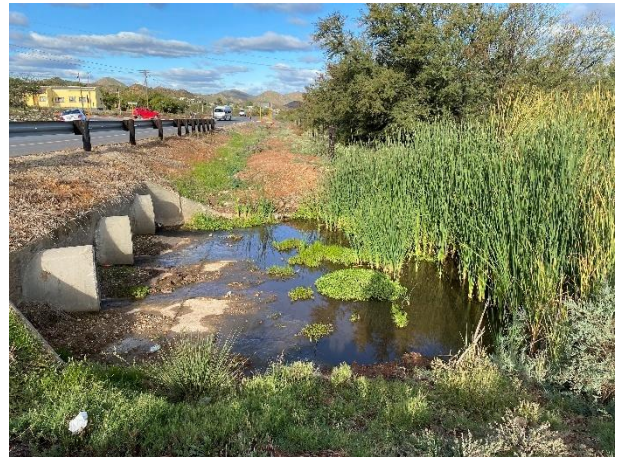
Removal of vegetation and debris from the waterway.

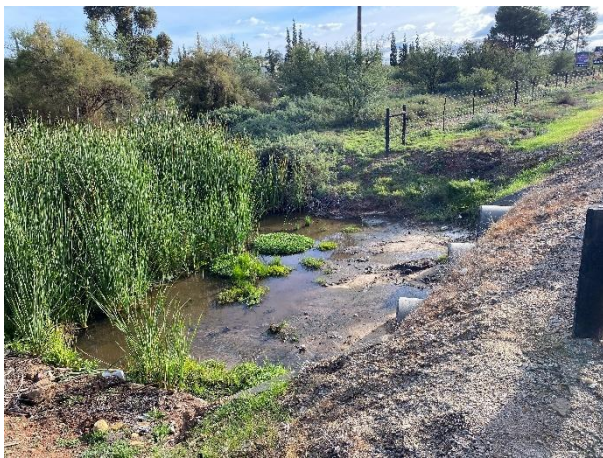
Removal of vegetation and debris from the waterway.
