## APPENDIX A – SITE PHOTOGRAPHS

Culvert 10875: TR 83/1 at km 26.24

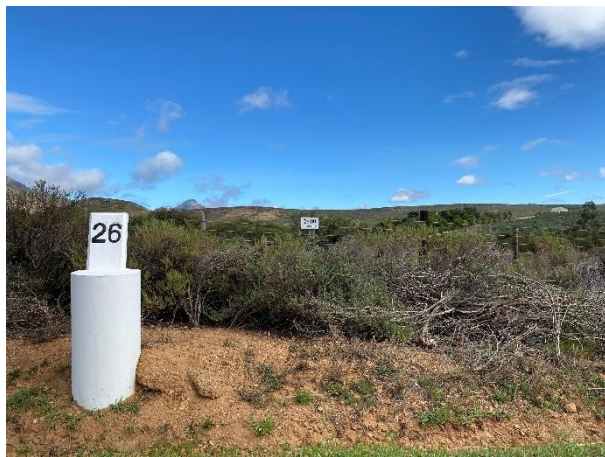
km 26 marker off TR 83/1.

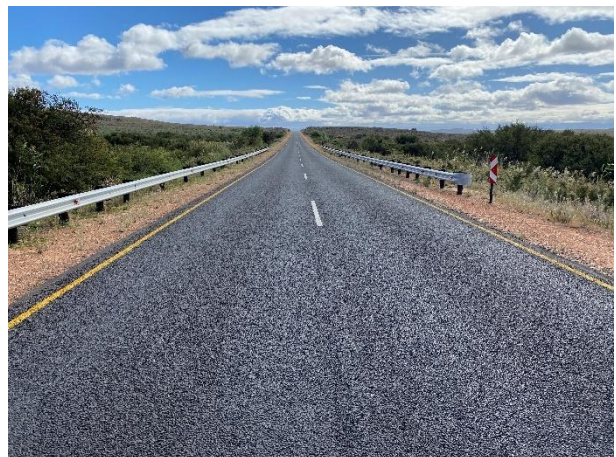
Newly surfaced and installed guardrails at culvert 10875 off TR 83/1.

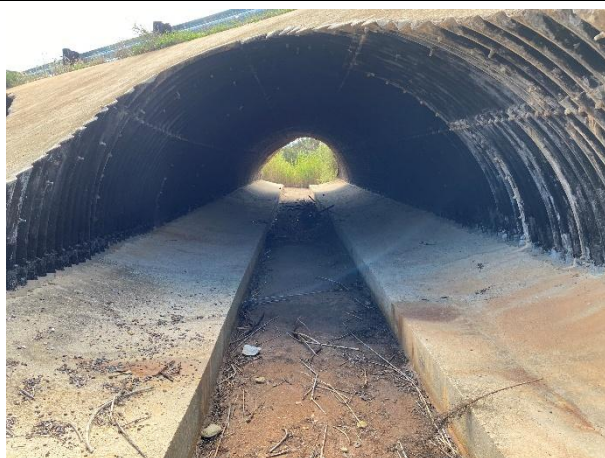
Trimming and removal of dense vegetation at the inlet and outlet and removal of silt deposits inside the barrel.

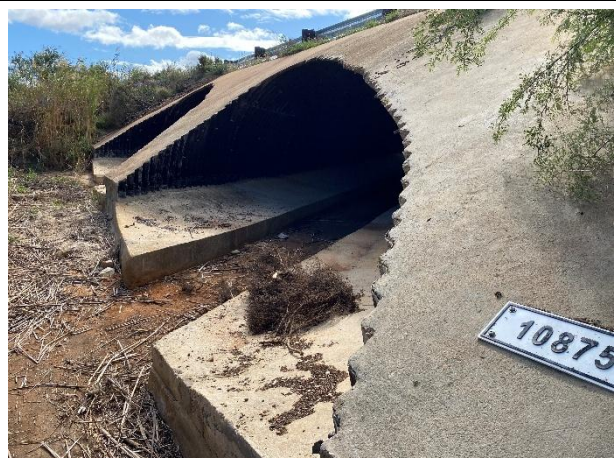
Trimming and removal of dense vegetation at the inlet and outlet and removal of silt deposits inside the barrel.

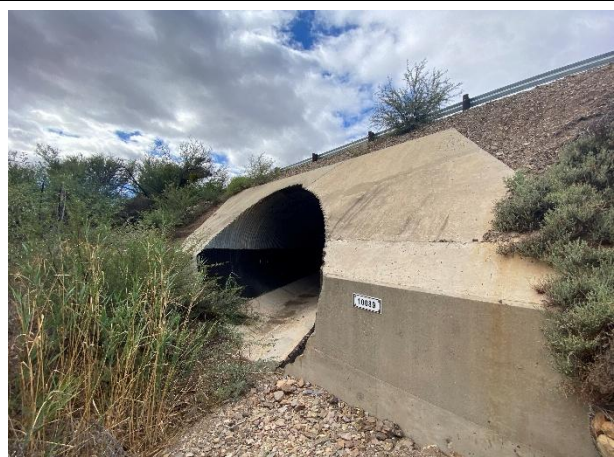
Installation of gabion baskets along the waterway and embankments to prevent further scouring and erosion.

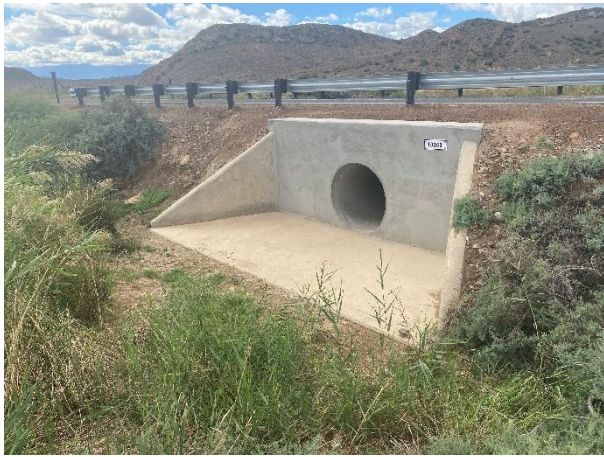
The construction of a new headwall, apron slab and wingwalls at the outlet.

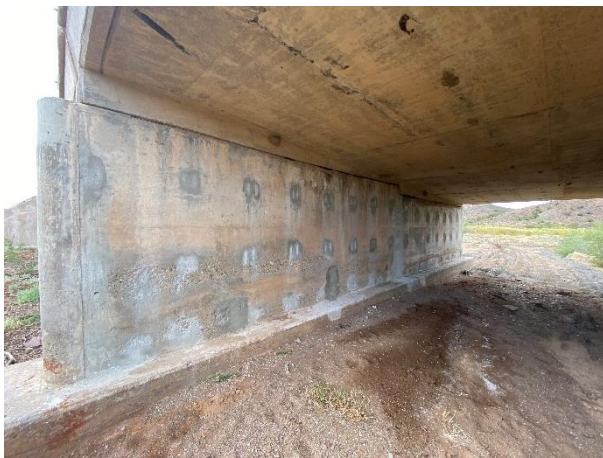
Repairing of cracks on the wingwalls and headwalls.

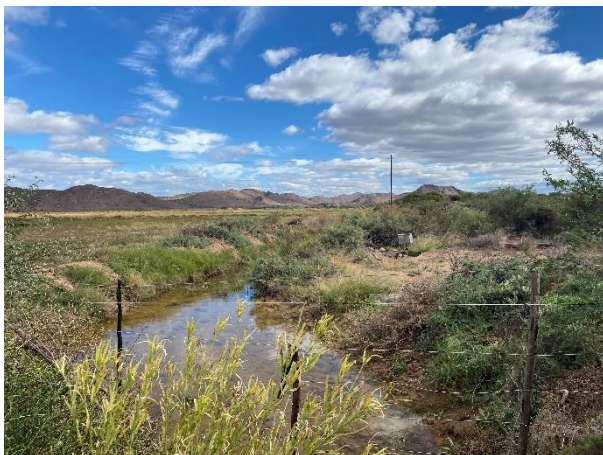
Condition of the vegetation surrounding the culvert. Fencing in place.

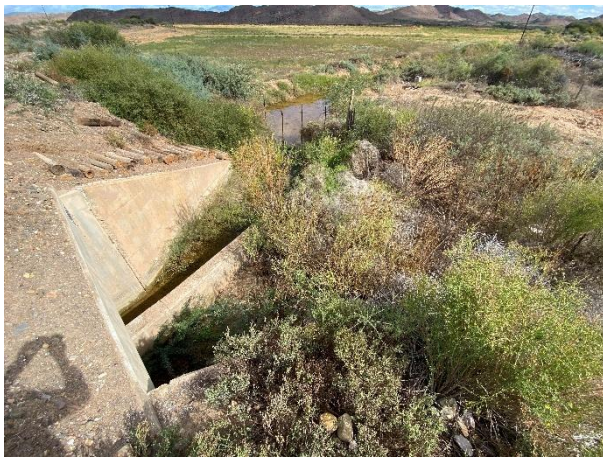
Condition of the vegetation surrounding the culvert.  
Fencing in place.

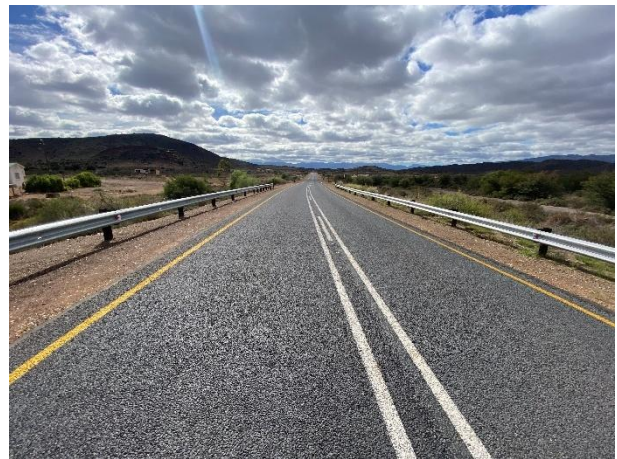
Condition of the newly installed guardrails and road surface at Culvert 10867.

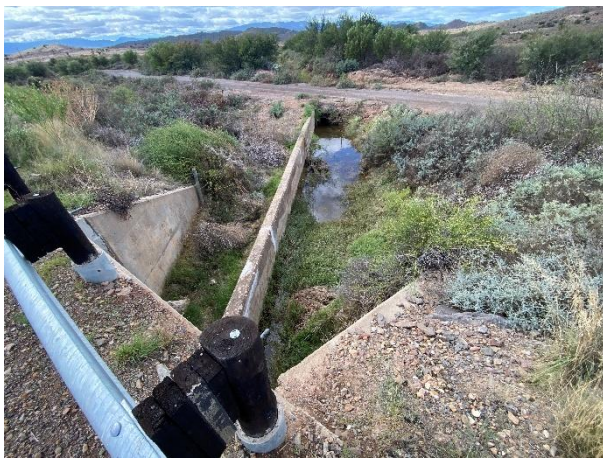
Condition of the vegetation surrounding the culvert.  
Fencing in place.

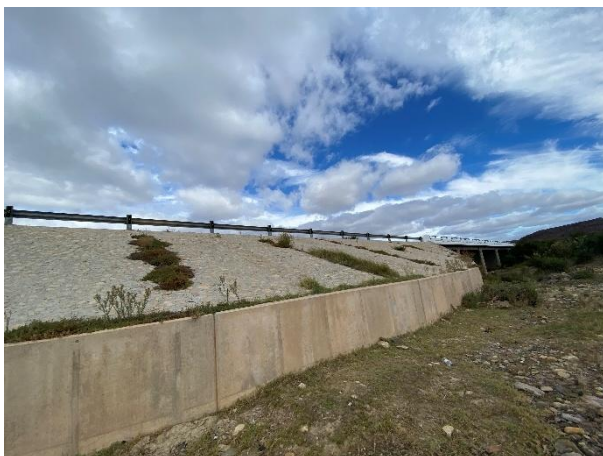
Backfilling and dump rock riprap around the piers and abutments.

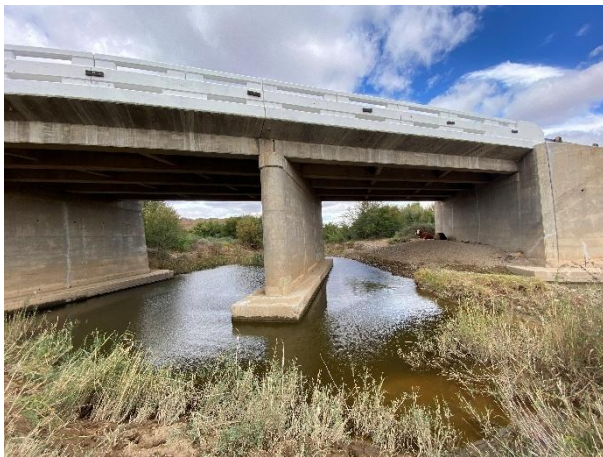
Bridge 4838: TR 83/1 at km 57.61

Removal of dense vegetation overgrowth and debris deposits underneath bridge 4838.

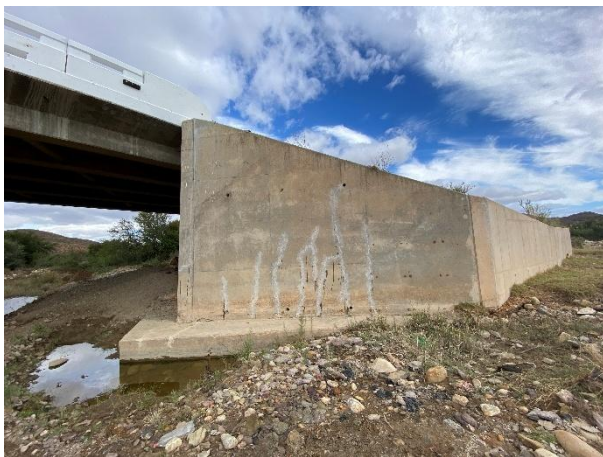
Repairs of vertical and horizontal cracks.

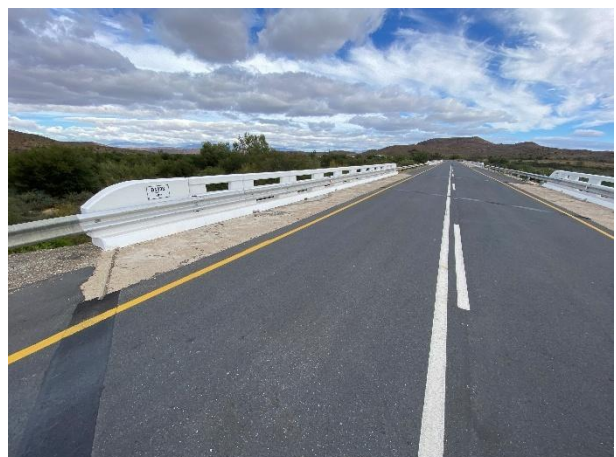
Replaced expansion movement joints.

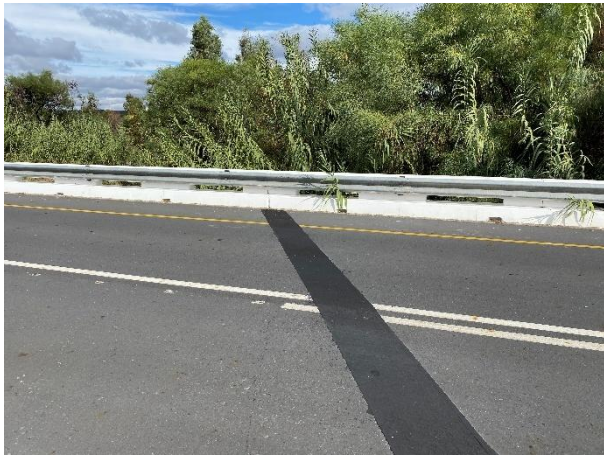
Replaced expansion movement joints.

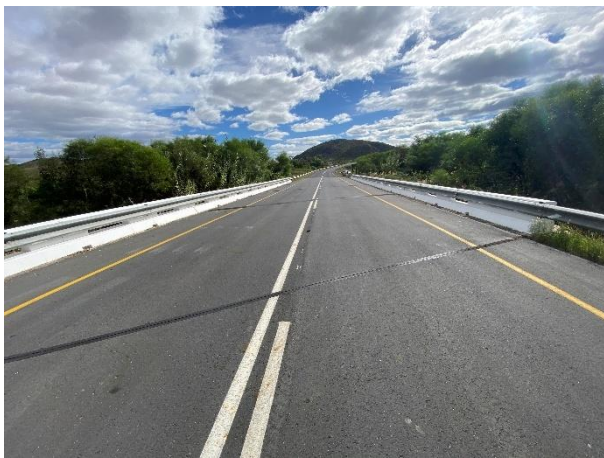
Replaced expansion movement joints.

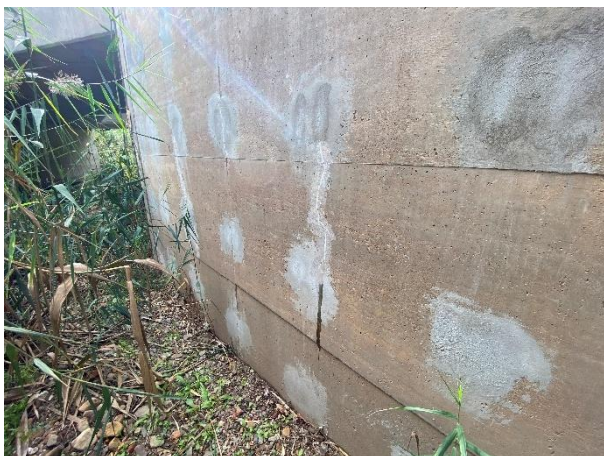
Repairing of cracks.

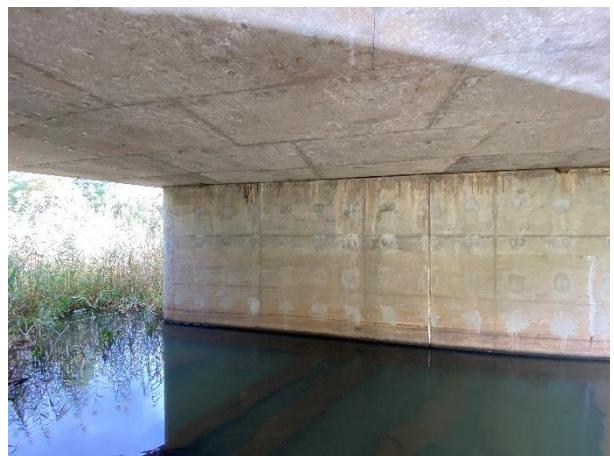
Repairing of cracks.

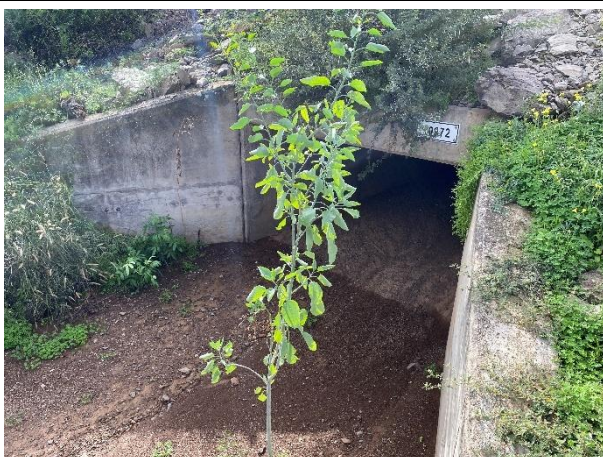
## Culvert 10972: TR 83/2 at km 9.32

Clearance of dense vegetation and removal of the debris from the waterway.

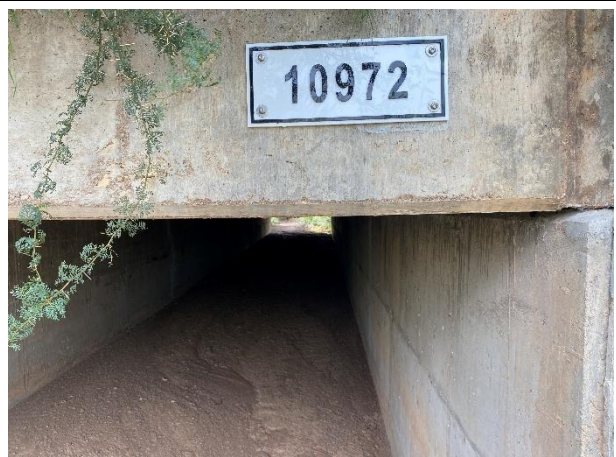
Clearance of dense vegetation and removal of the debris from the waterway.

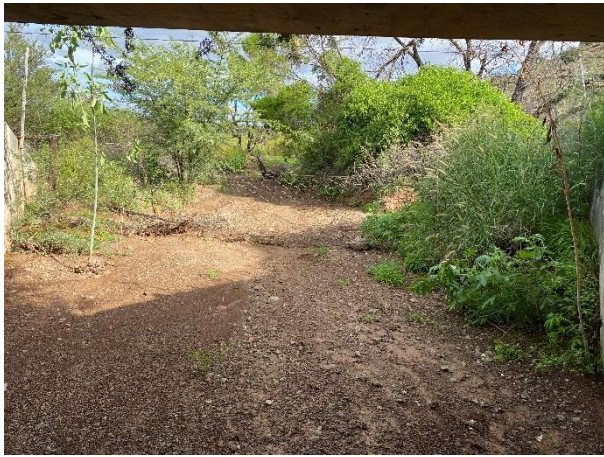
Clearance of dense vegetation and removal of the debris from the waterway. Fencing is in place.

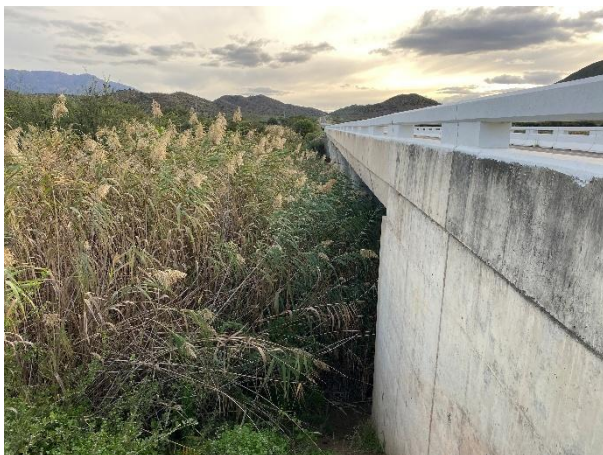
Overgrown vegetation due to the recent rainfall.

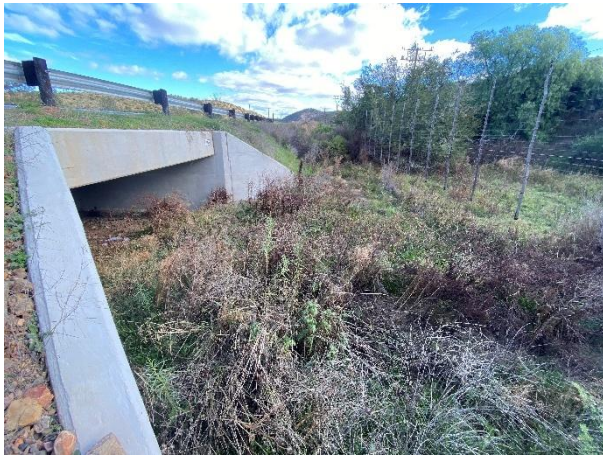
Overgrown vegetation due to the recent rainfall.

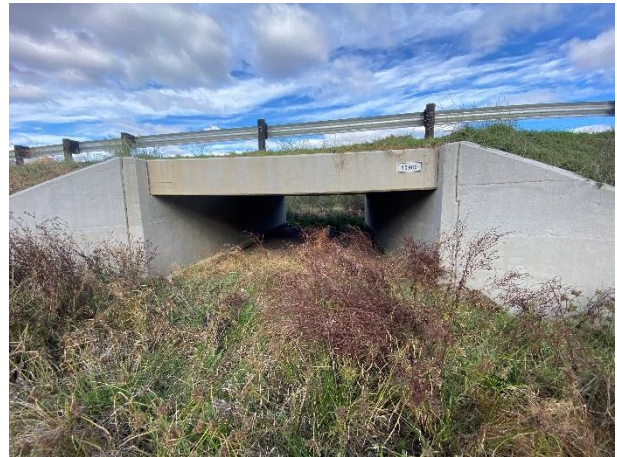
Overgrown vegetation due to the recent rainfall.

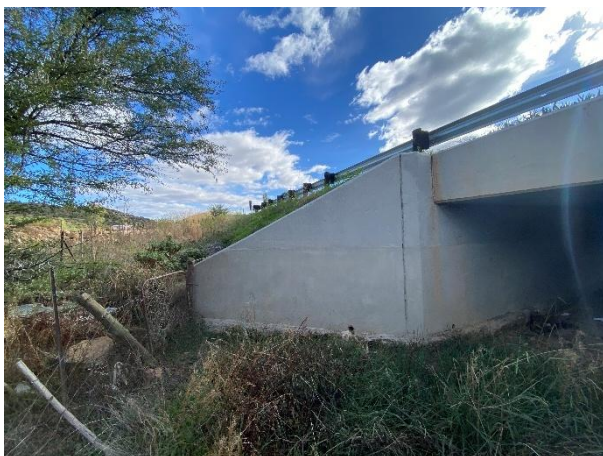
Concrete spalling and cracks repaired with an epoxy repair mortar.

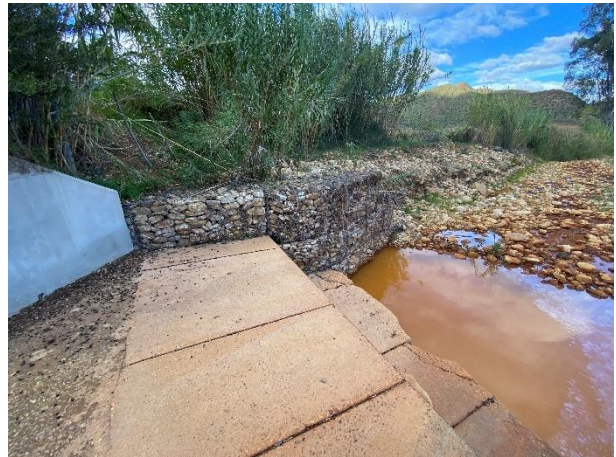
Removal of vegetation at wingwalls and the installation of gabion boxes.

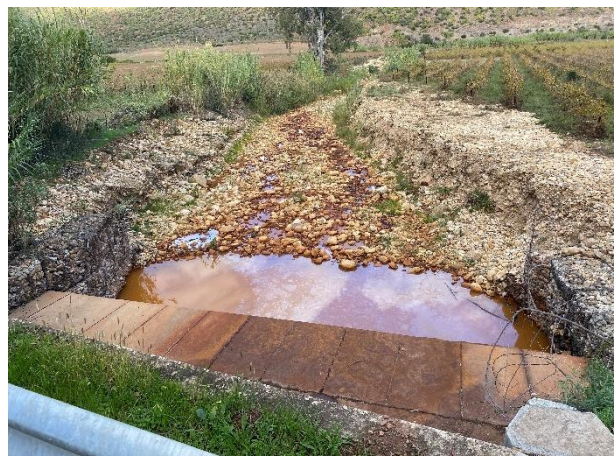
Removal of vegetation at wingwalls and the installation of gabion boxes.

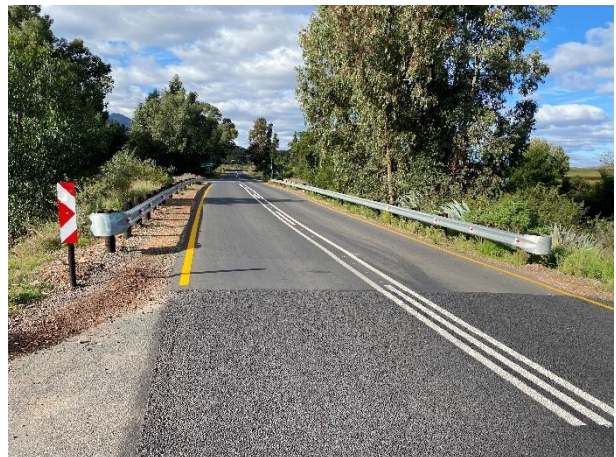
Condition of the newly installed guardrails and road surface.

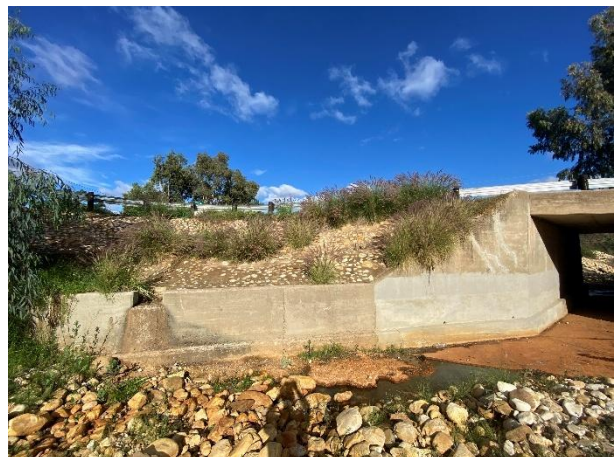
Repaired vertical and horizontal cracks along with concrete spalling in the abutment, piers, and wingwalls.

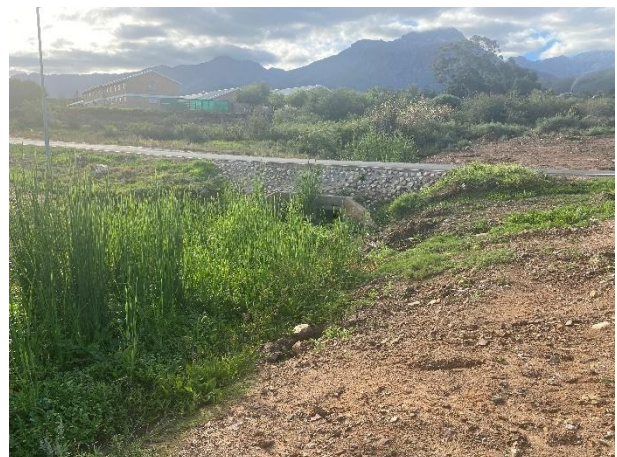
Overgrown vegetation due to the recent rainfall.

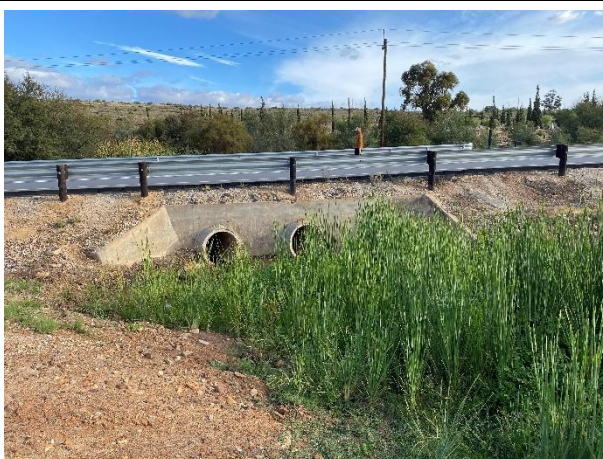
Overgrown vegetation due to the recent rainfall.

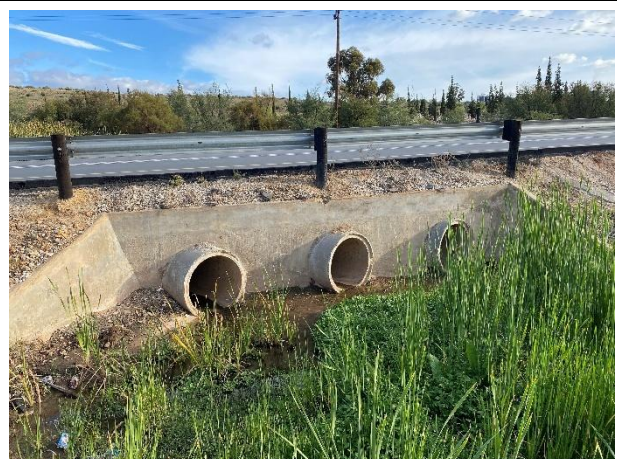
Repaired culvert.
