## APPENDIX A – SITE PHOTOGRAPHS

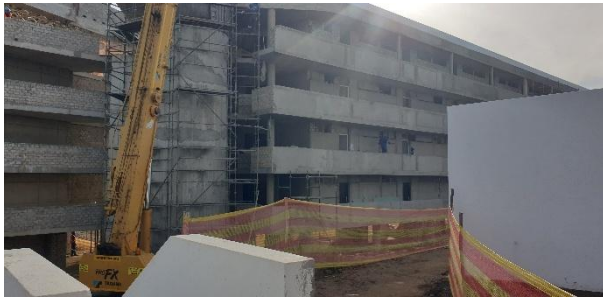
Demarcation in place around the construction of the apartment blocks.

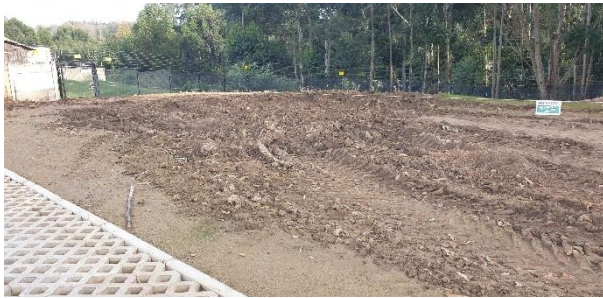
Edge of bush/natural buffer area that will undergo riparian rehabilitation.

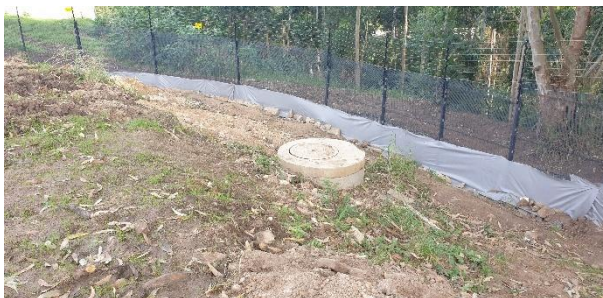
Security fence installed along with sewage service that has been tied into the municipal network.

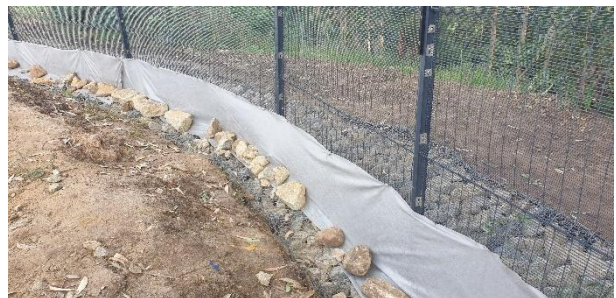
Gabion mattresses installed to prevent uncontrolled surface flow.

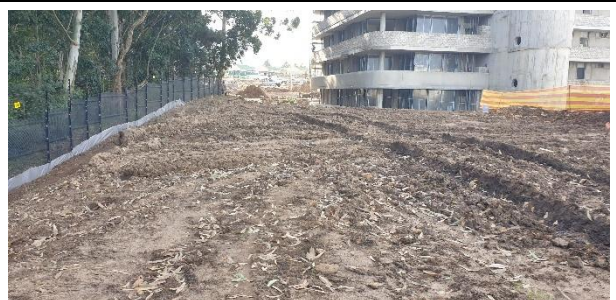
Edge of bush/natural buffer area that will undergo riparian rehabilitation.

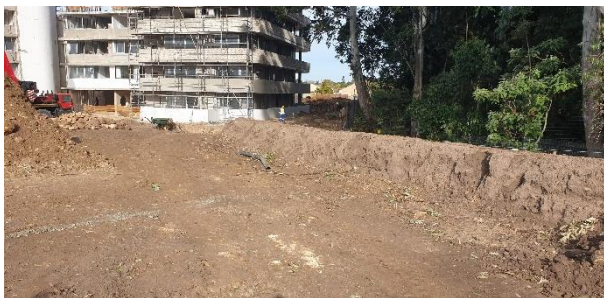
Topsoil temporary swale for stormwater diversion and will be used for rehabilitation.

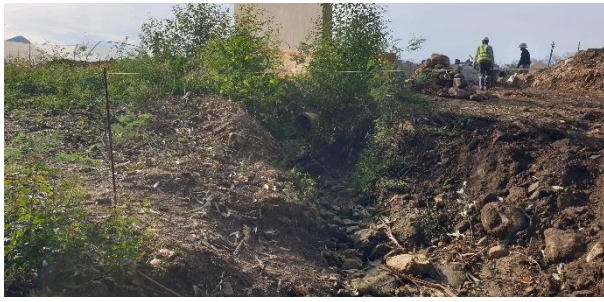
Stormwater outlet towards the riparian area.

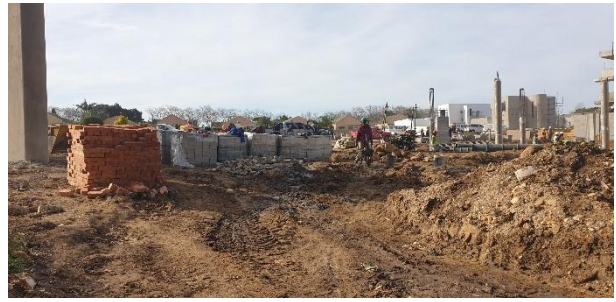
Construction area and temporary laydown area of construction material.

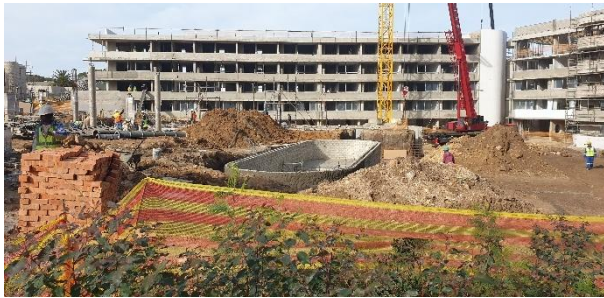
Clubhouse pool and associated infrastructure being constructed.

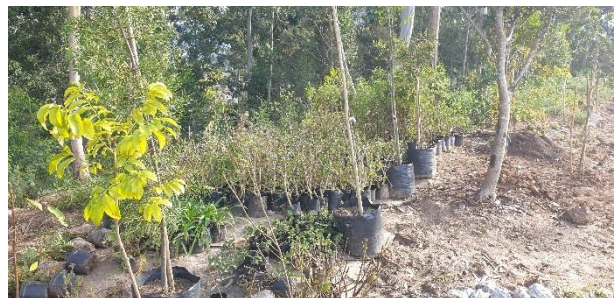
Indigenous plants being planted in the rehabilitation zone.

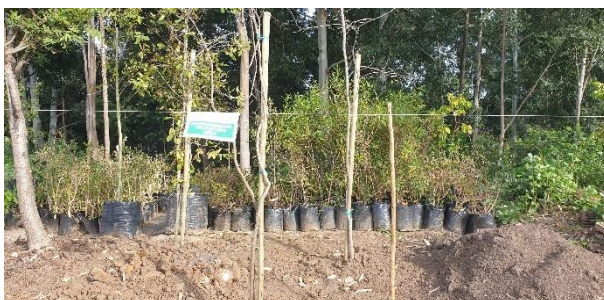
Indigenous plants being planted in the rehabilitation zone.

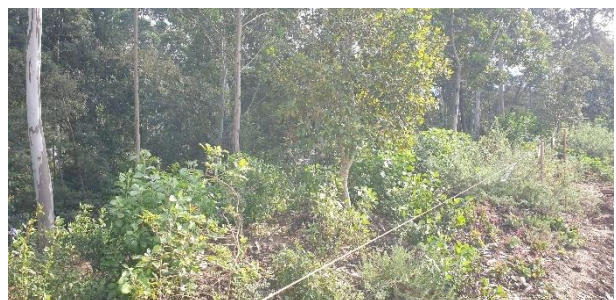
Indigenous plants being planted in the rehabilitation zone.

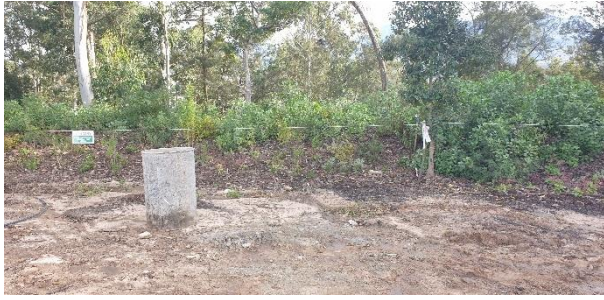
Bin in place near the no-go area.

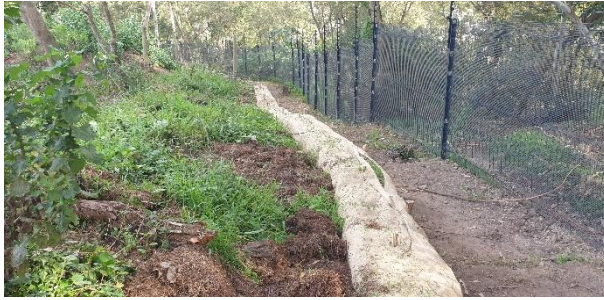
Newly installed hay bale along the riparian zone and security fence.

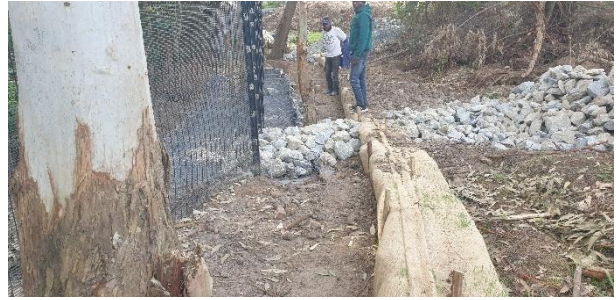
Contractors busy installing the gabion base along the low-lying sections of the buffer area.

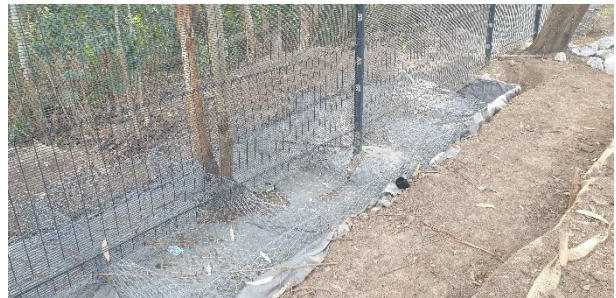
Contractors busy installing the gabion base along the low-lying sections of the buffer area.

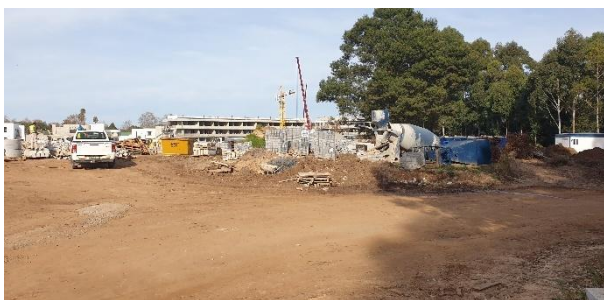
Temporary construction laydown area.

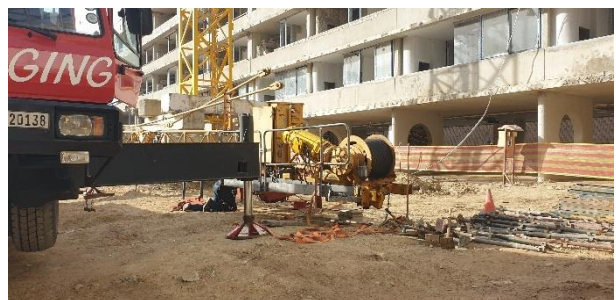
Construction vehicles being serviced.

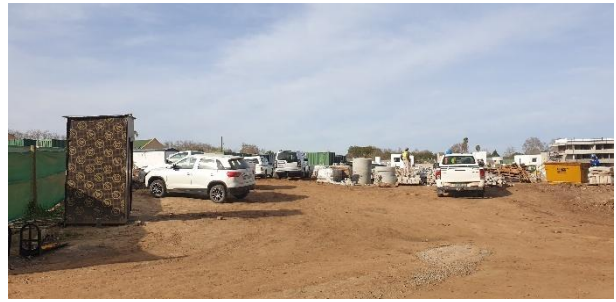
Construction site camp.

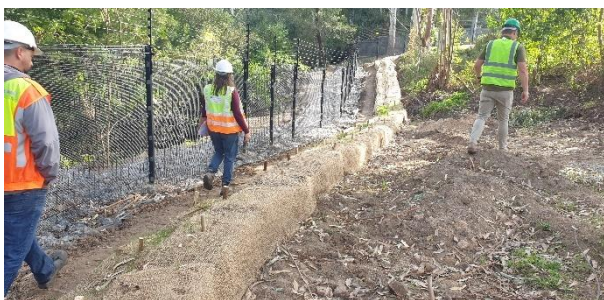
Installed hay bales and gabion mattresses towards the corner of the property.

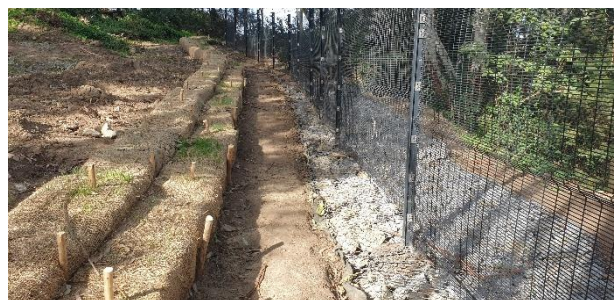
Installed hay bales and gabion mattresses towards the corner of the property.

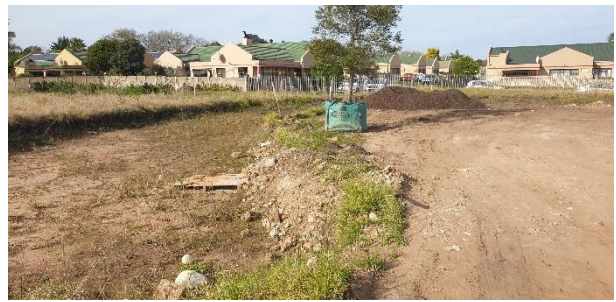
Indigenous trees are to be planted for rehabilitation.

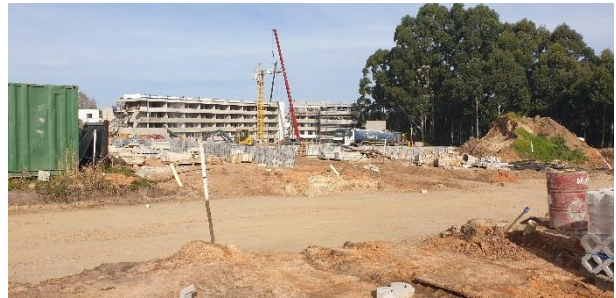
Construction laydown area where civil services are being installed.

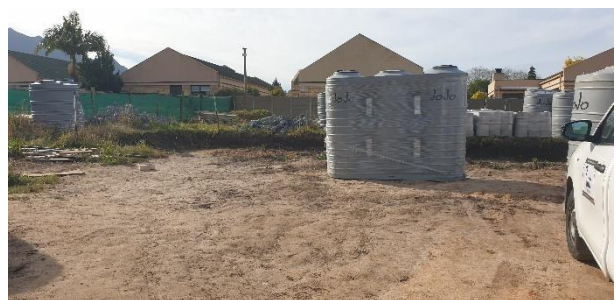
Jojo tanks are to be installed at each unit.

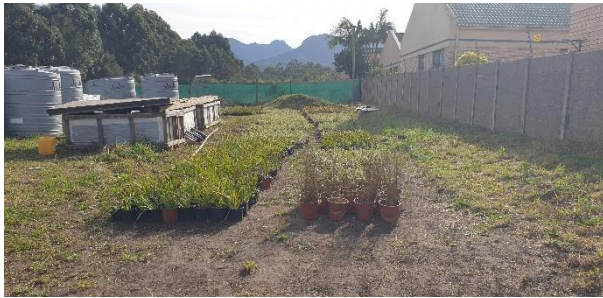
On-site nursery containing the search and rescue plants behind the site camp.

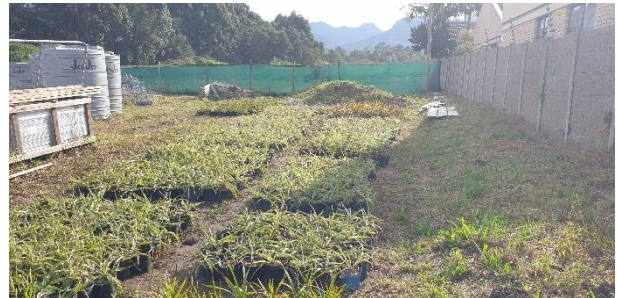
On-site nursery containing the search and rescue plants behind the site camp.

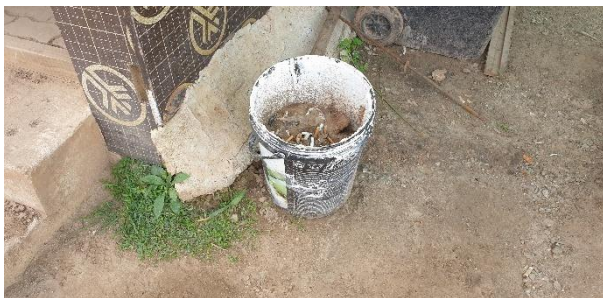
Fire bucket to extinguish cigarette buds.

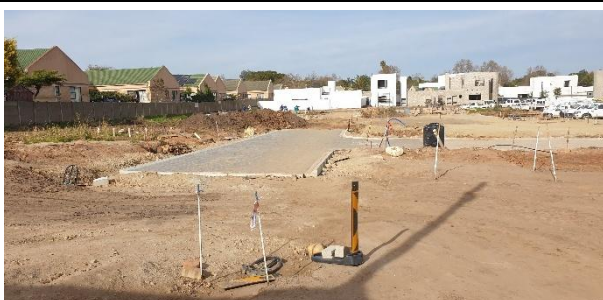
Civil services being installed along with the roads being paved.

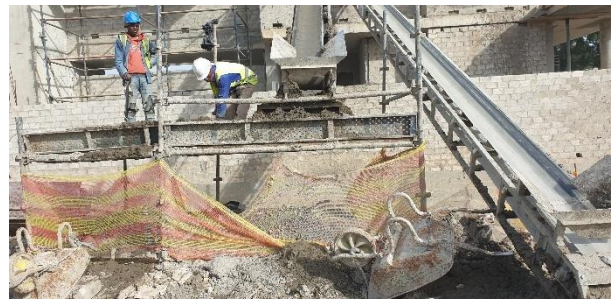
Cement conveyor belt, demarcation around the area.

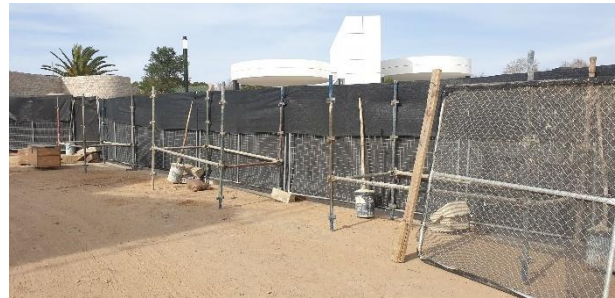
Screening around the construction area in place.
