## APPENDIX A – SITE PHOTOGRAPHS

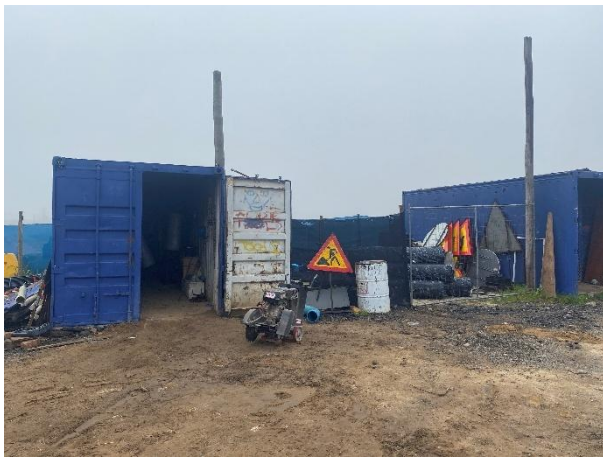
Concrete cutting saw stored at the site camp.

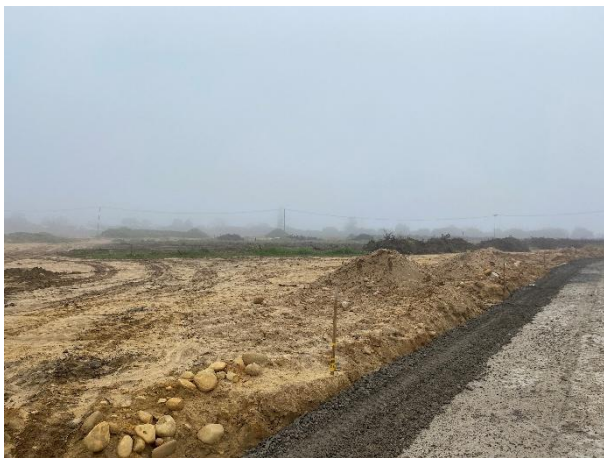
Towards the west, internal roads are being chipped and sprayed with material placed along the development.

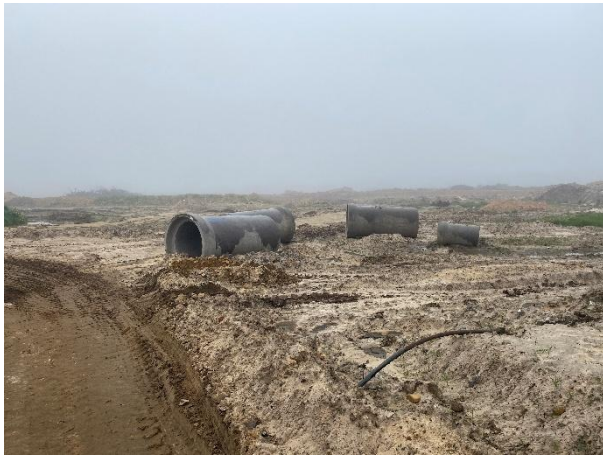
1.1m stormwater pipeline material adjacent to the large stormwater pond to be installed.

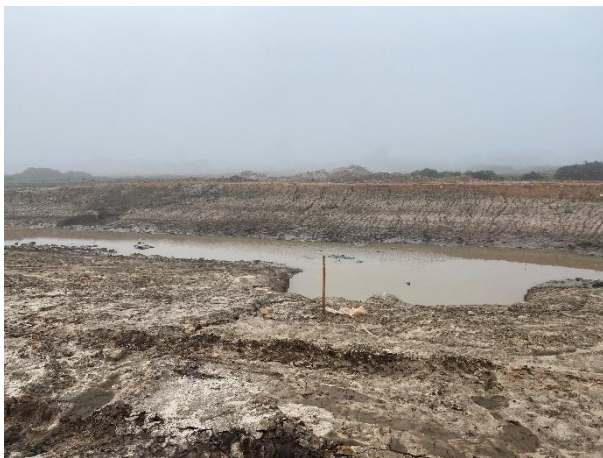
Condition of the large stormwater pond located east of the existing Firwoods Homestead.

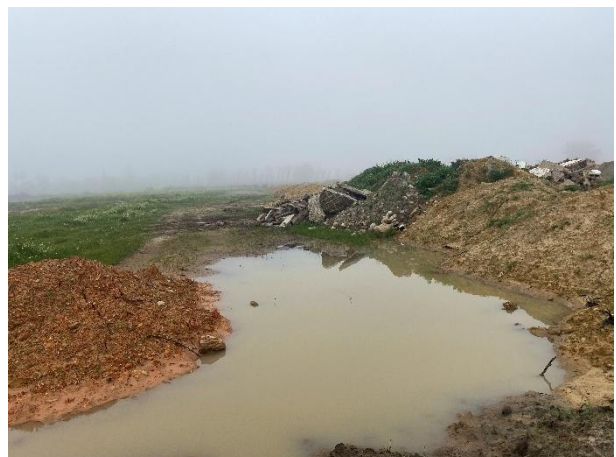
Demolished buildings crushed on-site for reuse as G7 material in road construction.

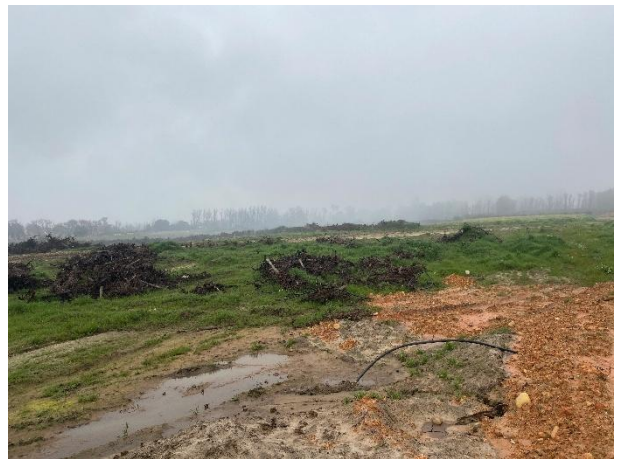
Vineyards cleared due to unproductive vines.

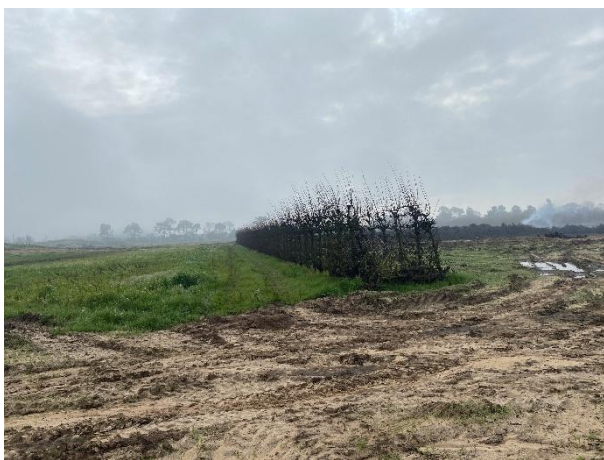
Vineyards to be cleared due to unproductive vines.

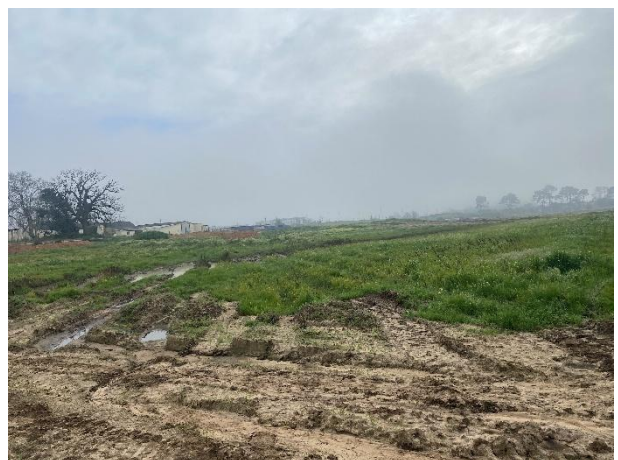
View of the site towards the site camp looking northwest.

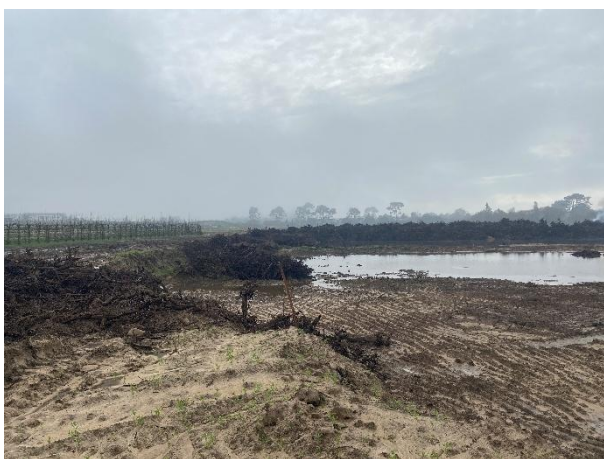
Cleared vines have been placed adjacent to the Homestead and stormwater pond.

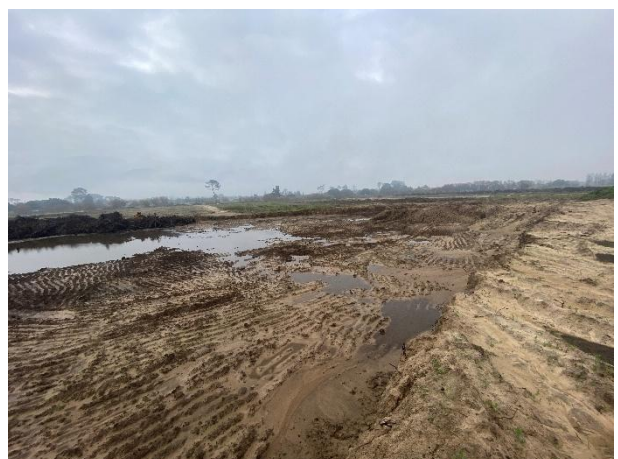
Cleared area adjacent to the Homestead and stormwater pond wet due to the recent rain.

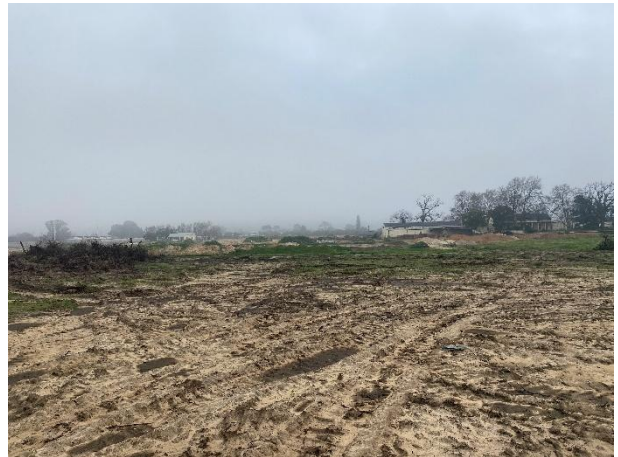
View of the existing Firwoods Homestead and stockpile laydown area towards the southwest.

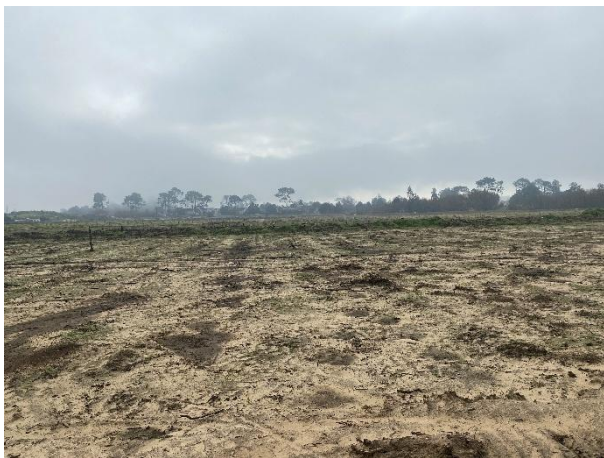
Cleared area towards the east designated for agriculture along the Berg River.

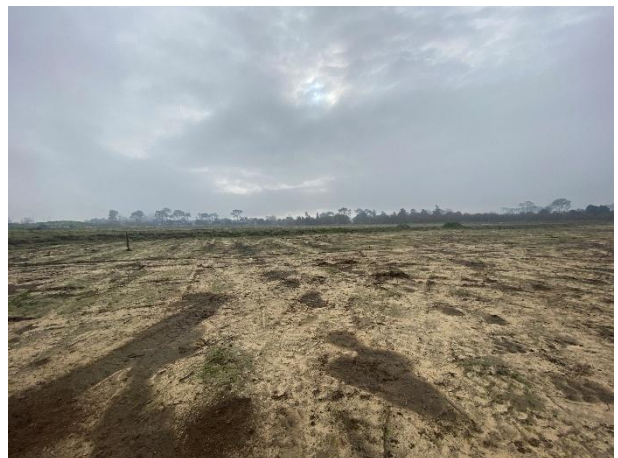
Cleared area towards the east designated for agriculture along the Berg River.

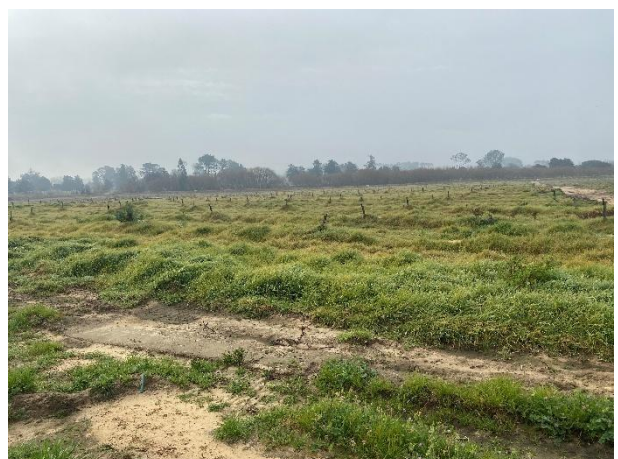
Cleared area towards the east designated for agriculture along the Berg River.

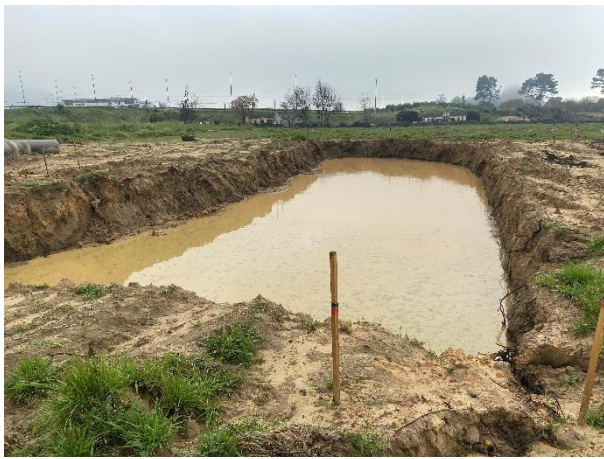
Smaller stormwater pond towards the north.

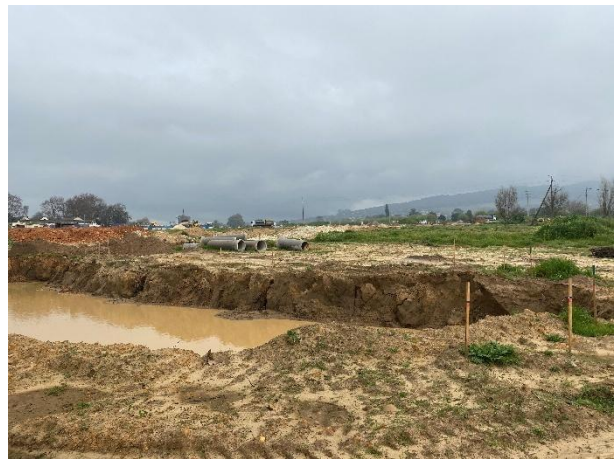
Smaller stormwater pond towards the north.

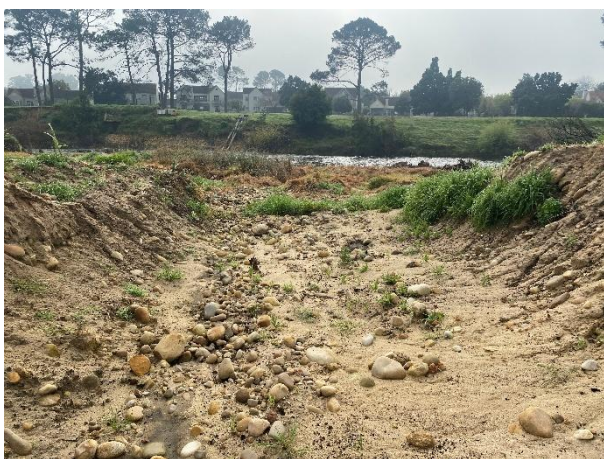
Excavated stormwater outlet channel north towards the Berg River.

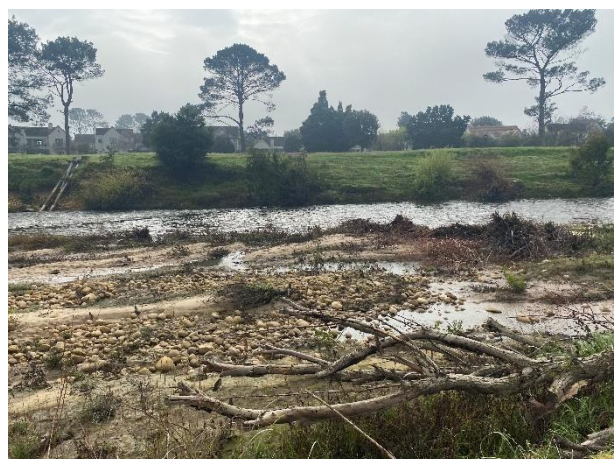
Condition of the Berg Riverbank north of the development site.

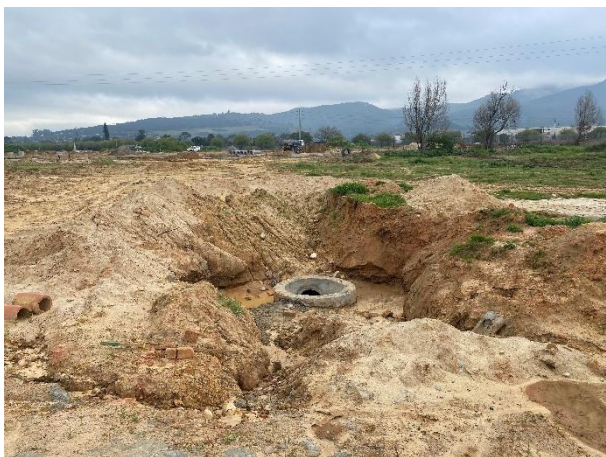
Civil service installations adjacent to the site camp.

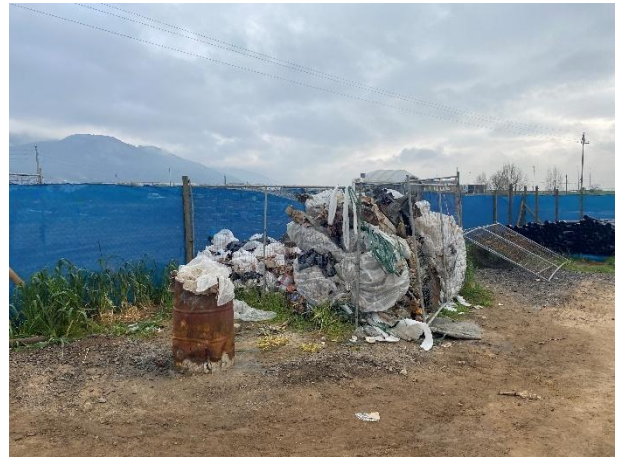
Bin and wire structure available within the site camp for waste disposal.

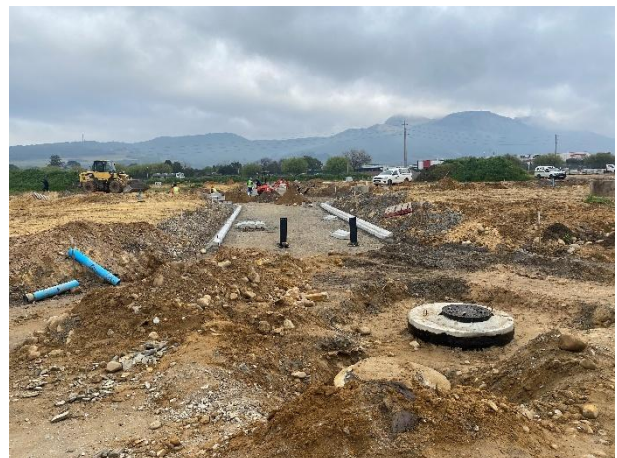
Civil services, kerbs, and road surface being prepared west of the site camp at the entrance to the site.

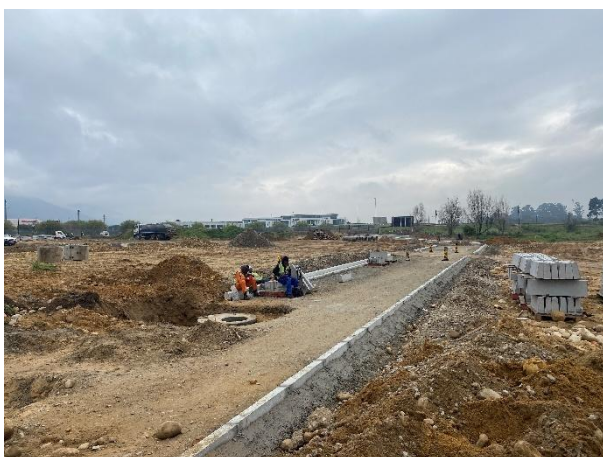
Civil services, kerbs, and road surface being prepared west of the site camp at the entrance to the site.

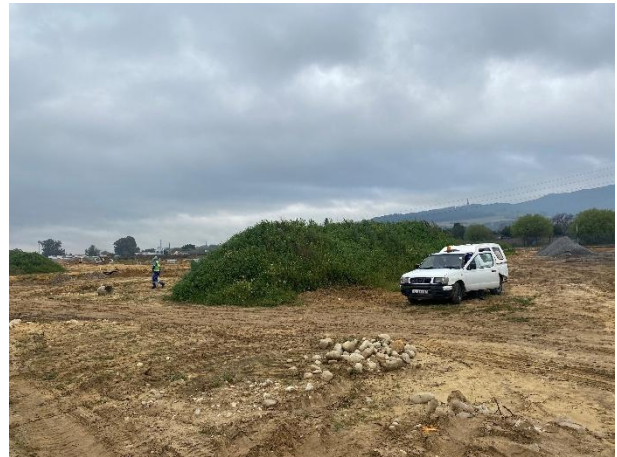
Revegetated topsoil stockpiles adjacent to the site camp.

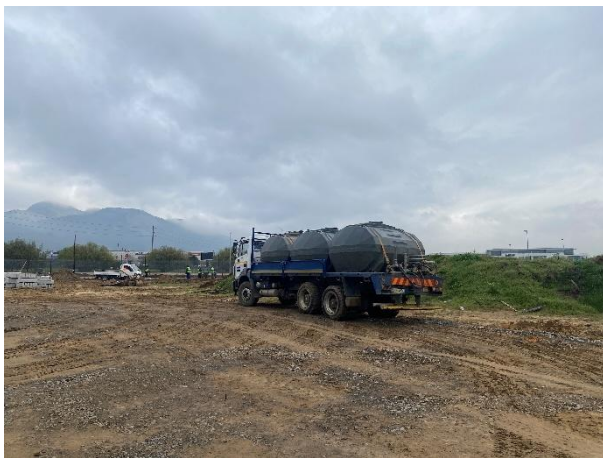
Water truck available for dust fallout on site.

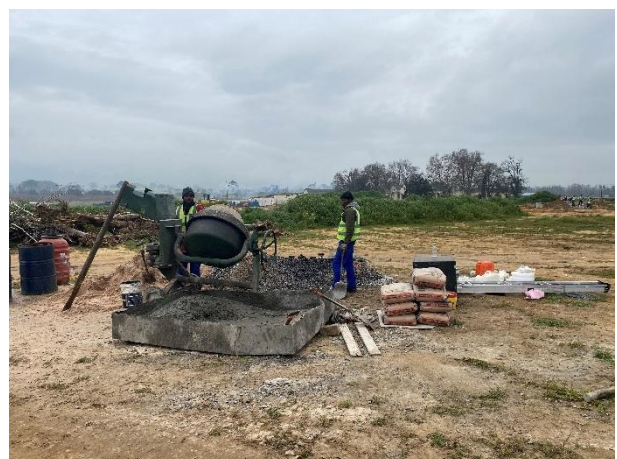
Asphalt mixing with a mortar board in place.

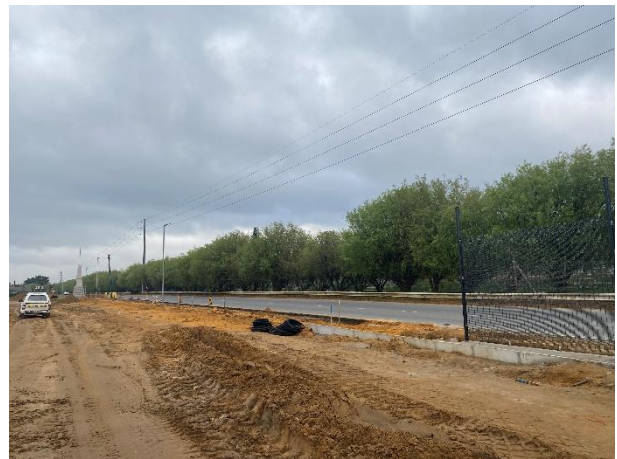
Condition of New Eskdale Street towards the southwest where the ClearVu boundary fence is being installed.

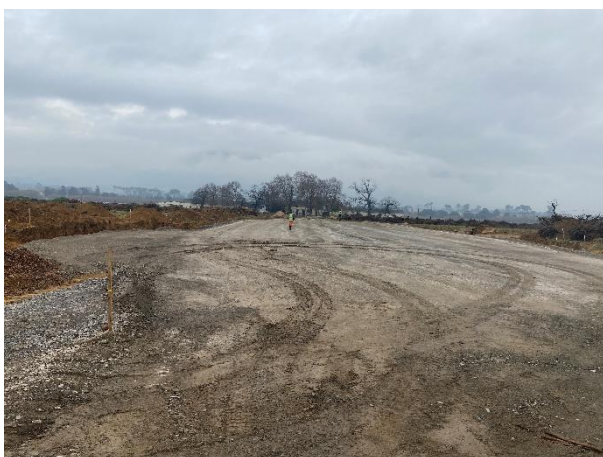
Internal road surfaces being chipped and sprayed. Entrance to the site towards the Firwoods Homestead.

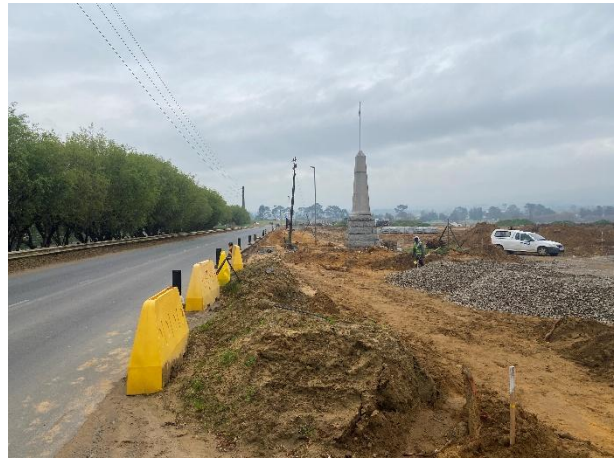
Condition of New Eskdale Street towards the North. Civil services being installed along the road.

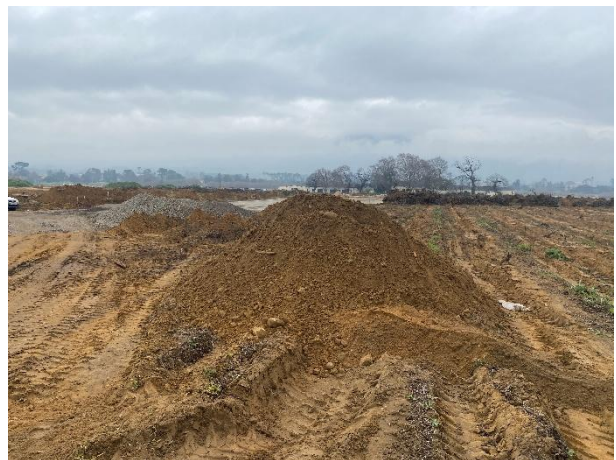
Stockpile area towards the southwest where roads are being excavated.

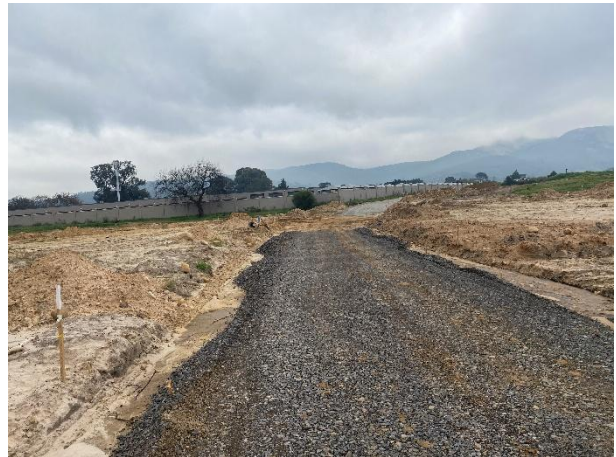
Roads being chipped and sprayed south of the foreman's house.

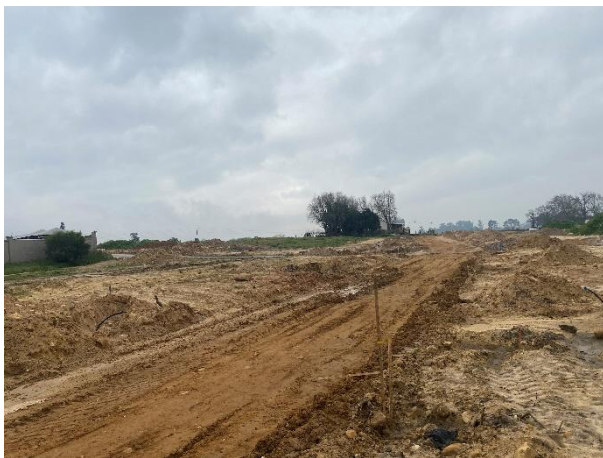
Roads being excavated and cut south of the foreman's house.

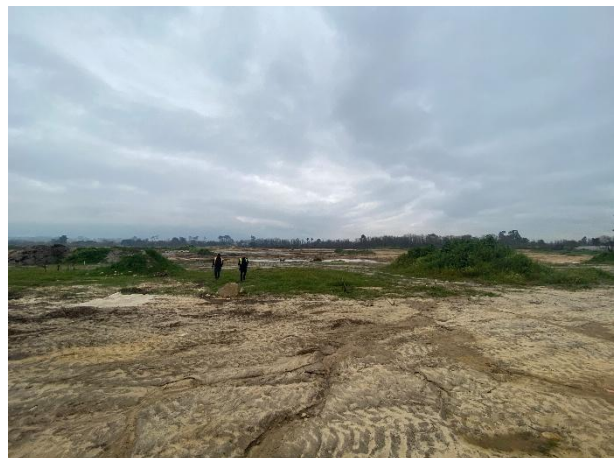
Stockpile area southwest of the site. Topsoil stockpiles have been revegetated.

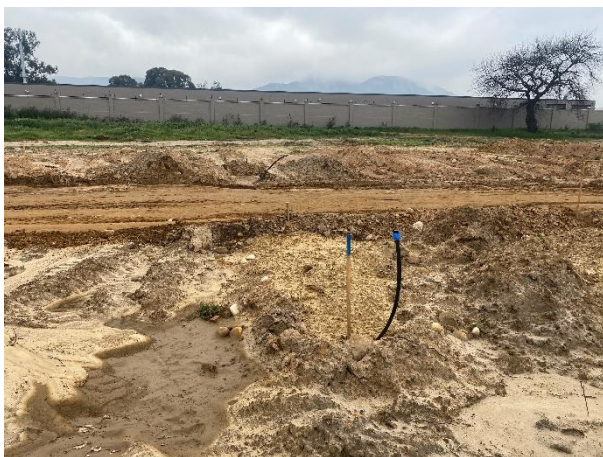
Roads being excavated and cut south of the foreman's house.

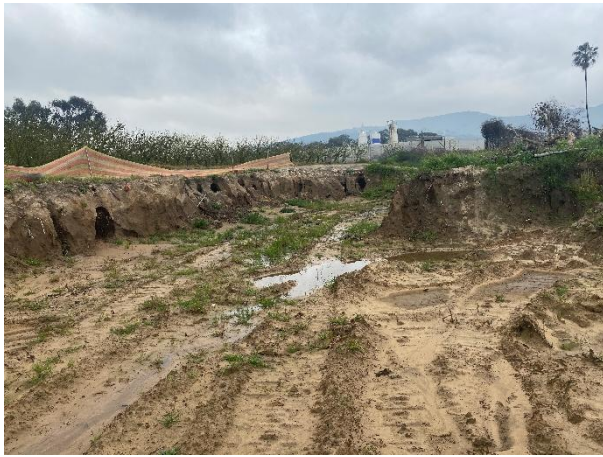
Excavated stormwater channel towards the southwest.

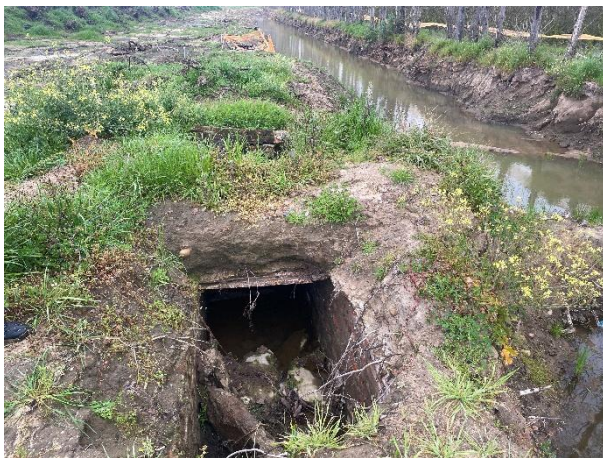
Collapsed culvert to be upgraded.

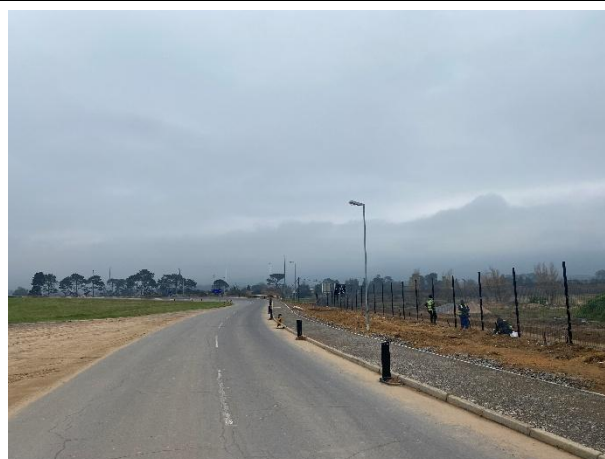
ClearVu boundary fence being installed along the western boundary of the site.

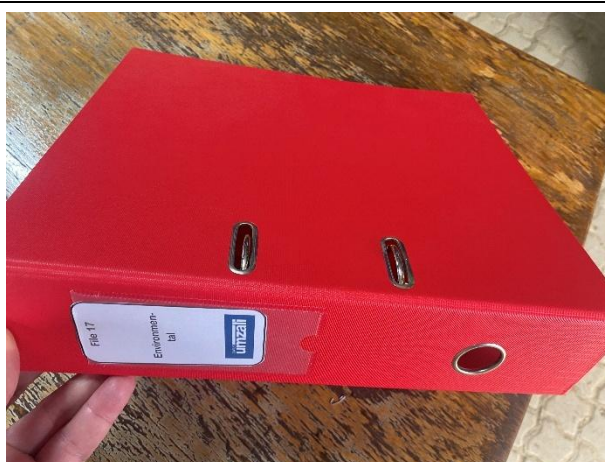
Environmental file available at the site office.

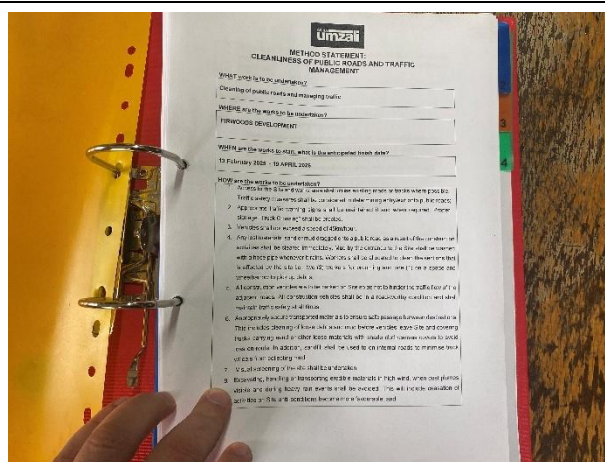
Method Statement for Traffic Management.

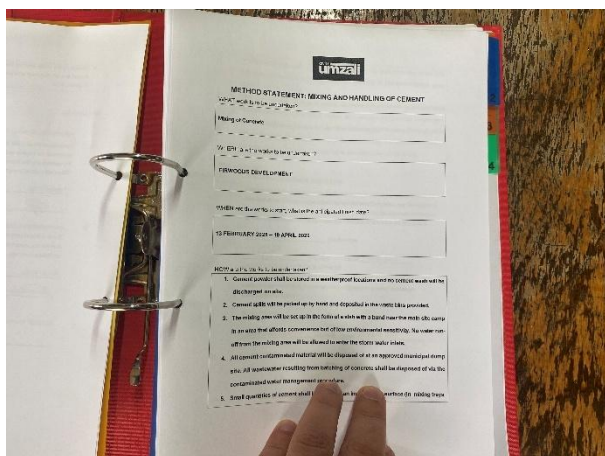
Method Statement for Cement Handling.

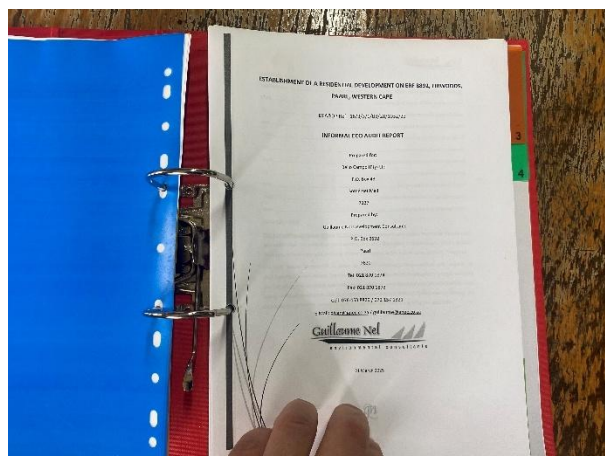
ECO reports submitted.

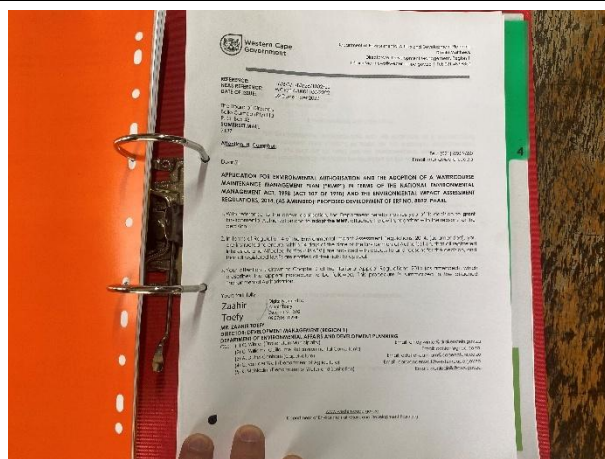
Notification of the 2022 Environmental Authorisation.

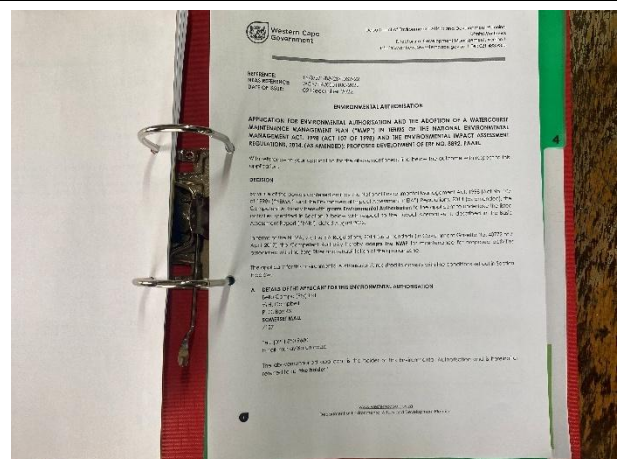
2022 Environmental Authorisation.

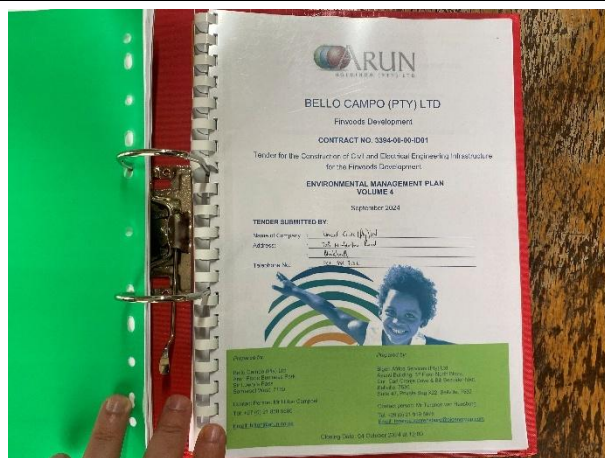
EMP included in contract documents.

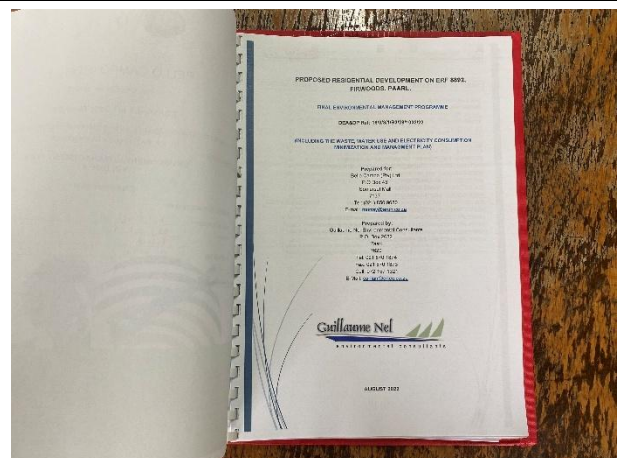
Environmental Management Programme.

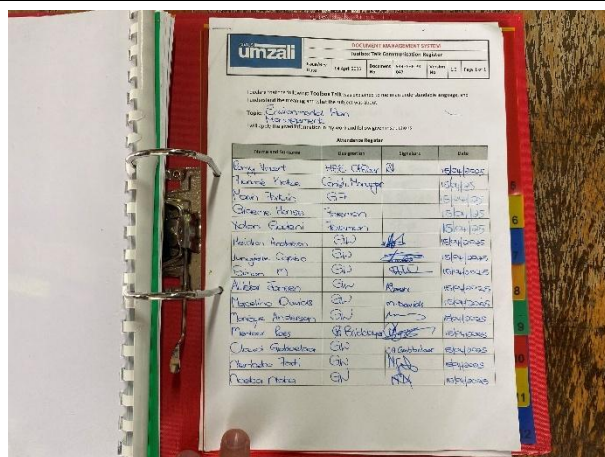
Environmental induction register.

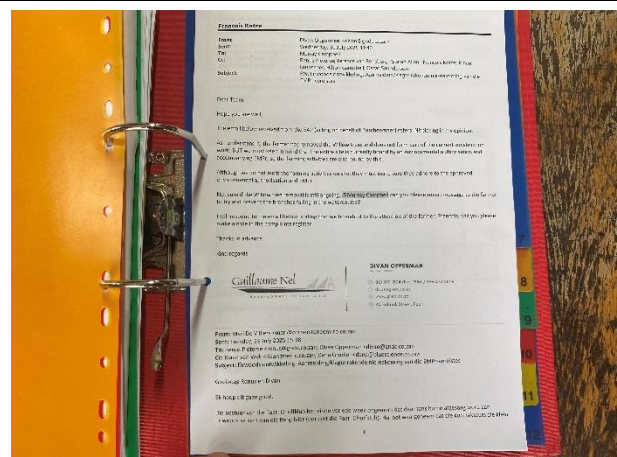
Project team and farmer have been made aware of the communication received from the Golfklub.

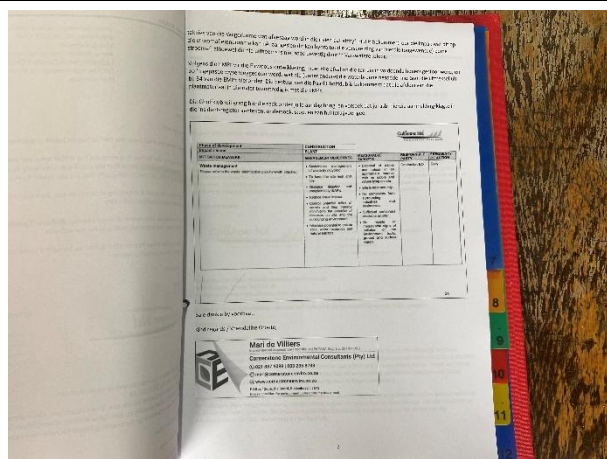
Correspondence from the Golfklub regarding waste removal.

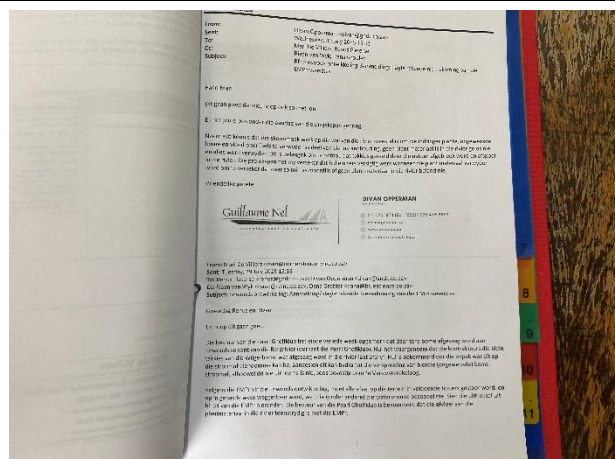
Correspondence from the EAP and contractor regarding the raised concern.

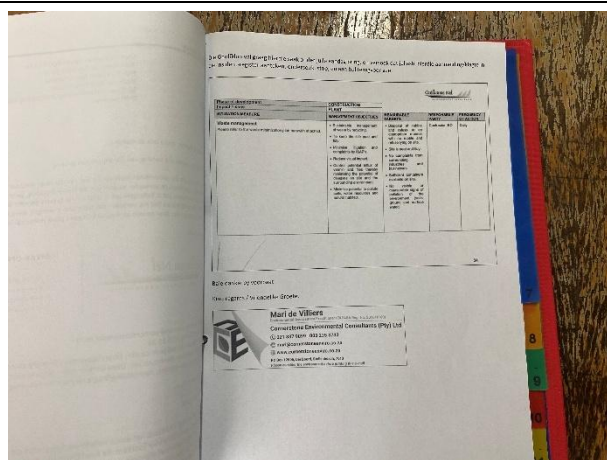
Correspondence from the EAP and contractor regarding the raised concern.
