## APPENDIX A – SITE PHOTOGRAPHS

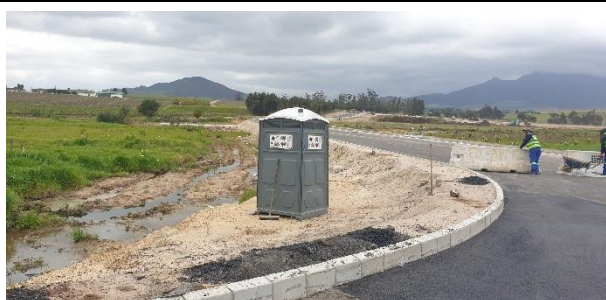
Chemical toilet in place at the construction site of the main access road.

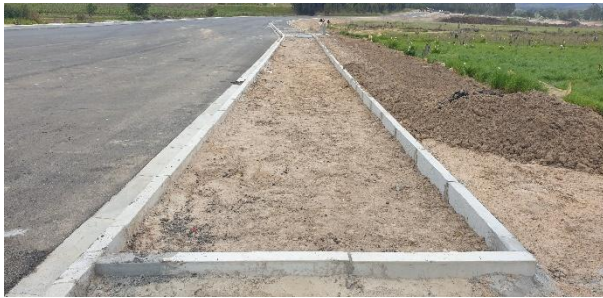
Pedestrian walkways under construction alongside the main access road.

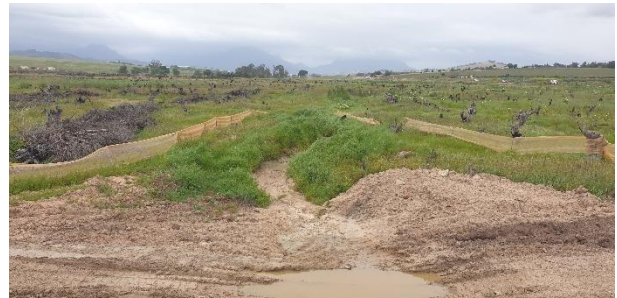
Box culvert outlet with shaped discharge channel directing stormwater toward the wetland.

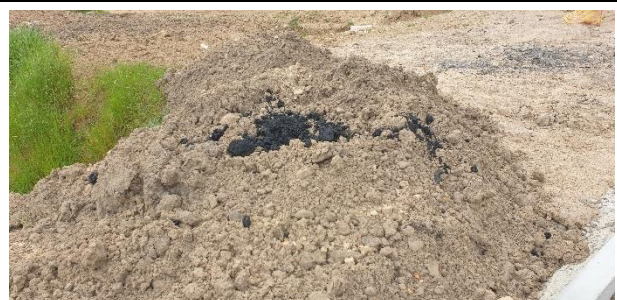
Access road and civil services (stormwater) being installed. Bitumen remains must please be removed.

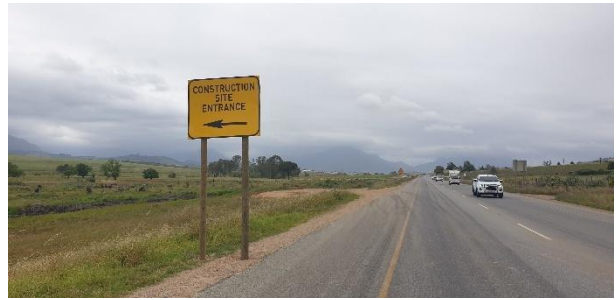
Traffic notification along the R44 to Stellenbosch

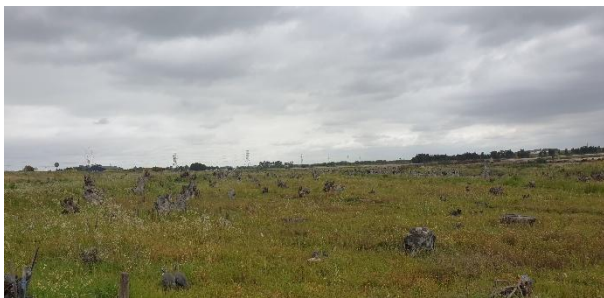
*Eucalyptus* and *Acacia* trees are being removed, stumps treated with herbicide to prevent regrowth.

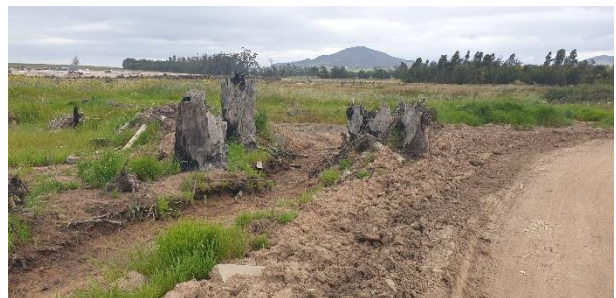
*Eucalyptus* and *Acacia* trees are being removed, stumps treated with herbicide to prevent regrowth.

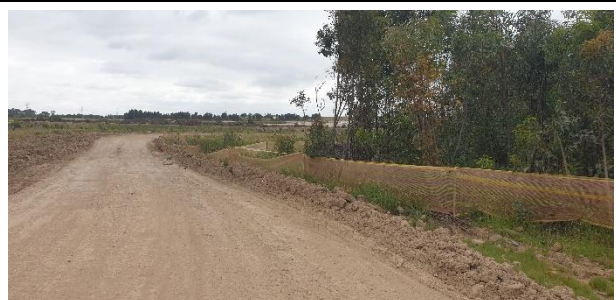
Buffer and wetland/rehabilitation areas have been demarcated with orange netting and danger tape.

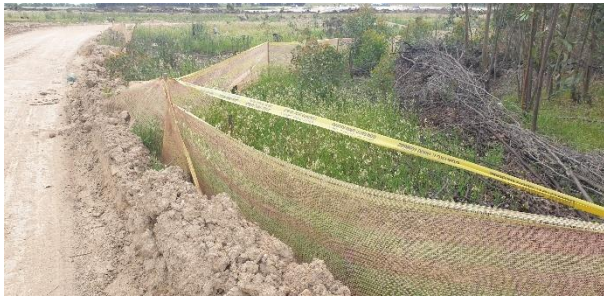
Buffer and wetland/rehabilitation areas have been demarcated with orange netting and danger tape.

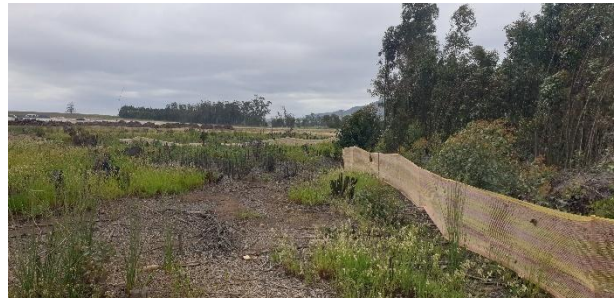
Buffer and wetland/rehabilitation areas have been demarcated with orange netting and danger tape.

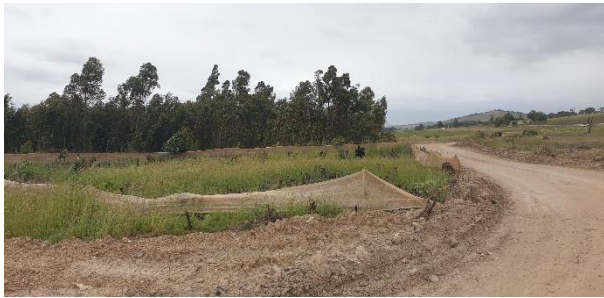
Buffer and wetland/rehabilitation areas have been demarcated with orange netting and danger tape.

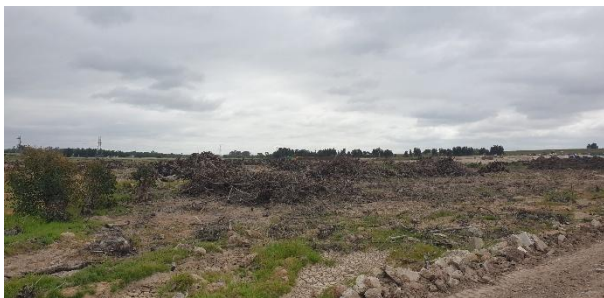
Unchipped material stockpiled to the west.

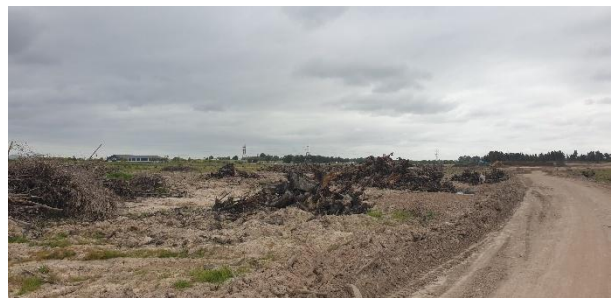
Unchipped material stockpiled to the west.

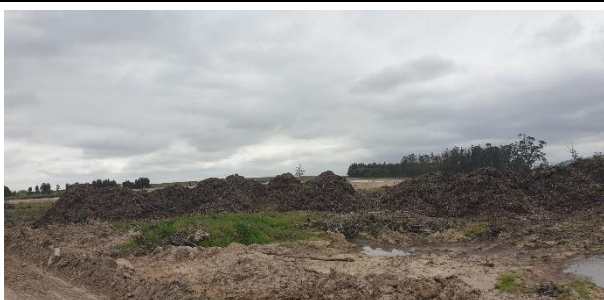
Cleared biomass has been chipped and stockpiled separately in the eastern portion of the site.

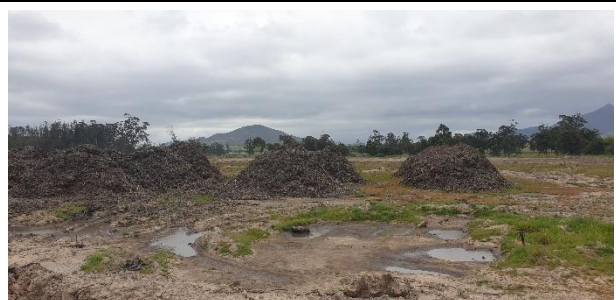
Cleared biomass has been chipped and stockpiled separately in the eastern portion of the site.

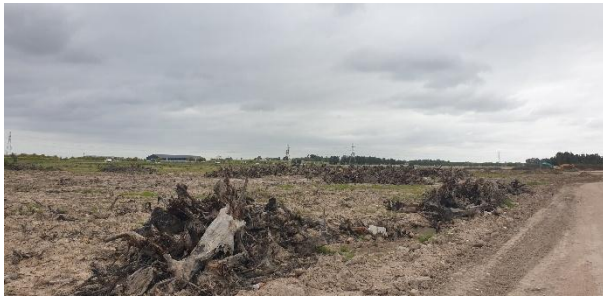
Unchipped material stockpiled to the west.

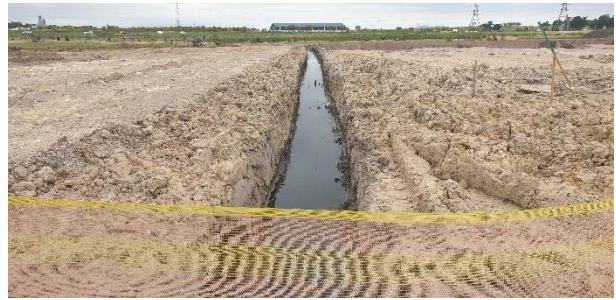
Stormwater drainage line/stream transecting the site from west to east.

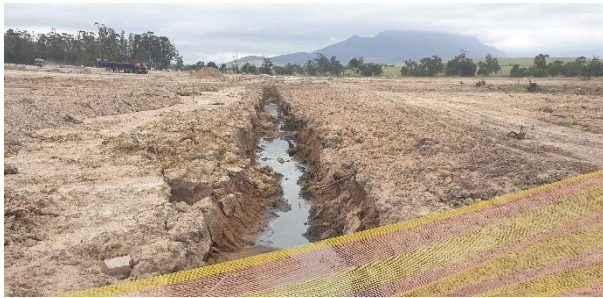
Stormwater drainage line/stream transecting the site from west to east.

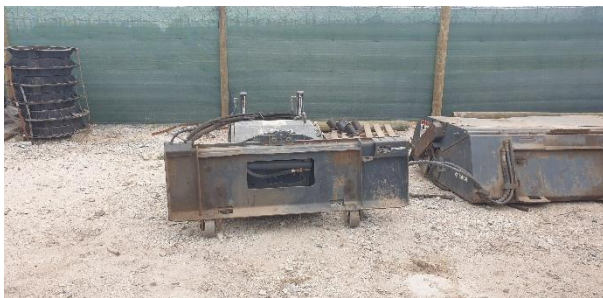
Machinery kept in good condition within the site camp.

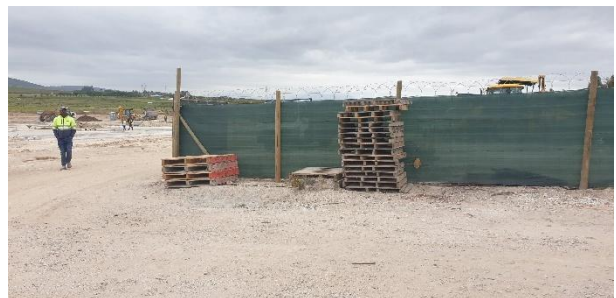
Screened site camp towards the northwest.

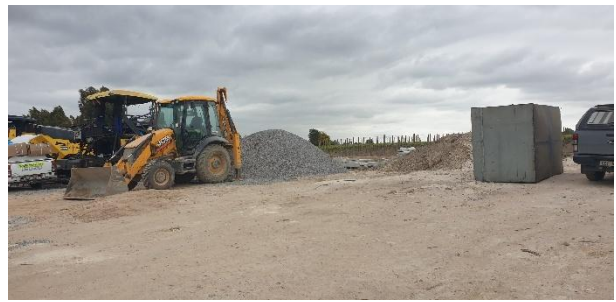
Material stockpiles have been placed adjacent to the site camp along with the machinery in use.

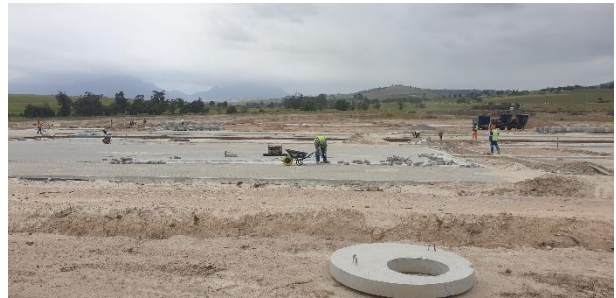
Bus and visitor parking being constructed towards the north.

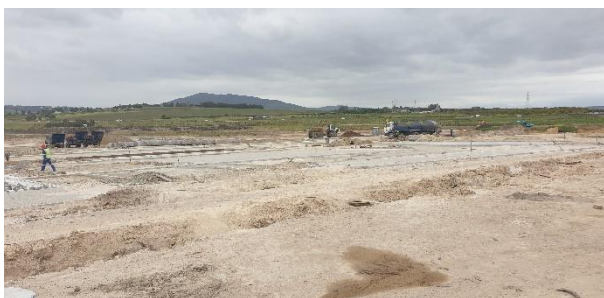
Bus and visitor parking being constructed towards the north.

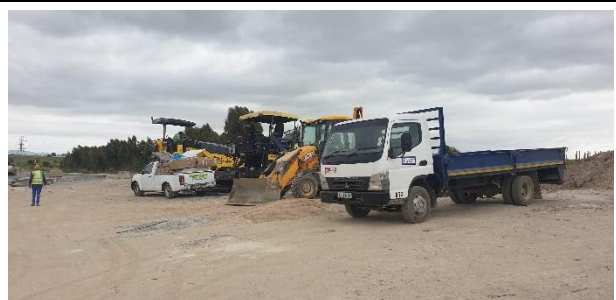
Material stockpiles have been placed adjacent to the site camp along with the machinery in use.

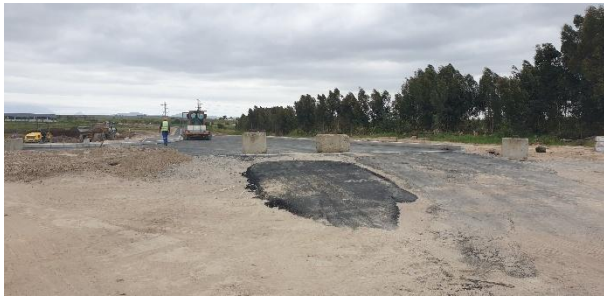
Main access road towards the west, bitumen surfacing in progress.

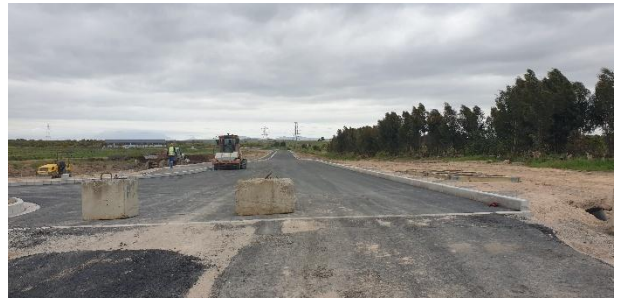
Main access road towards the west, bitumen surfacing in progress.

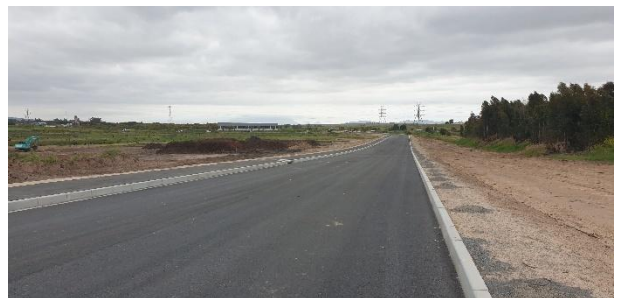
Condition of the main access road towards the west.

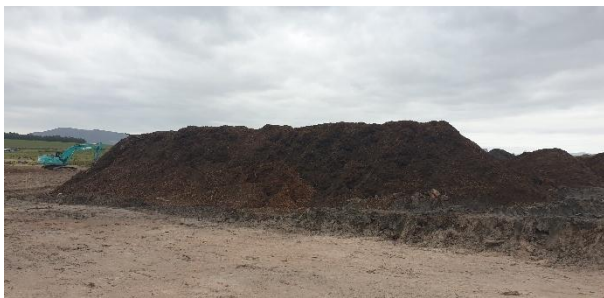
Composting material stockpiled towards the northwest.

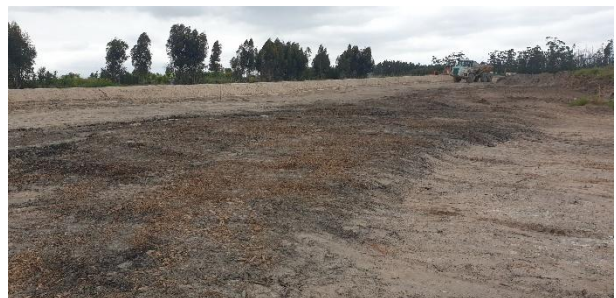
View of the main access road towards the north.

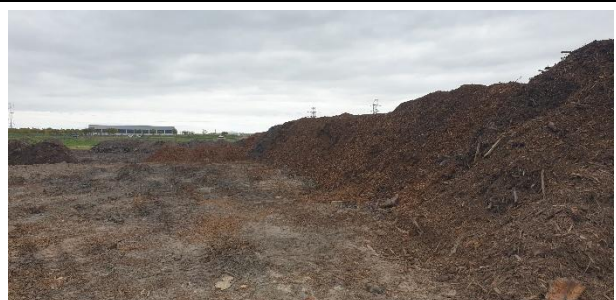
Composting material stockpiled towards the northwest.

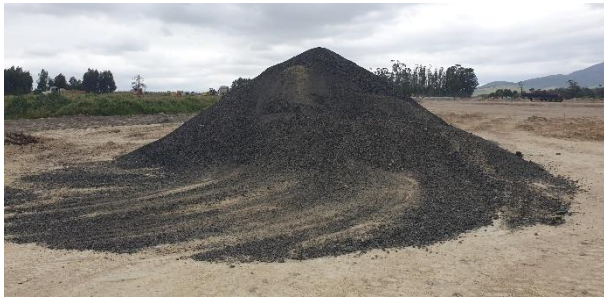
Crushed stone aggregate prepared for asphalt surfacing.

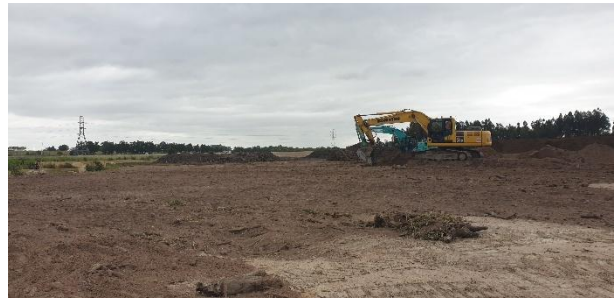
Location of the traditional headstone grave site. Topsoil and composting are being spread across the site.

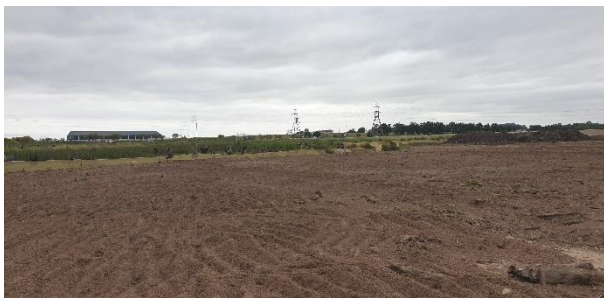
Location of the traditional headstone grave site. Topsoil and composting are being spread across the site.

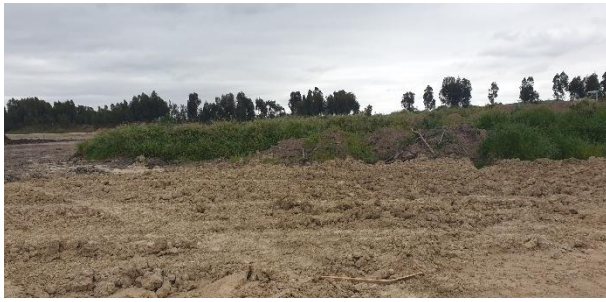
Topsoil stockpiles have been vegetated.

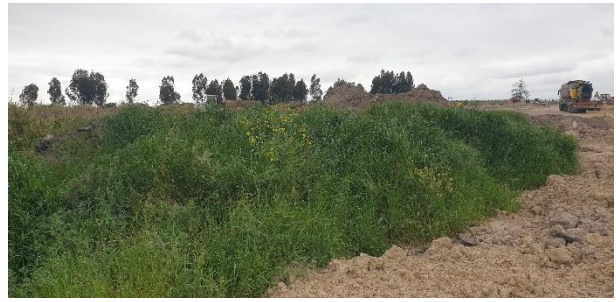
Vegetated topsoil stockpiles towards the north.

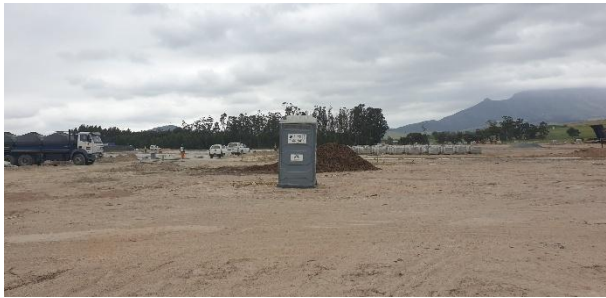
Chemical toilet adjacent to the parking construction area.

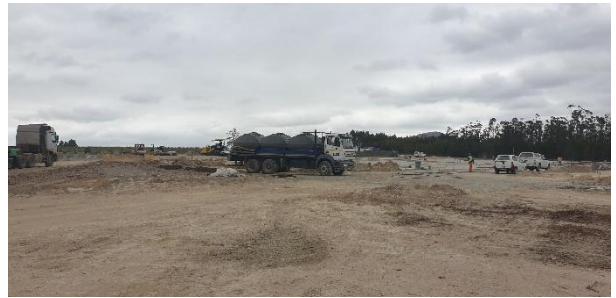
Water truck available on site near the works area.

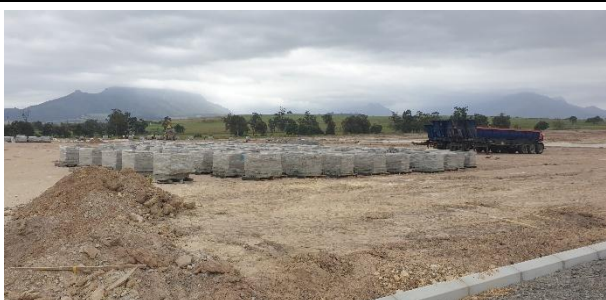
Kerbs being installed within the bus and visitor parking area.

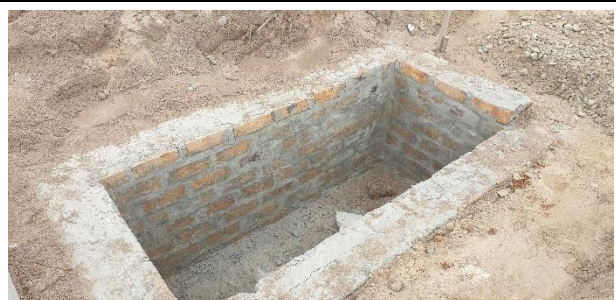
Stormwater inlet structures being constructed within the bus and visitor parking area.

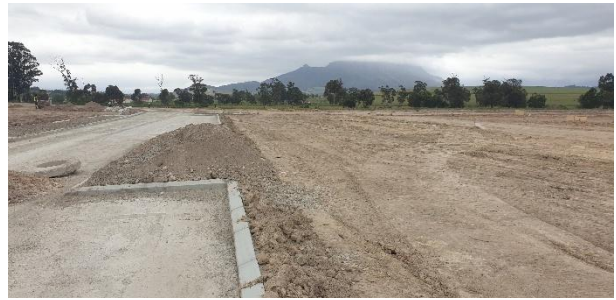
Civil services and internal roads being installed.

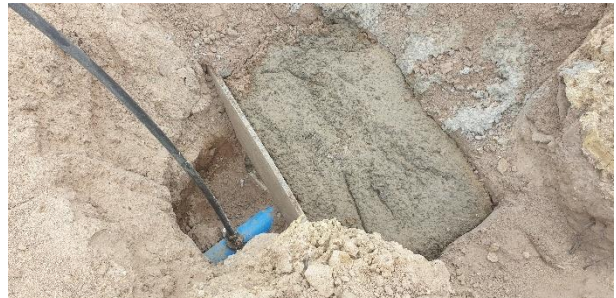
Civil services being installed.

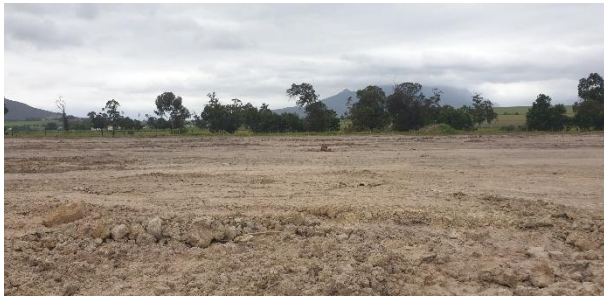
View towards the east, where the staff housing, maintenance yard, and stock nursery will be located.

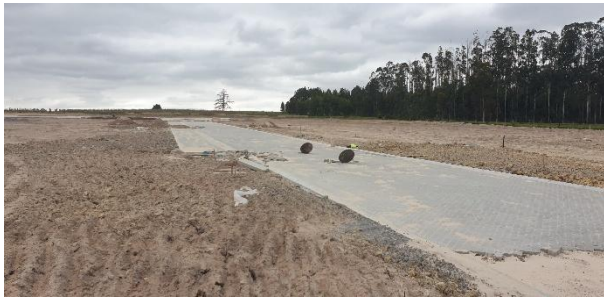
Internal roads are being paved, and kerbs are being installed.

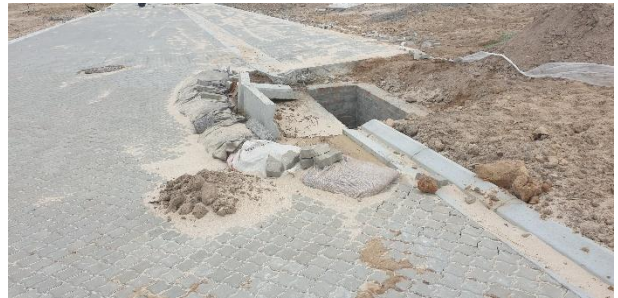
Sandbags placed alongside stormwater inlets to prevent sediment runoff.

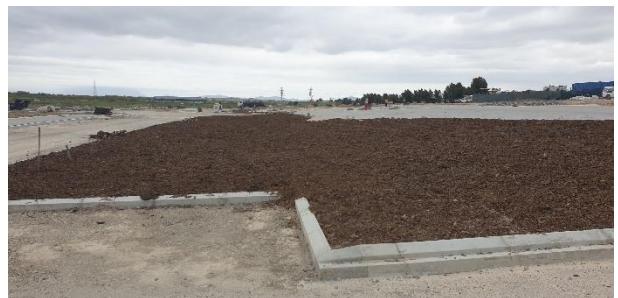
Gardens being landscaped at the parking area.

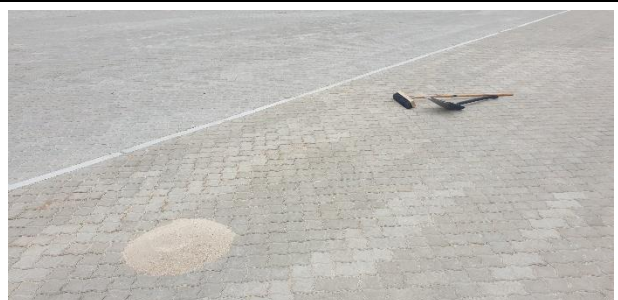
Sand grouting in progress on newly paved internal roads.

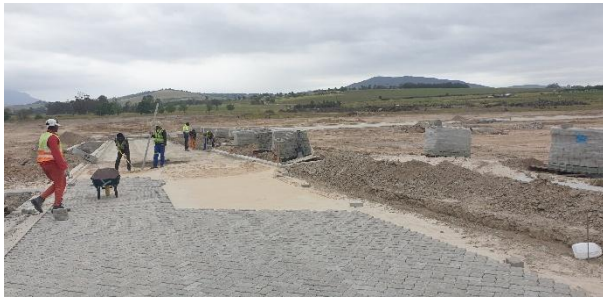
Internal roads are being paved, and kerbs are being installed.
