## APPENDIX A – SITE PHOTOGRAPHS

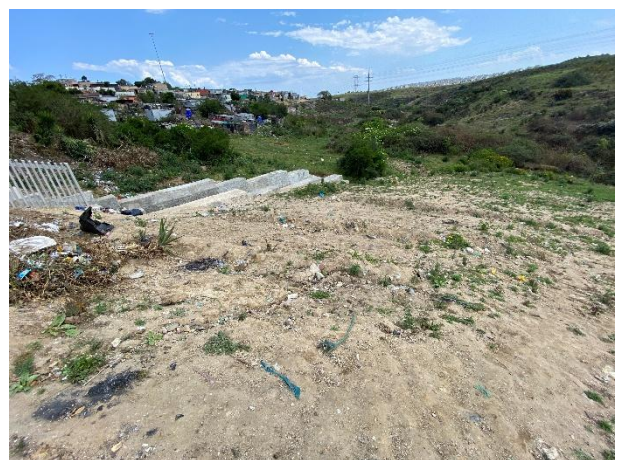
Backfilling and shaping of area adjacent to the works completed.

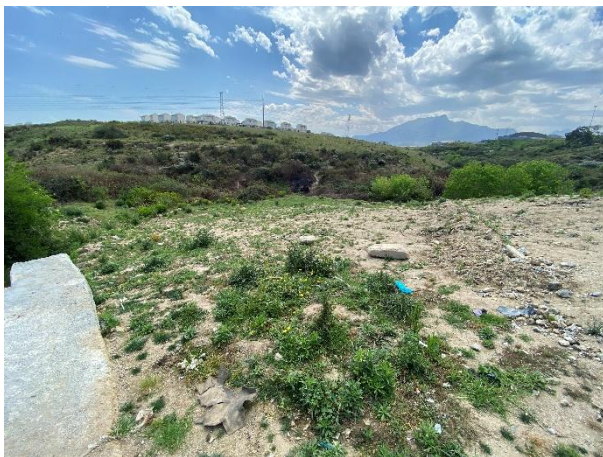
Backfilling and shaping of area adjacent to the works completed.

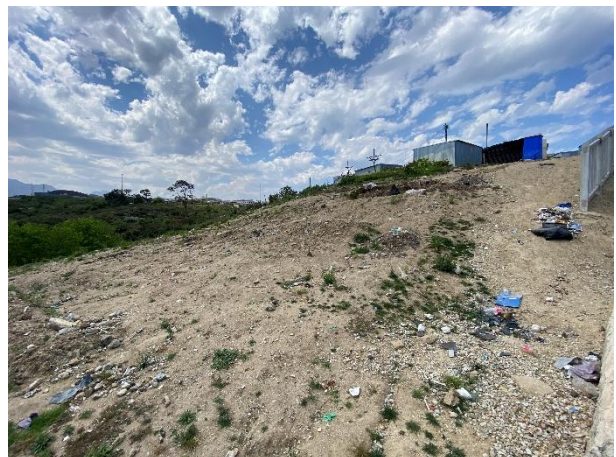
Backfilling and shaping of area adjacent to the works completed.

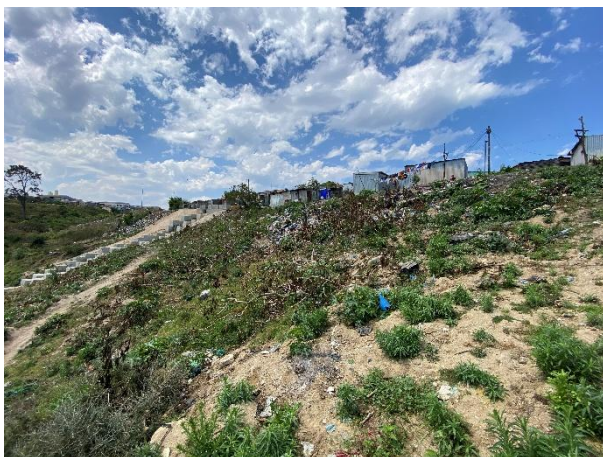
Backfilling and shaping of area adjacent to the works completed.

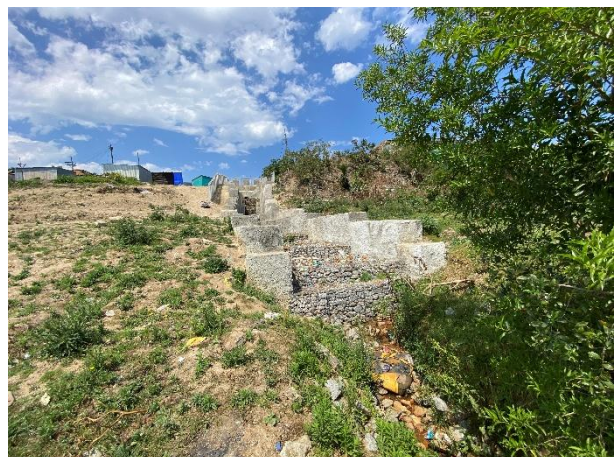
New gabion/mattress flood attenuation works completed. Local residents responsible for dumping.

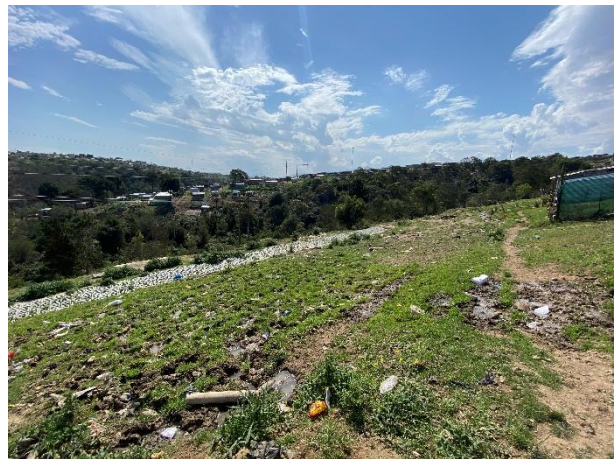
Slopes adjacent to the drainage channels have been shaped and rehabilitated, erosion backfilled.

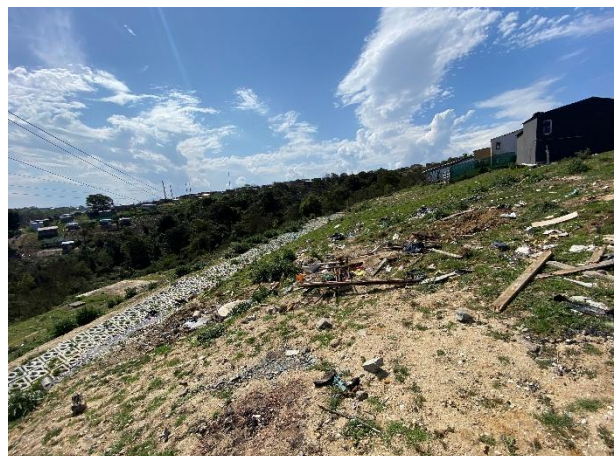
Slopes adjacent to the drainage channels have been shaped and rehabilitated, erosion backfilled.

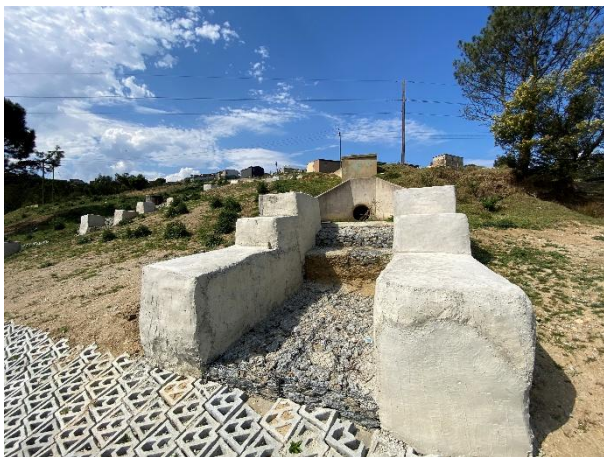
New terramesh and gabions constructed for main drainage channel

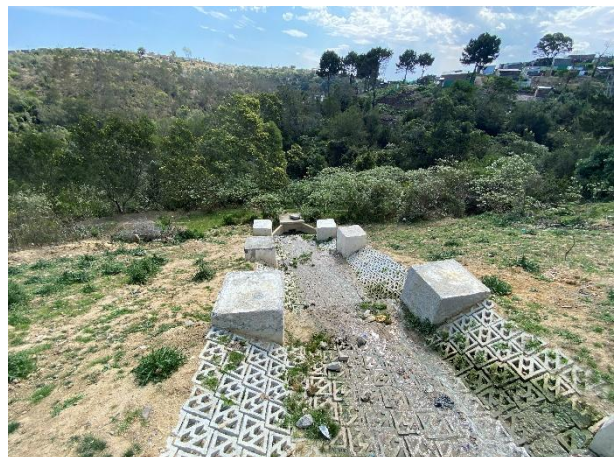
New terramesh and gabions constructed for main drainage channel.

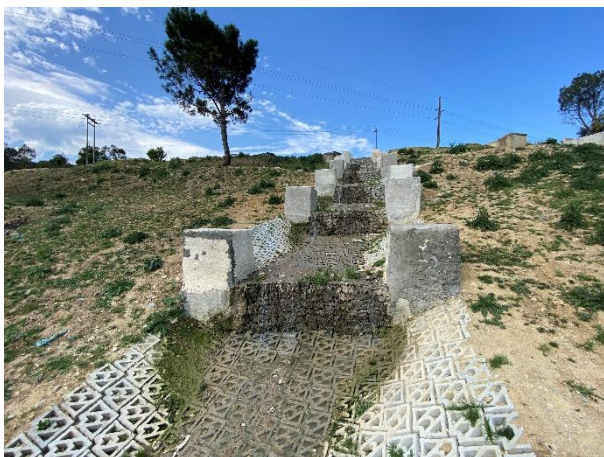
New terramesh and gabions constructed for main drainage channel.

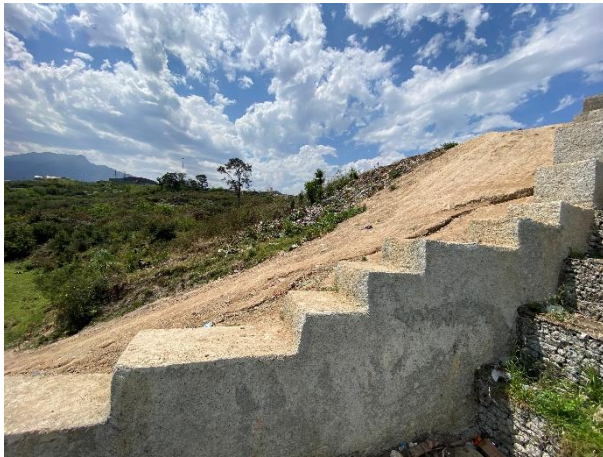
Backfilling and shaping of area adjacent to the works completed.

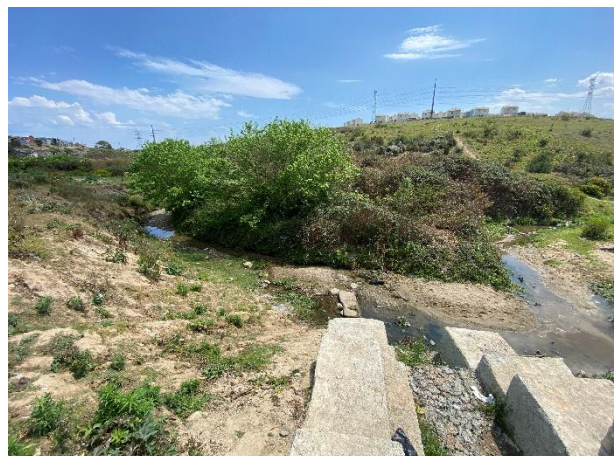
New gabion/mattress flood attenuation works completed.

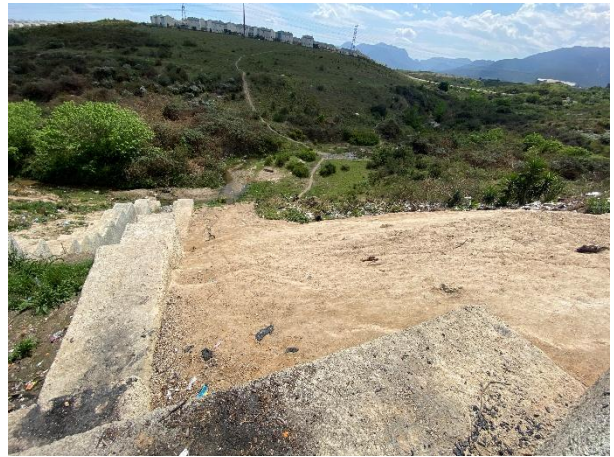
Backfilling and shaping of area adjacent to the works completed.

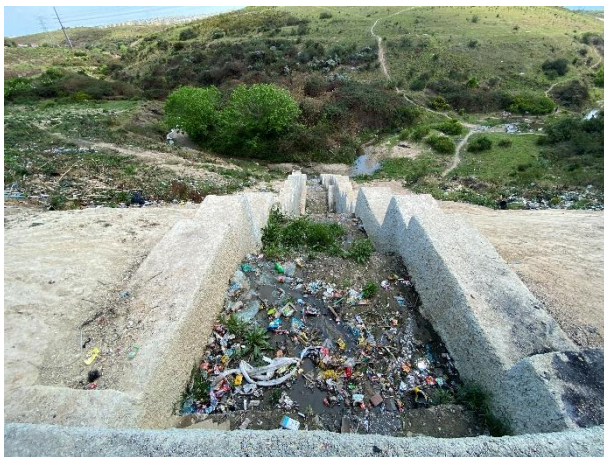
New gabion/mattress flood attenuation works completed.  
Local residents responsible for dumping.

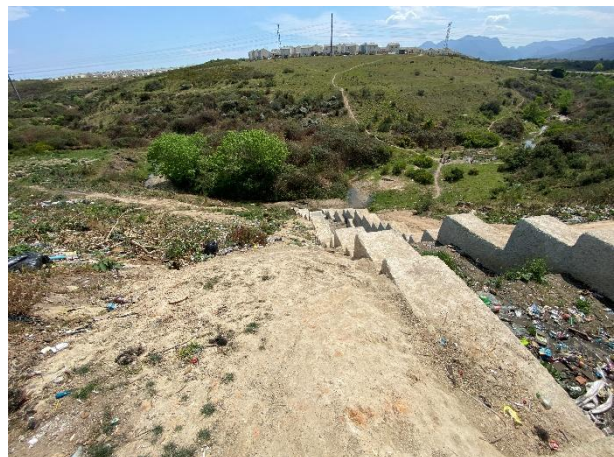
Backfilling and shaping of area adjacent to the works completed.

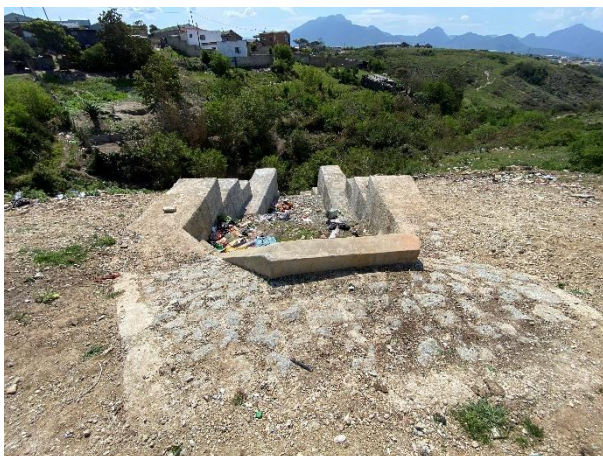
Site 28(1).69 (a & b)

New gabion/mattress flood attenuation works completed. Local residents responsible for dumping.

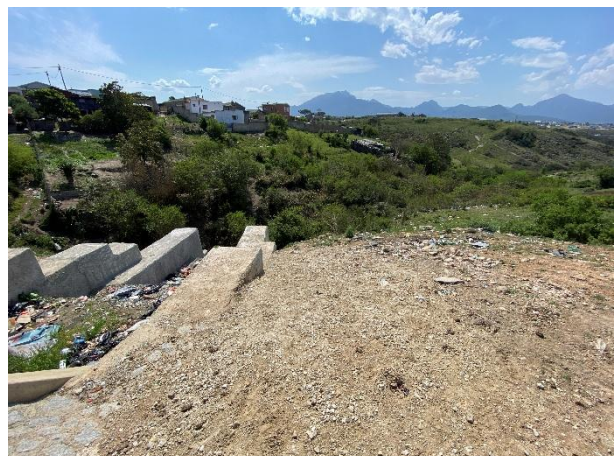
Backfilling and shaping of area adjacent to the works completed.

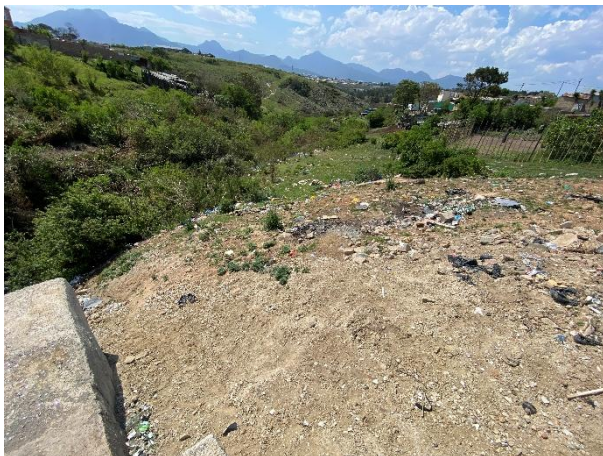
Backfilling and shaping of area adjacent to the works completed.

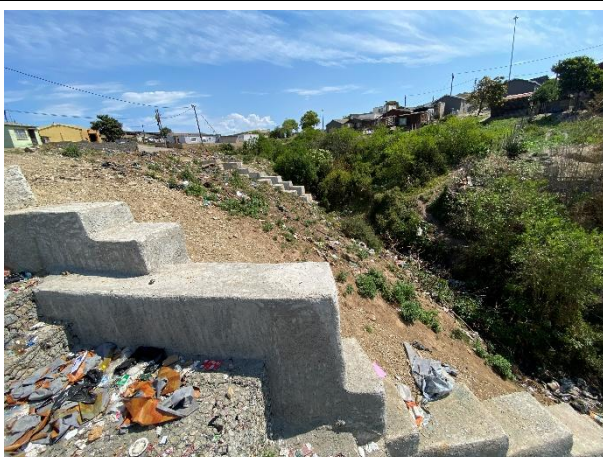
New gabion/mattress flood attenuation works completed. Local residents responsible for dumping.

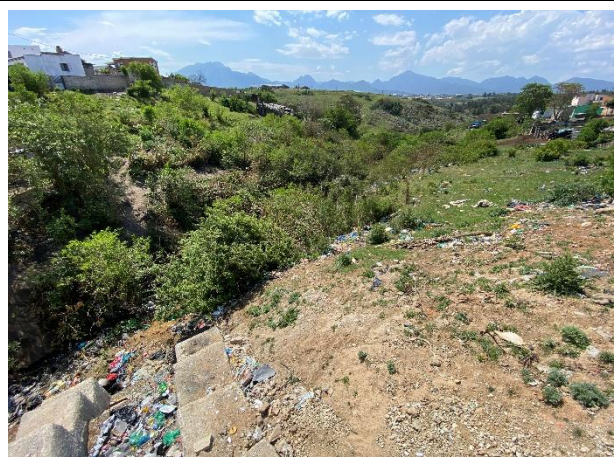
New gabion/mattress flood attenuation works completed. Local residents responsible for dumping.

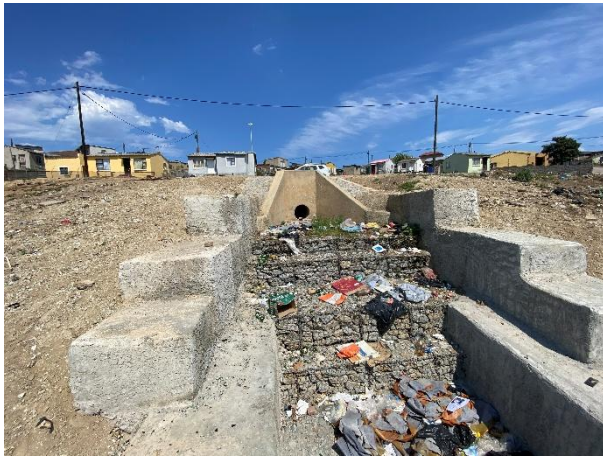
New gabion/mattress flood attenuation works outlet completed. Local residents responsible for dumping.
