**THE MAINTENANCE ACTIVITIES OF TRUNK ROAD  
33/4 BETWEEN KM 4.6 AND KM 14.4 ALONG THE  
MEINRINGSPOORT PASS, WITHIN THE PRINCE  
ALBERT AND OUDTSHOORN LOCAL  
MUNICIPALITIES, WESTERN CAPE.**

**EXTERNAL ENVIRONMENTAL AUDIT **CLOSURE** REPORT  
IN TERMS OF REGULATION 34 OF THE NEMA EIA  
REGULATIONS, 2014 (AS AMENDED).**

DEFF REF. NO. 14/12/16/3/3/1/2226

**3 December 2025**

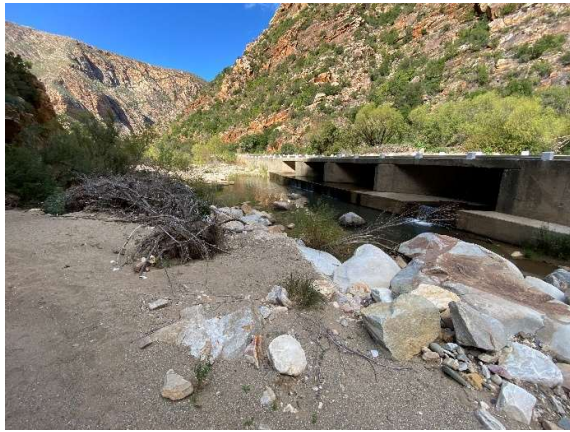
Downstream of Causeway No 7 B2698C with cleared watercourse flow path.

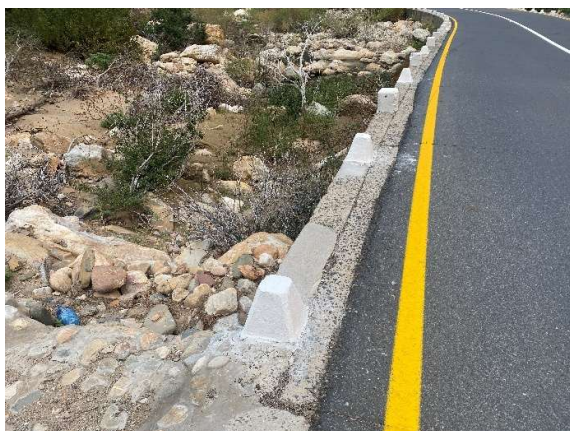
Damages of bollards repaired after the initial audit findings.

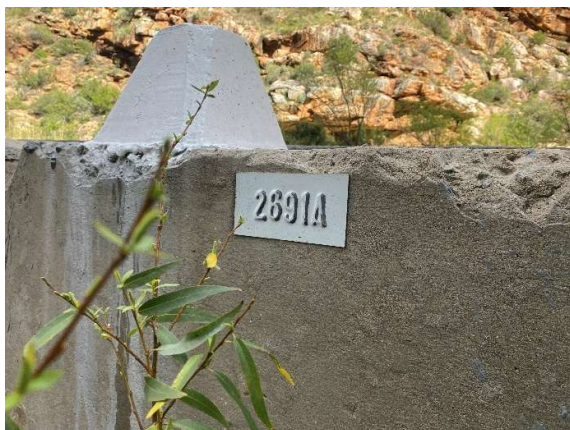
Newly installed structure number plate at causeway 11.

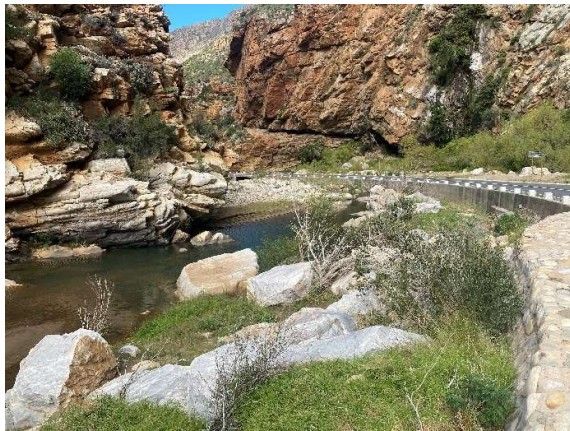
Downstream of causeway No 13 B2692A with no debris present and repair works evident.

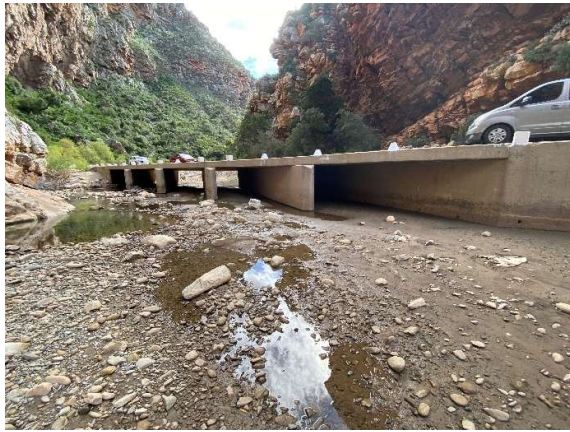
Downstream of causeway No 13 B2692A with no debris present and repair works evident.

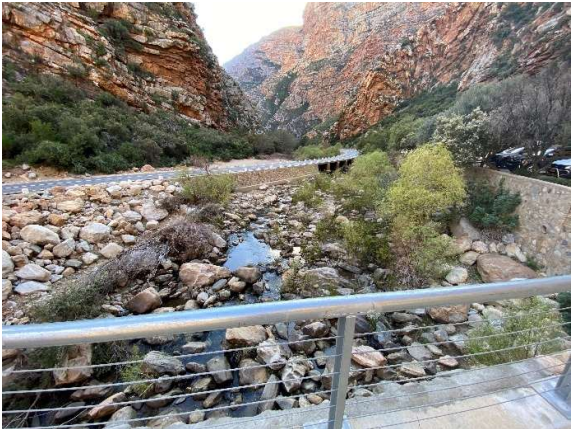
| Visual of the causeway towards the south with vegetation debris cleared. | Stone-pitched side drains at causeway 17. |

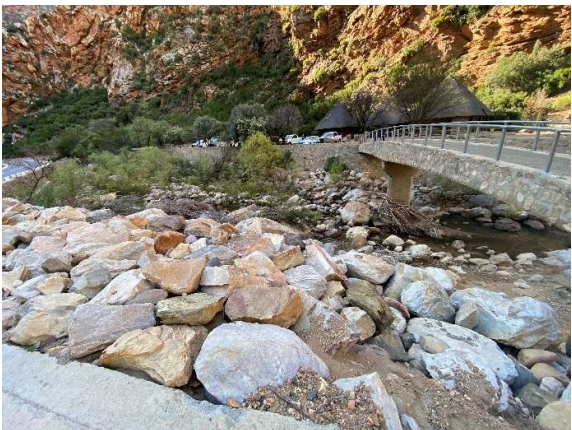
| Downstream of causeway 17 as seen in the direction of De Rust towards the pedestrian bridge. | Indication of the waterval river causeway |
