ANNEXURE A – SITE PHOTOGRAPHS

Site Camp and Stockpiles @ km 25

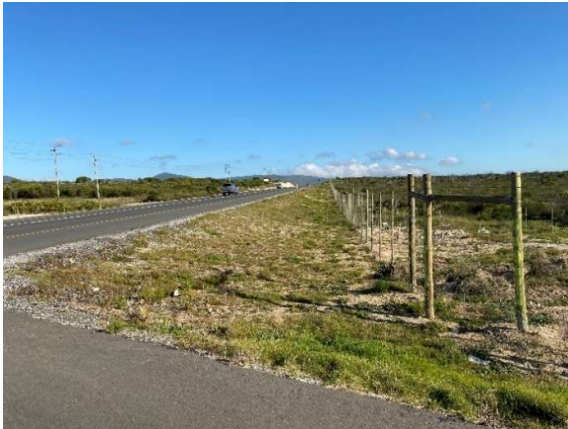
The access off R43 towards stockpile area 3 and the site camp as seen towards the south.

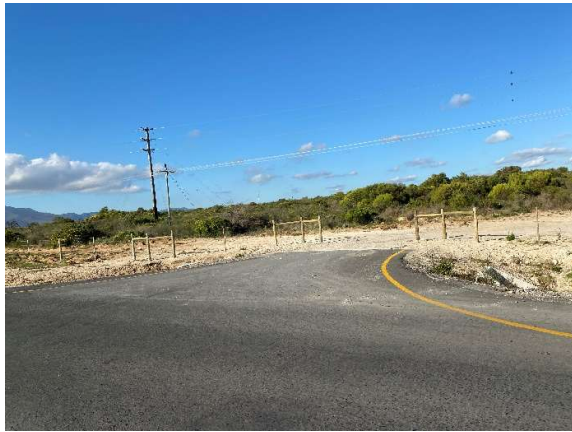
Access off the MR 269 towards Stockpile area 2

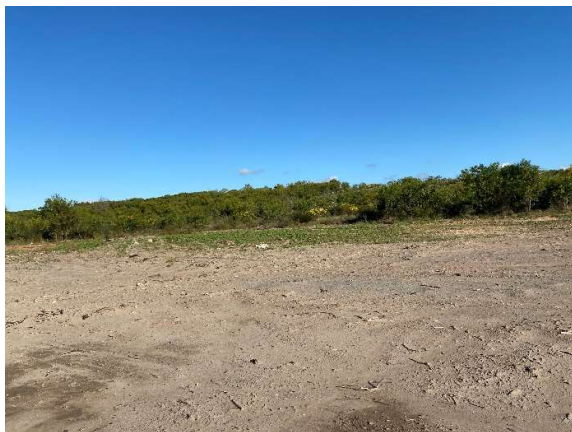
Stockpile area 2, at approximately km 27.5 where all stockpiled material has been removed and the area ripped.

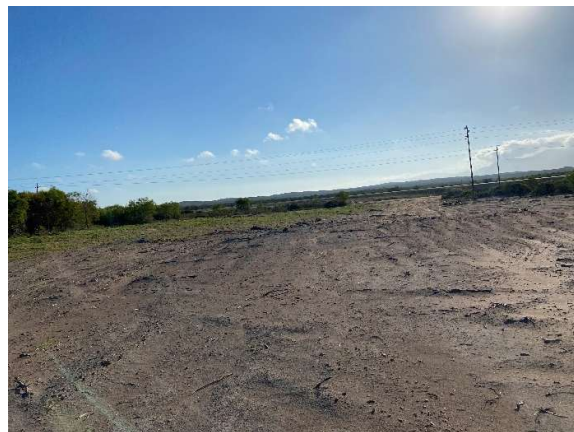
Stockpile area 2, at approximately km 27.5 where all stockpiled material has been removed and the area ripped.

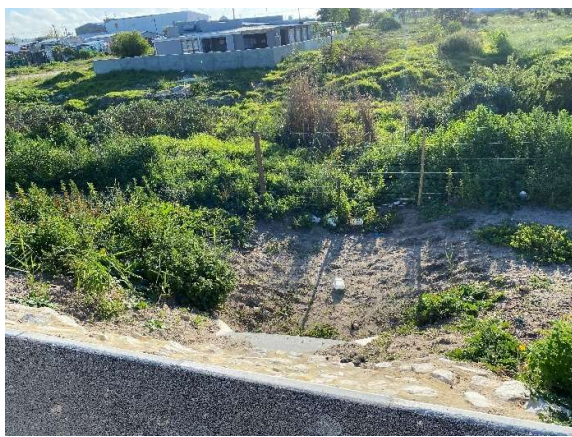
Pipe culvert with headwall completed along the west of the road at km25 as seen towards the west.

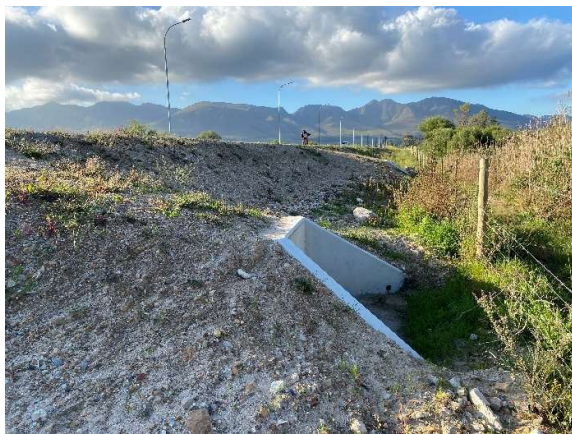
Pipe culvert with headwall completed along the east of the road at km25 as seen towards the north.

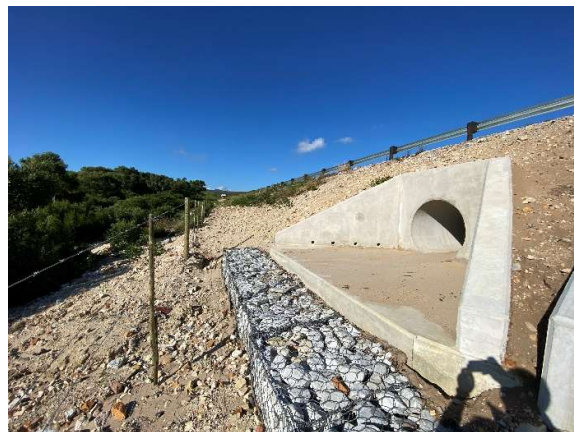
Completed culvert outlet with wingwall and mattress downstream at km 37.84.

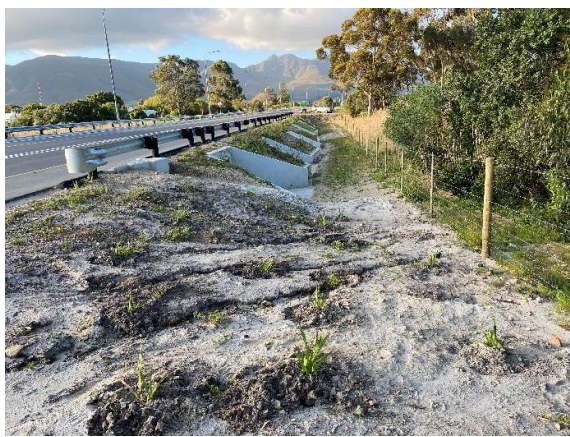
Completed rehabilitation along the eastern road shoulder at km24.

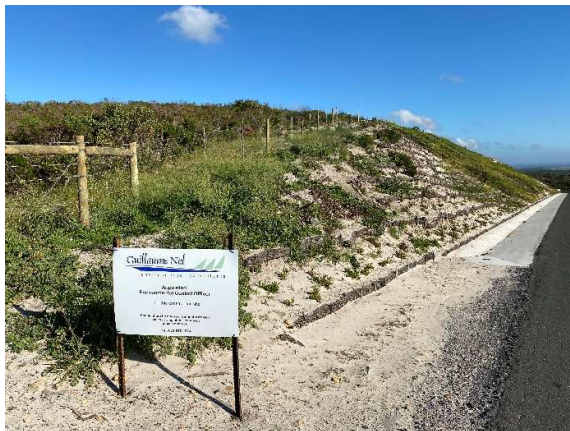
Completed large scale rehabilitation at the larger and steeper cuttings along the R43.

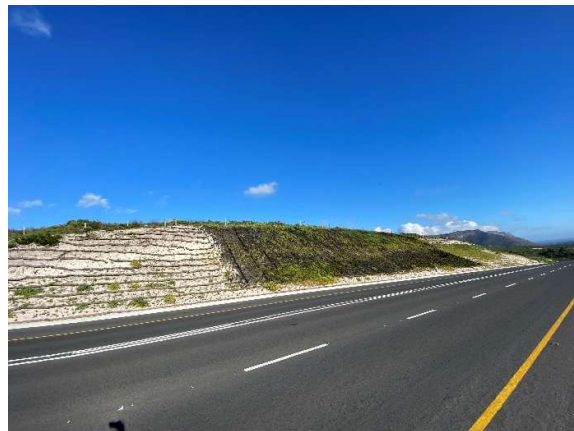
Completed large scale rehabilitation at the larger and steeper cuttings along the R43.

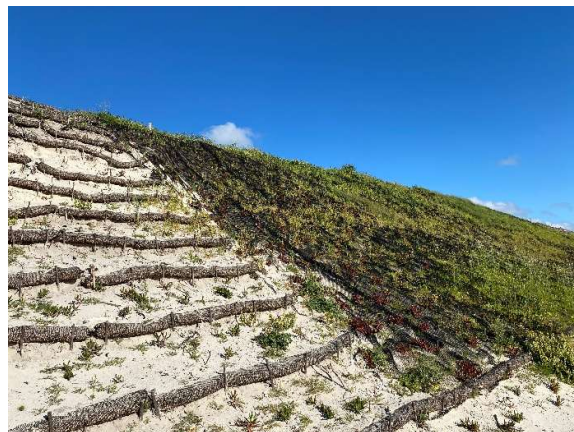
Completed large scale rehabilitation at the larger and steeper cuttings along the R43.

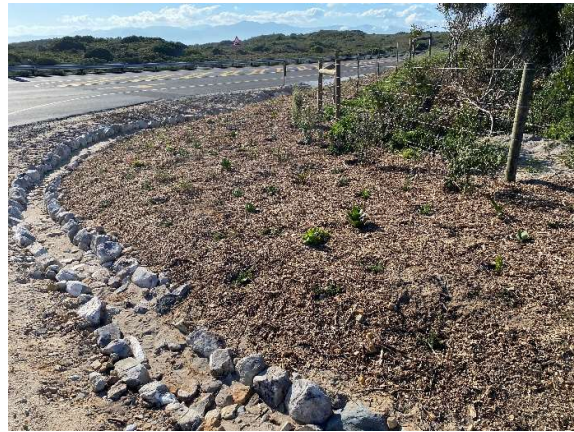
Completed planting and rehab at the Grootbos turnoff complete with stone pitched stormwater drainage.

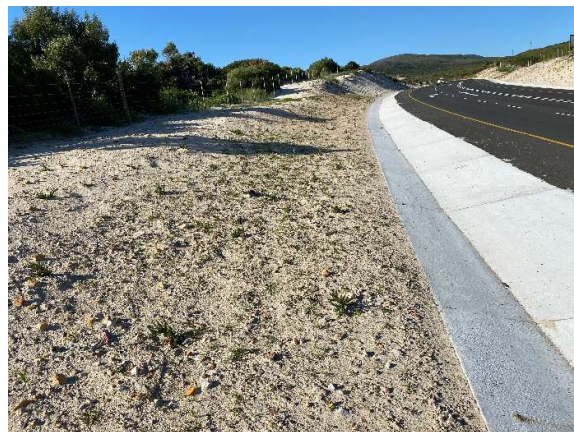
Completed planting and rehab along the sandy exposed slopes as seen towards the north.

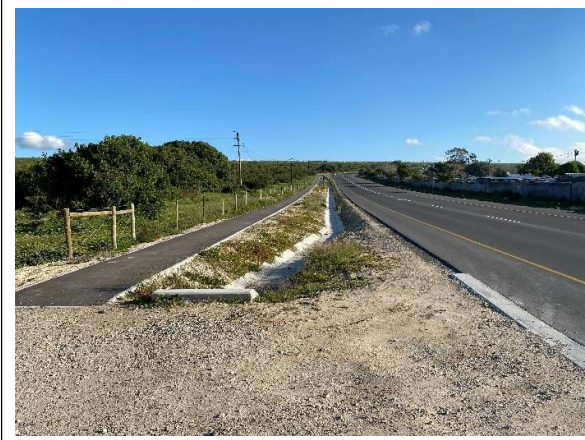
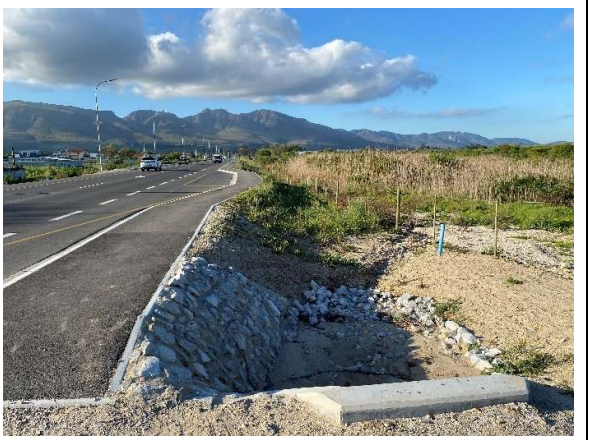
| <p>Sidewalk and formal stormwater channel completed at km 25 as seen towards the south.</p> | <p>Sidewalk and formal stormwater channel outlet completed at km 25 as seen towards the north.</p> |

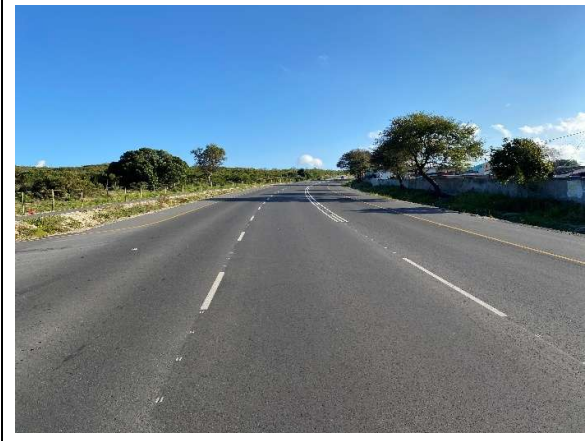
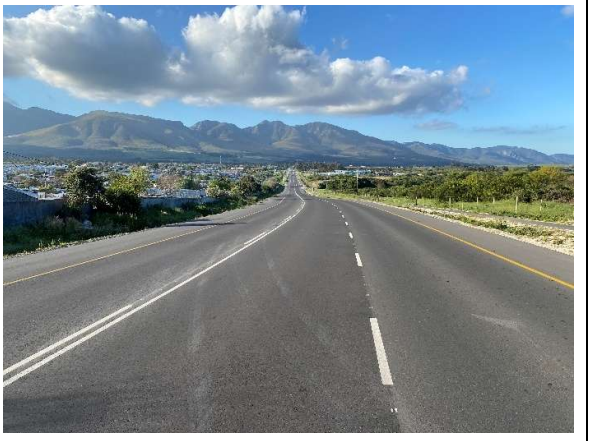
| <p>Completed road surface near km 25 seen towards the south.</p> | <p>Completed road surface near km 25 seen towards the north.</p> |

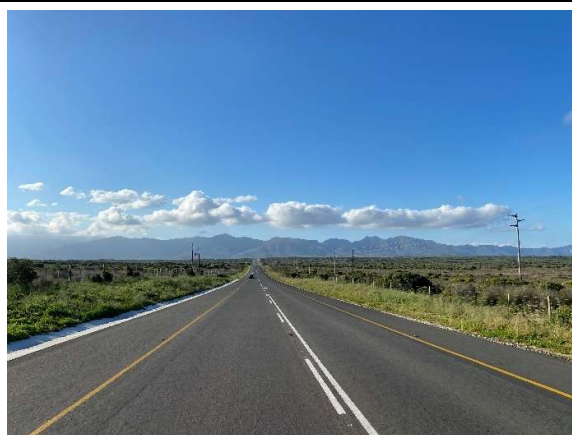
Completed road surface near km 29 seen towards the north.

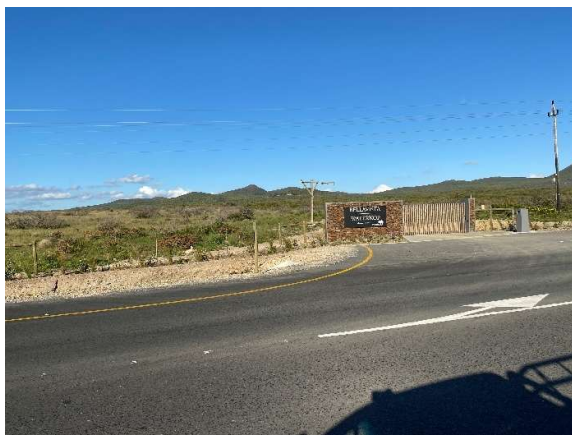
Decommissioned water collection point at Waterkop nature reserve at km 32 seen towards the east.

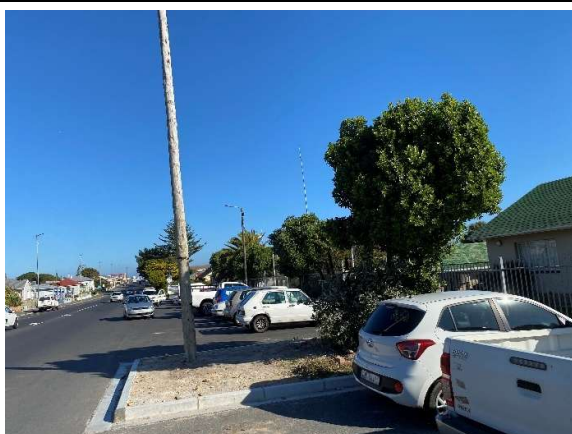
Protected Milkwood tree along the western edge of the road in Gansbaai at km43.
