## APPENDIX A – SITE PHOTOGRAPHS

## External Audit

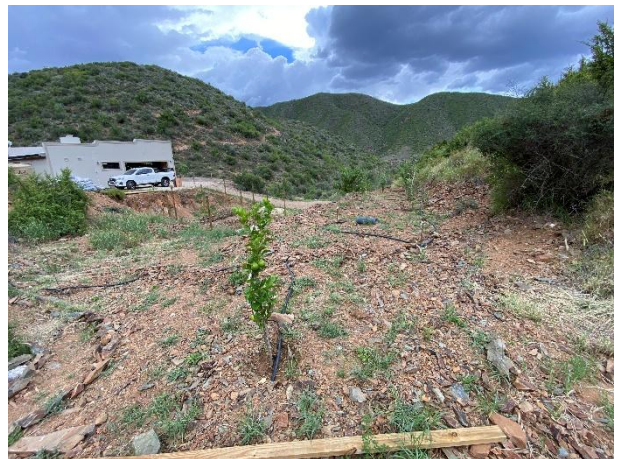
Garden area with fruit trees towards the northeast.

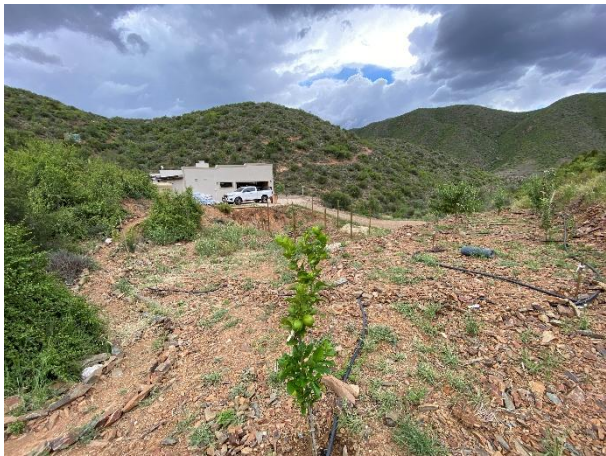
Garden area with fruit trees towards the northeast.

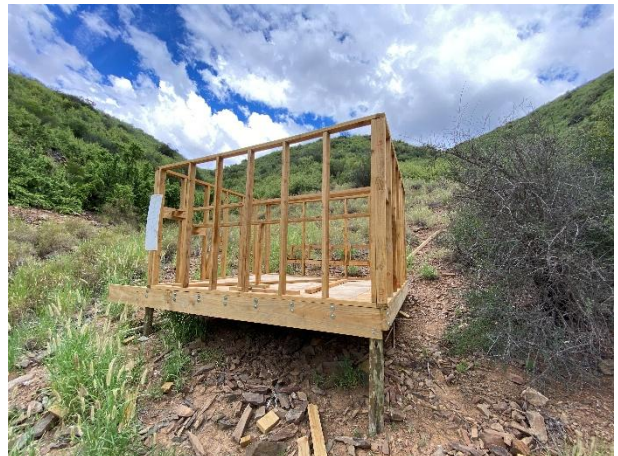
Chicken coop deck on stilts.

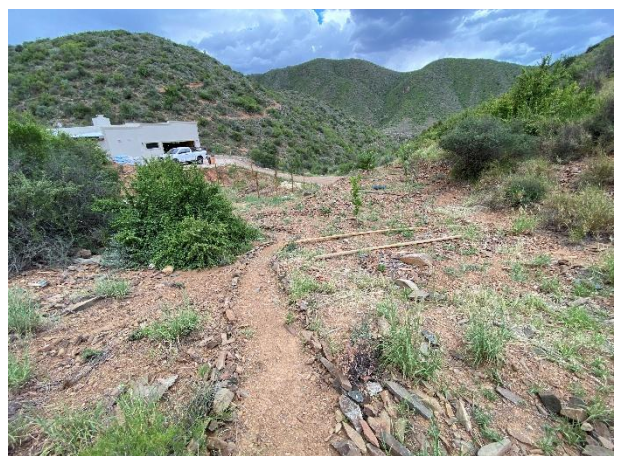
Walkway towards the house as seen from the garden area.

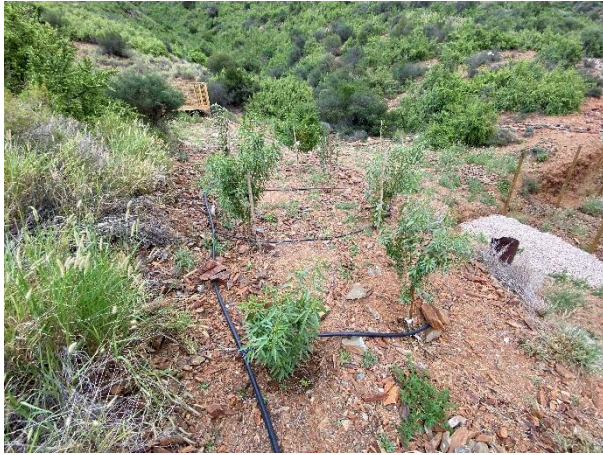
Planted fruit trees along the northeast.

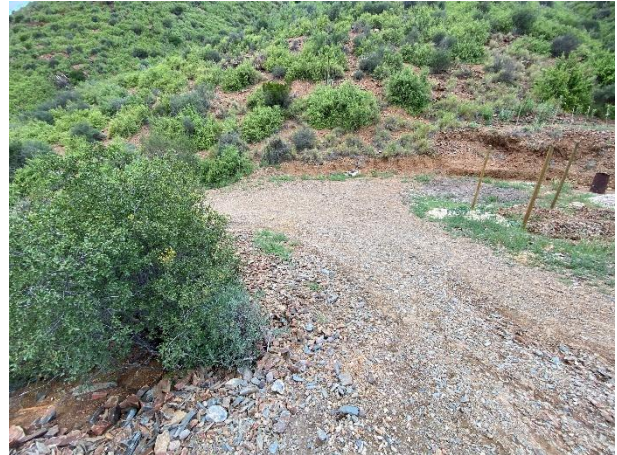
Access road towards the northeast.

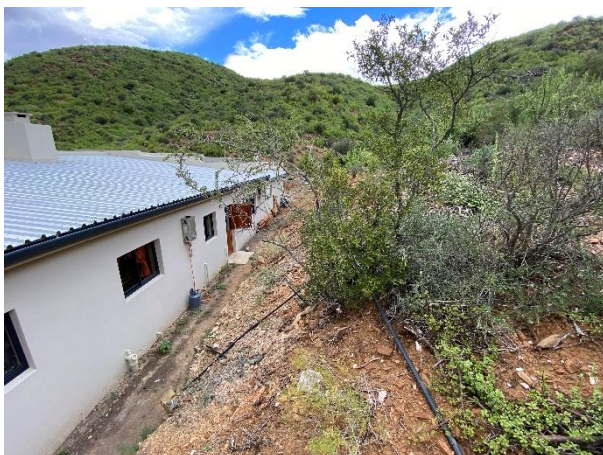
Vegetation surrounding the main house along the southwest boundary.

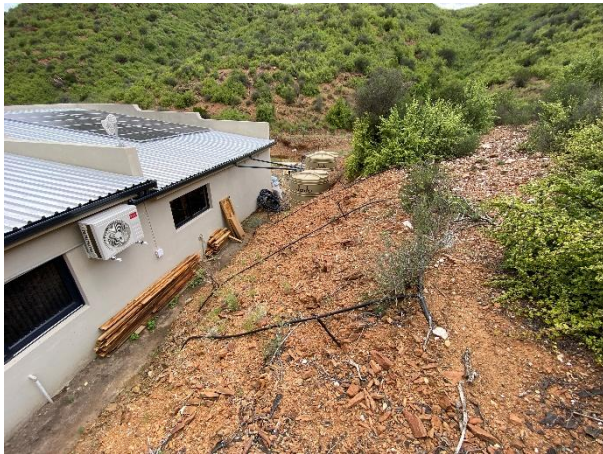
Vegetation surrounding the main house along the southwest boundary.

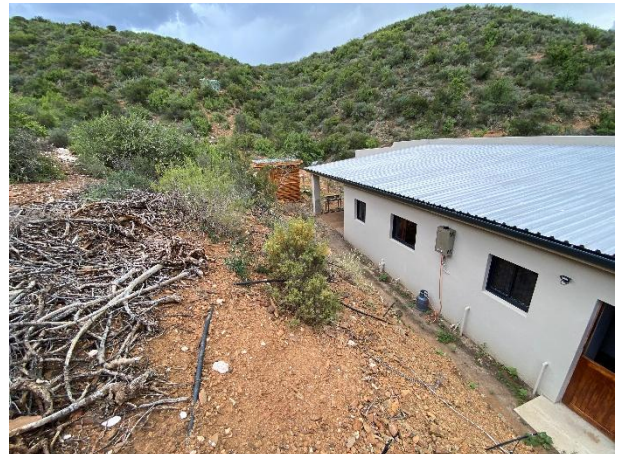
Vegetation surrounding the main house along the southwest boundary.

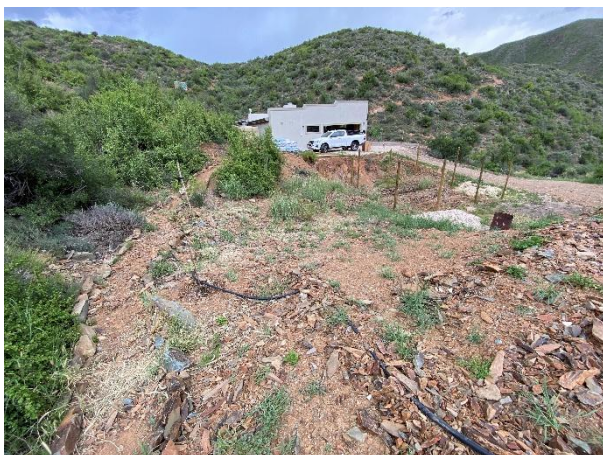
View of the garden and proposed greenhouse location as seen from the chicken coop deck towards the northeast.

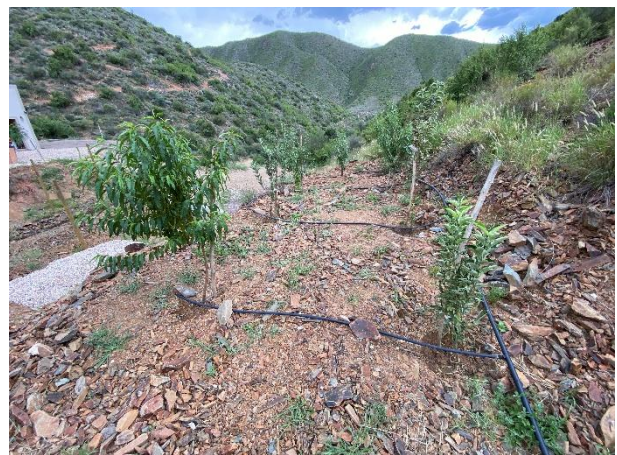
View of the planted fruit trees towards the northeast.

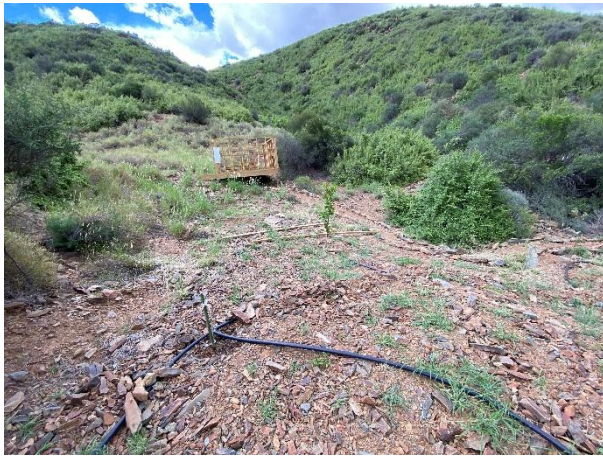
View of the chicken coop deck towards the northwest from the garden.

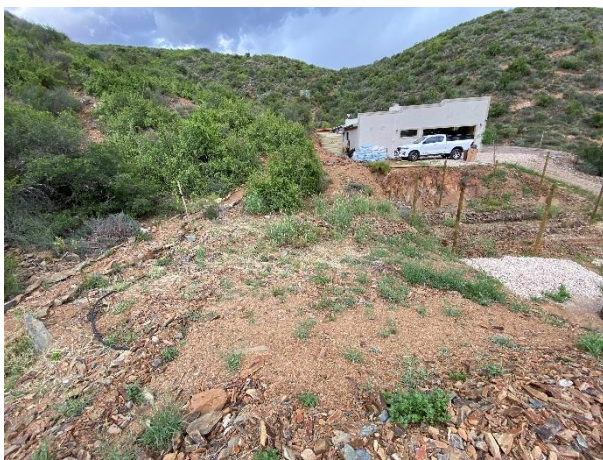
View of the garden and proposed greenhouse location as seen from the chicken coop deck towards the northeast.

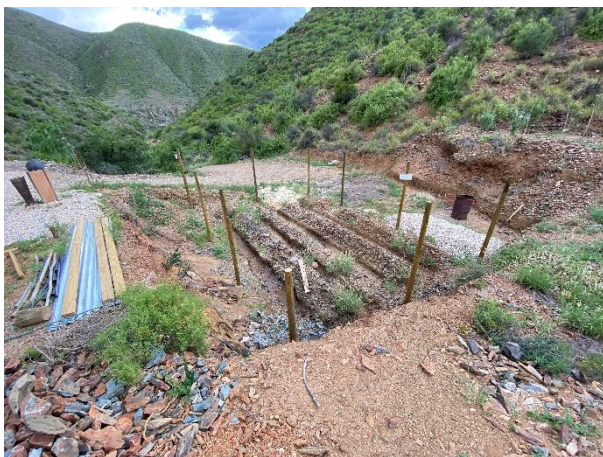
View of the proposed greenhouse from the house towards the southeast.

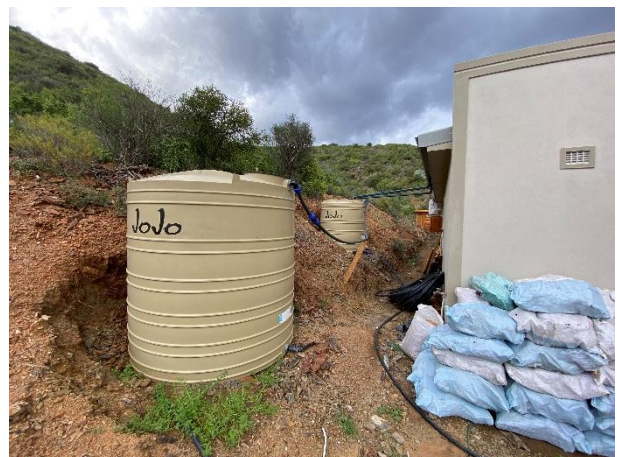
Jojo tank along the southern boundary of the main house.

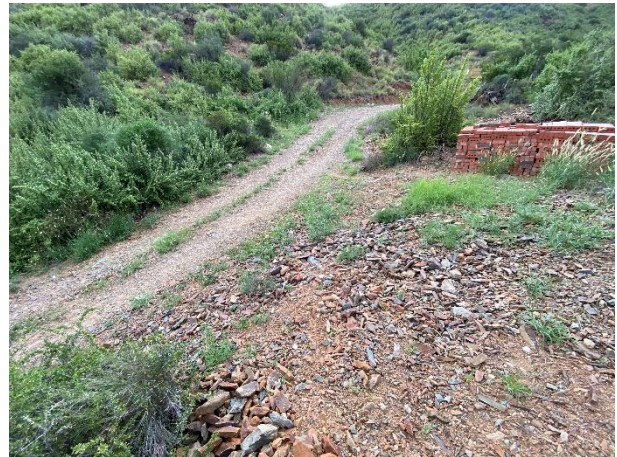
Access road to the property at 33°29.6426' S; 21°36.9680' E.

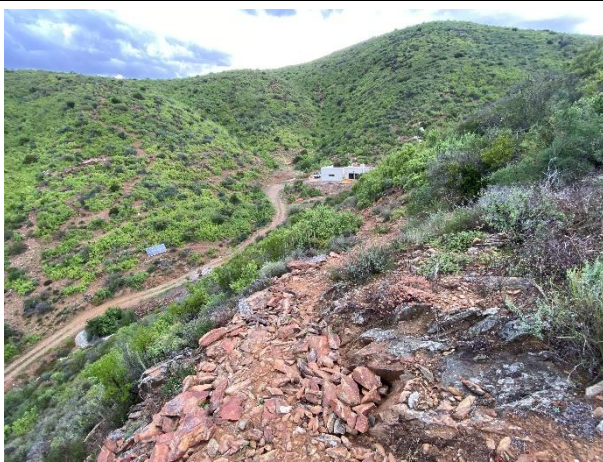
View of the access road and house towards the south.

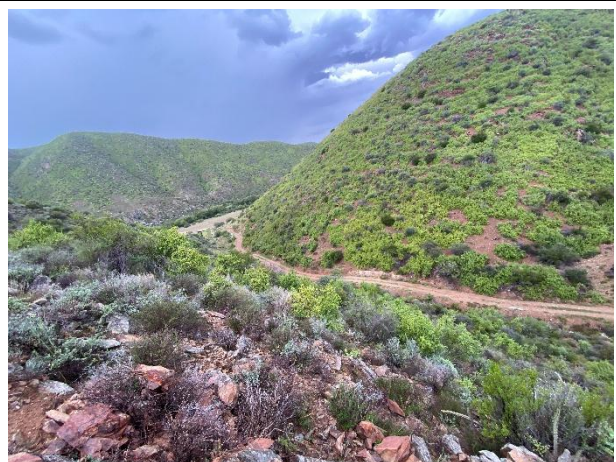
Access road along the mountain towards the west.

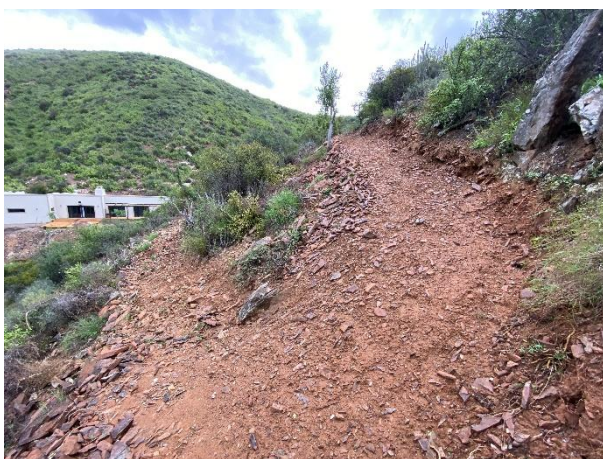
View of the house towards the south.

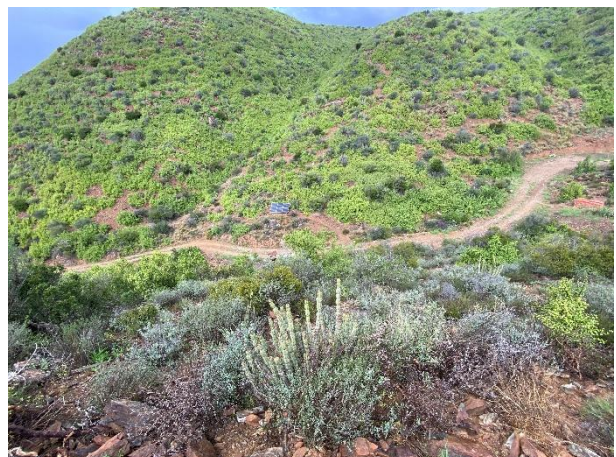
View of the solar panels and access road at the entrance of the house.

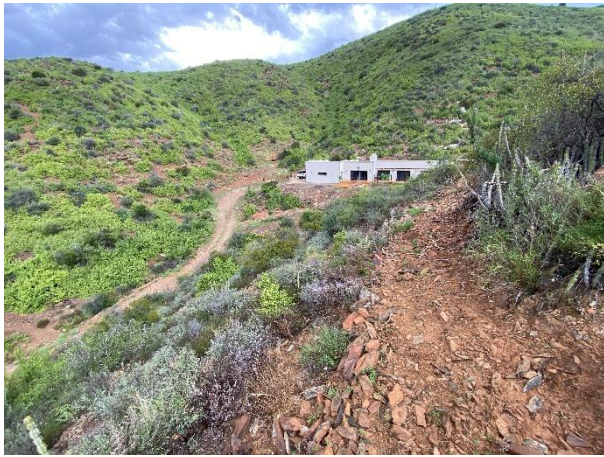
View of the access road and house towards the south.

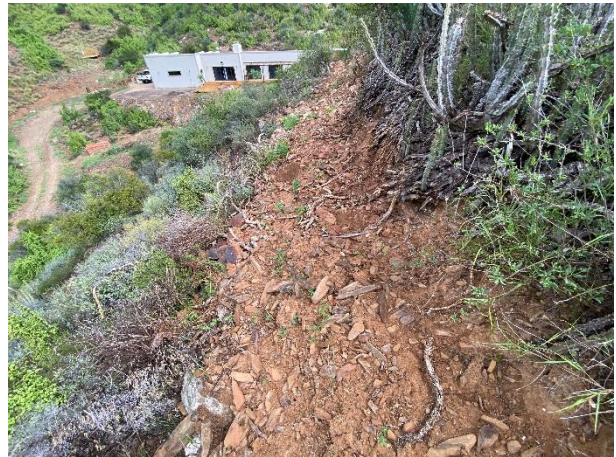
View of the access road and house towards the south.

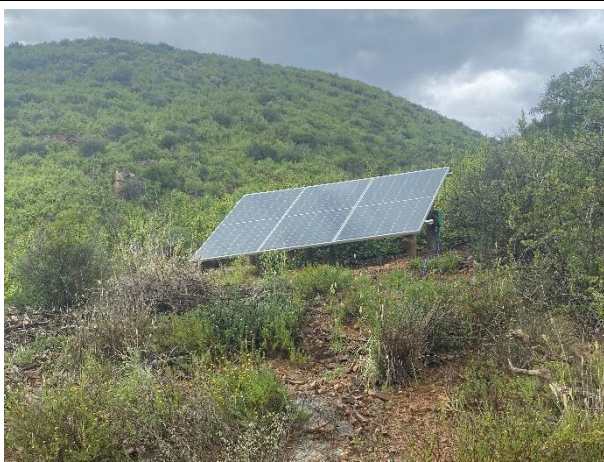
Solar panels at the entrance of the house.
